Case study on the global slope failure with geogrid reinforced soil wall

ABSTRACT: This paper describes a case study on global slope failure in a tiered geogrid reinforced soil wall. Site investigations and slope stability analyses were conducted to investigate the causes of the collapse. The collapsed history with the regional rainfall records indicates that the decrease of the bearing capacity in foundation ground induced by seepage of rainwater was one of causes of the collapse. The other reason of the collapse was the increasing of the active forces in the slope induced by pile driving on the embankment slope. These results were confirmed by slope stability analyses with considering rainfall and construction stages respectively.

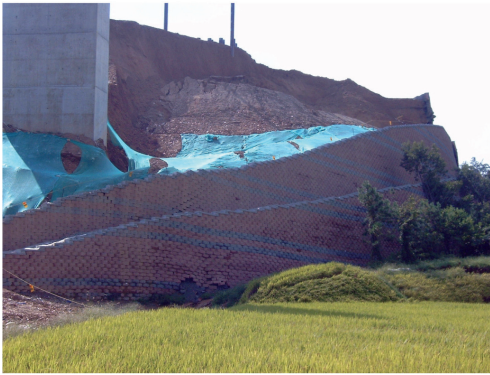
Figure 2. Photo of collapse in the reinforced soil wall.

The collapse of the structure occurred at slope with geogrid reinforced soil wall during pile driving for the abutment foundation as shown in Figure 2. Figure 3 shows two representative cross sections of the structure with soil profile at the collapsed area. The

Figure 4 shows the situation at the time of the collapse. Total 34 piles were planned to install to support the abutment. The global slope failure occurred at No. 5 pile driving which was twentieth pile driving.

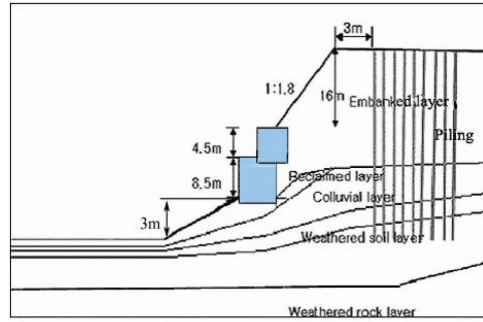
(a) A-A section

locations of two sections, A-A and B-B section, are shown in Figure 1. The original ground existing under the embankment is composed of reclaimed soil, colluvial soil, weathered soil and weathered rock respectively as shown in Figure 3. The colluvial layer is composed of clay and sandy gravel. The soil properties are shown in Table 1.

The results of the analysis are presented in Table 3. The safety factor of slope was larger than 1.2 in case of the analysis on A-A section. However, in case of B-B section, the safety factor of slope was less than the required safety factor of slope, 1.2, and decreased with the rise of the groundwater level.

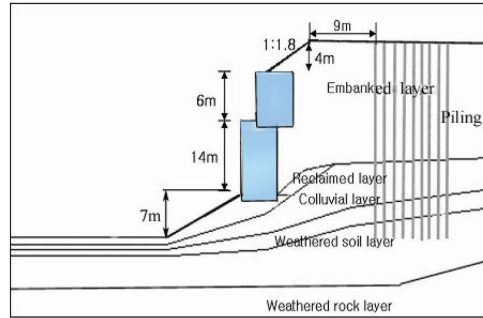
(b) B-B section

Especially, when the ground water level was distributed in the surface of reclaimed soil layer, the safety factor of slope was less than 1.0, which is the critical safety factor of slope. This means that the slope is very unstable so as to generate sliding failure in slope.

groundwater levels. The safety factor of slope was larger than 1.2 in case of the analysis on A-A section. However, in case of B-B section, the safety factor of slope was less than the required safety factor of slope after the completion of the upper wall. After the construction of the upper wall, the safety factor of the slope with reinforced soil wall was near in critical safety factor of slope. Moreover, it was found that the repeat of the pile driving cause the decrease of the slope safety factor. This means that the slope with reinforced soil wall is unstable.

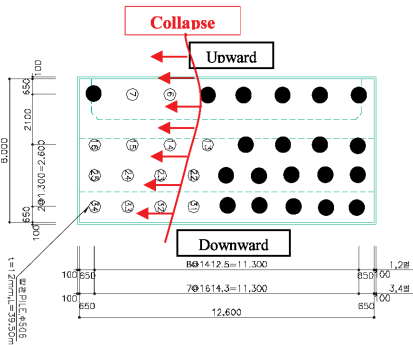
Figure 4. Situation of installation of foundation piles.

the bearing capacity of the foundation might induce not only the differential settlement of the foundation ground but also the decrease of the resisting forces against the slope failure. Furthermore, pile driving, which was begun at August 31, might be worked as active forces in the slope. As a result, there were two inferences to be drawn from the collapsed history with rainfall records. One was the decrease of the resisting forces induced by the seepage of rainwater and the other was the increment of the active forces by pile driving.

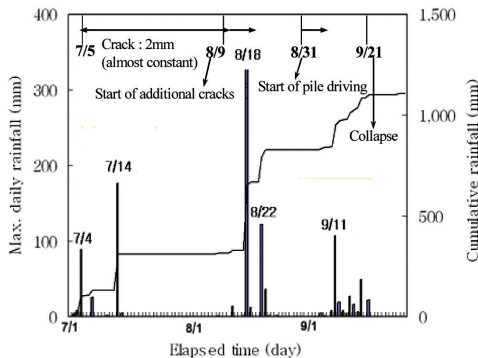
Figure 5. Collapsed history with rainfall record.

In June 24, some cracks were found firstly at the facing blocks of the wall. Figure 5 shows the collapsed history with the regional rainfall records. The cracks were more progressed slightly until July 5, and then stopped until August 8.

Although it rained heavily at July 4 and July 14, 90 mm/day and 176 mm/day respectively, the length

of cracks was very slightly increased during about 30 days after the heavy rainfall. However, additional cracks were observed again at August 9. These occurrences of cracks mean a sign of failure induced by seepage of the rainwater through the colluvial layer as shown in Figure 6. The colluvial soil has large permeability as shown in Table 1. The seepage induced the decrease of the bearing capacity in foundation ground. Moreover, the bearing capacity of the foundation might be decreased severely by additional heavy rainfalls at August 18 (328 mm/day) and August 22 (122 mm/day). The decrease of

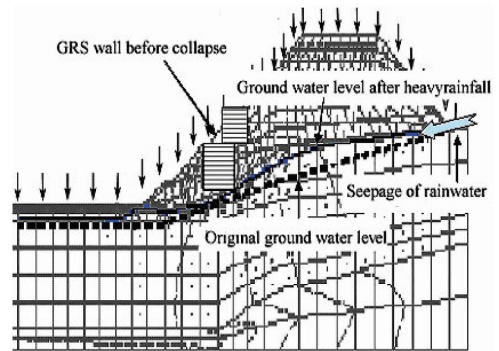
Figure 6. Seepage of rainwater and change of ground water level.

levels were performed by Bishop simplified method. From the results of site investigation after the collapse, it was found that the original groundwater level was distributed between colluvial soil layer and weathered soil layer. However, the groundwater level can be risen upward by the seepage of rainwater as shown in Figure 6. Therefore, the analyses of slope stability were performed on three different ground water levels, which are distributed in the central part of colluvial soil layer, the surface of colluvial soil layer and the surface of reclaimed soil layer shown in Figure 3 respectively.
