Investigation of stress cracking in a reinforced polypropylene floating cover

Peggs, I.D.

I-Corp International, Inc., USA

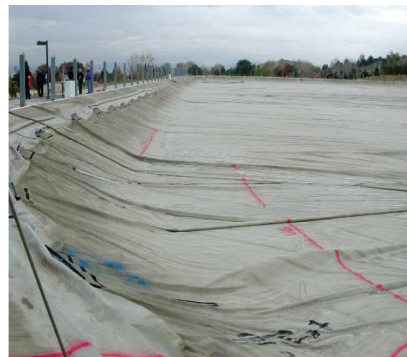
After about 6 years the cover started cracking, primarily on the slopes, and predominantly on the upwind side of the reservoir where the inside slope was in the lee of the wind (Figure 1). At some locations the excess material was neatly folded (Figure 2) but at others the tensioning wire had pulled away from the pulley at the base of the tensioning post and was lifting the fold (Figure 3) towards the top of the post, increasing the tensions and exposing the cover to wind. The cracks were generally in the darker areas on the exposed part of the fold as shown in Figure 1.

Figure 1. Cracking in dark area on slope.

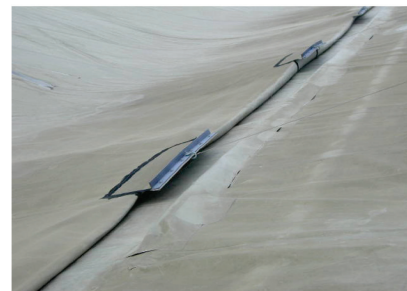
Figure 2. Tidy fold of excess cover material.

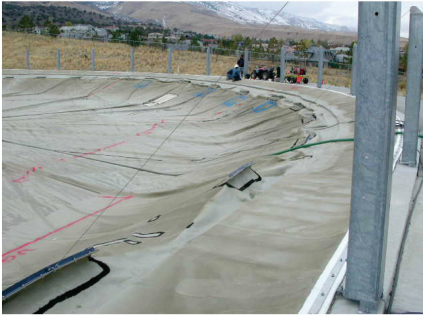
Figure 3. Cover tensioned directly to top of post rather than via pulley at base of post.

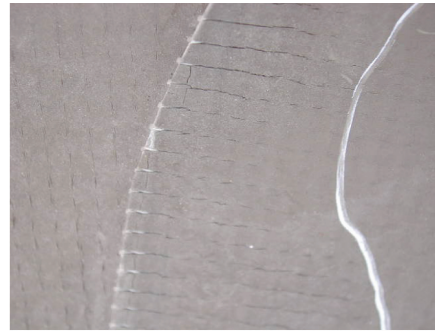
Figure 6. Cracking on cover (left) and patch (right).

Cracking along the weft yarns subsequently occurred (Figure 5), then the resulting small squares of exposed PP began to spall off the liner. At one interesting location cracks occurred normal to one another in the cover and a patch (Figure 6).

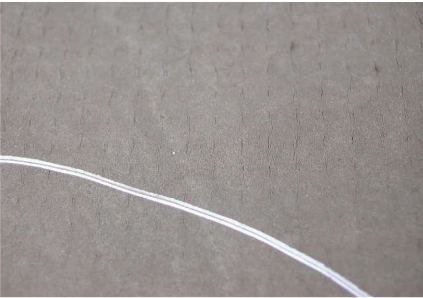
The cracks were initiated on the warp (roll direction) reinforcing yarns up and down the slopes (Figure 4)

Figure 4. Cracks initiating on warp yarns up and down the side slope.

Therefore, the bending stresses of the PP polymer over the warp yarns were higher, hence the first failures at these locations.

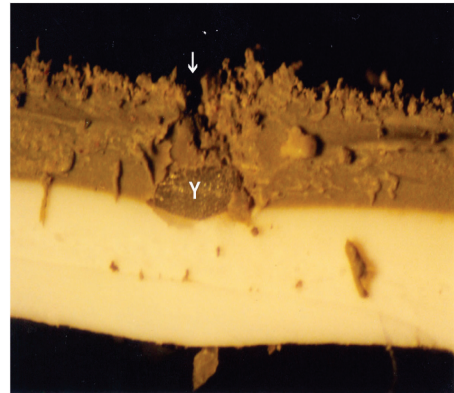
Figure 7. Crack (arrowed) above round warp yarn (Y).

There was essentially no cracking in the cover in contact with the water at lower stresses and lower temperatures. Microsections of the cover showed the warp yarns to be round in cross section (Figure 7) while the weft yarns were more elliptical with the longer axis in the plane of the sheet (Figure 8).

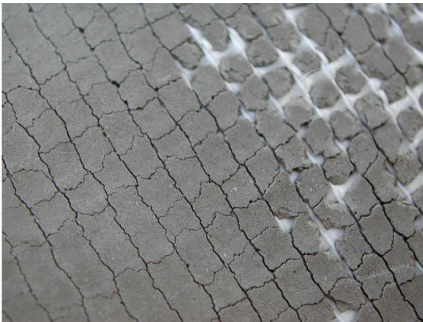
and at 45° to the slopes in corners (Figure 5). Thus, the initial cracks were not perpendicular to the expected primary stress direction, up and down the slopes.

Figure 5. Major cracks on warp yarns (top left to bottom right) at 45° to slope and minor cracks on weft yarns (bottom left to top right), with PP layer beginning to spall.

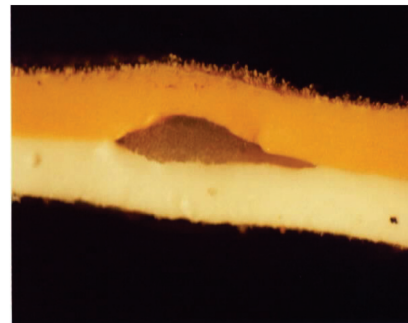
Figure 8. Elliptical weft yarn.

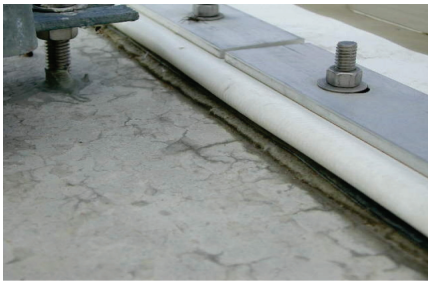
At another site and in another RPP product the complete exposed layer was removed (Peggs, 2005). Cracking was most advanced in the higher temperature stressed areas, but only occurred in the exposed green layer. There were no cracks in the underside white layer, even where it was exposed and tightly bent around a securing line outside the peripheral batten strip, as shown in Figure 9.

Figure 9. Stressed white layer exposed to UV radiation.

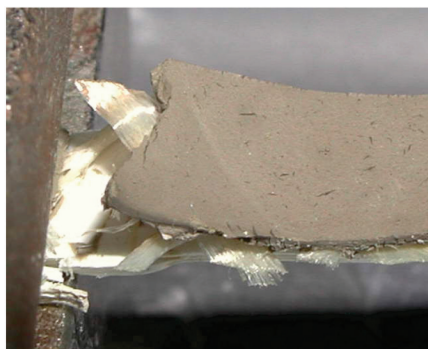
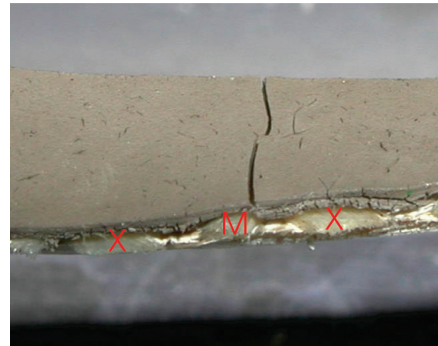
Specimens of unexposed archive material were subjected to GRI.GM18 Oven Aging and UV Resistance tests both with and without stress, approximately 1 MPa (147 psi). Specimens were cut on the bias so only the polymer layers would take the stress. Only the green layer was exposed to UV radiation. After only 500 hr of the 1600 hr UV test exposure the stressed specimen was found to have cracked in the green layer (Figures 10 and 11) with

Figure 10. Cracked constant load UV specimen. Break at jaws in upper green layer only on warp yarn. Note "flat" weft yarn.

Figure 11. Major crack above round warp yarn (M) only. Smaller cracks on surface. Flatter weft yarns X.

After the test its retained HP-OIT value was effectively zero, while that of the unstressed specimen was 77%. The oven aging unstressed and stressed specimens had retained HP-OITs of 98% and 47% respectively. Thus the synergism of both thermal and UV aging with stress is clearly evident, with stress having a more significant effect on UV degradation.

- UV resistance (GRI.GM18) under a constant stress of 1 MPa. No break and HP-OIT retained > 75%
- Oven aging (GRI.GM18) under a constant stress of 1 MPa. No break and HP-OIT retained > 75%
