# Evaluation of an airport pavement after almost 8 years of overlay rehabilitation with a polyester geogrid asphalt reinforcement

Keywords: polyester geogrid, asphalt reinforcement, overlay rehabilitation

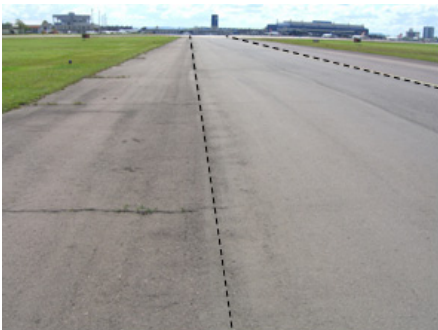
A different situation was observed on the non reinforced and on the shoulder track, without geogrid. Reflective cracks were more frequent and more opened (some with 10mm aperture), mainly over the slabs joints, from what the dimensions of the slabs could be clearly seen. Figure 2 presents an overview of the section. Figure 3 presents the visual situation of some inspected sections.

Figure 2. Overview of the studied section: view from the dockyards to the terminal.

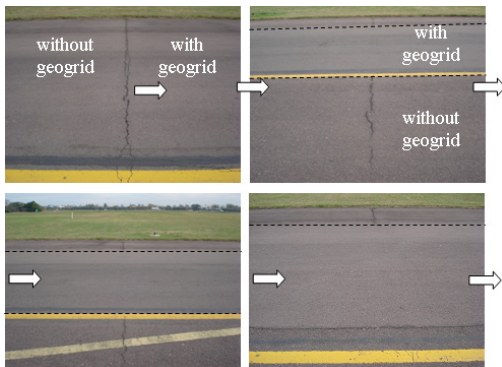
Figure 3. Sequence of pictures showing reflective cracks on the tracks (areas) without reinforcement, but no clear crack on the reinforced areas.

On the first pictures showed on Figure 3, the exact point of the beginning of reinforced stretch, where a remarkable reflective crack from a joint between two slabs may be seen upon the edge of the geogrid panel. The other pictures highlight the comparison between the two tracks, showing cracks on non reinforced tracks and no clear cracks on the reinforced one. The trace line marks the limit between track with and without reinforcement. The arrows indicate the direction from the terminal to the dockyards.

It is different the situation on the non reinforced area. On these areas, reflective cracks are thick and extremely opened. A new maintenance intervention should be forecasted. At least a sealing work over these cracks for avoiding water infiltration and fines pumping effect should be done.

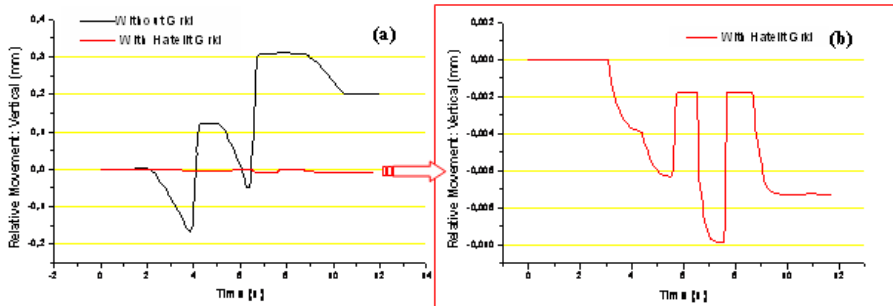
Figure 5 and Figure 6 present CAM data for two of the studied cracks, one on the reinforced zone, the other on the non reinforced zone, both over slabs joints, respectively vertical and horizontal relative displacements. Figure 7 presents a resume of all the measurements in terms of maximum measured displacement in each case.

Figure 5. Vertical relative displacements between crack walls: (a) cracks on areas with and without geogrid, (b) zoom of the results on the area with geogrid.

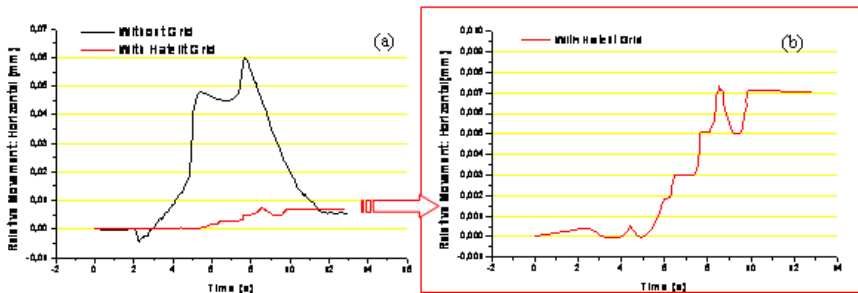
Figure 6. Horizontal relative displacements between crack walls: (a) cracks on areas with and without geogrid, (b) zoom of the results on the area with geogrid.

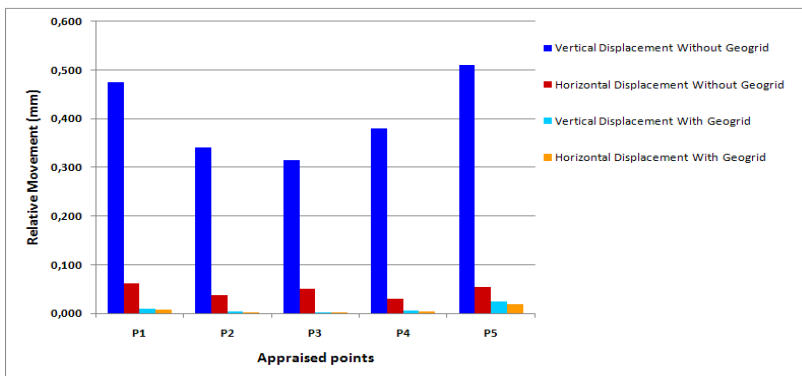
Figure 7. Maximum relative displacements measured in each case: vertical and horizontal relative movements of crack walls on areas with and without geogrid.

By analyzing the results present on Figure 7, it is clear that vertical displacements are dominant in the studied case. It is an important information at the time of studying a new maintenance project. Residual shearing strength on the cracks, promoted by the geogrids, allow for a remarkable decrease of vertical displacements on the cracks on the reinforced zones, what implies on much less severe condition in terms of potential for crack reflection on those areas.

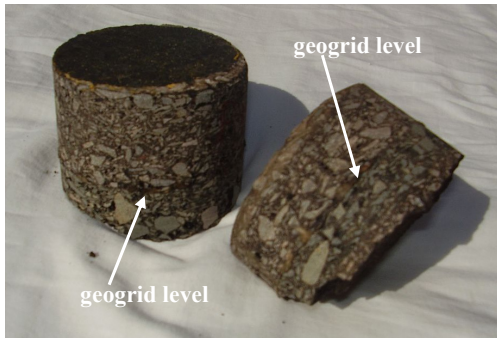
By analyzing those specimens, it was clear the effect of interrupting the crack propagation on the geogrid level (Figure 8). This means that the reinforcement protected the new overlay from stress concentration on that zone on that level, avoiding the reflection of pre-existing crack, or, in the worst cases, producing considerably less aggressive cracks on the new asphalt layer along almost 8 years of traffic loading. It could be also observed good adherence between asphalt layers on the geogrid level.

Figure 8. Specimens taken on reinforced areas: one non cracked (left) and another cracked (right).

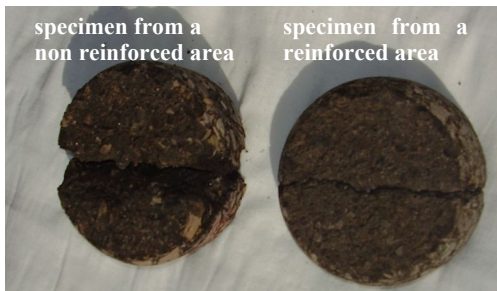
In the case of specimens taken from non reinforced zones, when including cracks, it was not possible to extract an integrate element since the crack took the full thickness and separated at least in two parts these pieces (Figure 9). In some of those cases, adherence between the two asphalt layers was lost during extraction, what was not the case of specimens taken from non cracked areas.

Figure 9. Specimens from areas with (right) and without (left) reinforcement.

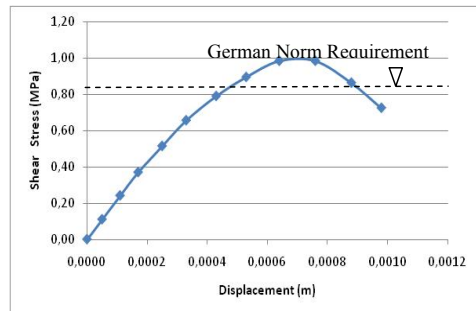
According to the German Norm ZTV SIB 90, for specimens with 10cm diameter, the adherence may be considered satisfied for a shear stress greater than 0,85 MPa. Figure 11 shows the results of the direct shear stress test, with a maximum strength reaching 1,00 MPa, satisfying this reference.

Figure 11. Direct shear test result.

It is also remarkable the good adherence of the geogrid on the asphalt pavement depicted from the direct shear tests performed on lab with some extracted cores. The obtained results are greater than the minimum required by German regulations. The good adherence is mainly due to the bituminous coating of the geogrid used in this.
