## Failure mechanism of a geogrid reinforced abutment on soft soil

A.R.S. FAHEL, University of Brasilia, Brazil  
 E.M. PALMEIRA, University of Brasilia, Brazil

**ABSTRACT:** Geosynthetics can be effectively used to reinforce embankments on soft soils. However, some times basic conditions to be fulfilled for a satisfactory performance of the reinforced structure may be overlooked. This paper describes a case-history where the lack of observation of some basic concepts for this type of work almost yielded to a catastrophic failure of a reinforced abutment on soft clay. The main reasons for that were bad construction practice and insufficient design considerations. Even under these circumstances, the presence of the reinforcement layer minimised the consequences of the failure mechanism developed and showed the influence of reinforcement tensile stiffness on the reduction of the horizontal displacements of the embankment.

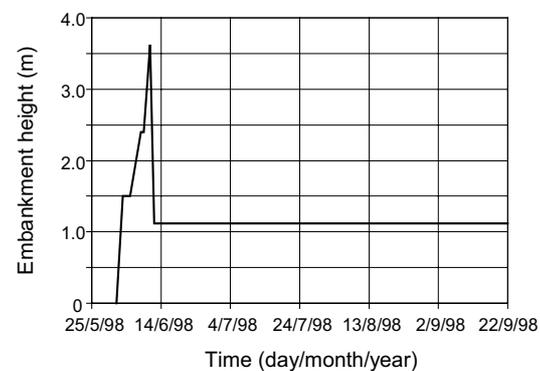
Figure 4. Variation of embankment height with time.

The embankment was lifted at a rate of approximately  $0.35 \text{ m/day}$ , as shown in Figure 4. After 10 days of construction, when the embankment height reached 3.6m, large cracks were observed along the embankment surface, parallel to its longitudinal axis, as shown in Figure 5 (a). The contractor and designers then decided to stop the construction and to remove a significant part (2.5 m) of the embankment height in order to build a berm (1.1 m high) for the stabilisation of its lateral slope. The reinforcement capacity to increase embankment stability at such a fast rate of construction was certainly overestimated. It was then decided to leave the embankment with a height of 1.1 m for approximately 4 months for the soft soil to gain strength due to consolidation before construction restarts. A similar failure mechanism and remedial measures to avoid embankment collapse was also observed in other reinforcement abutment in the region and it is described elsewhere (Fahel et al. 2000). Figure 5 (b) shows a pit excavated in the fill to locate the region where the reinforcement failed in tension.

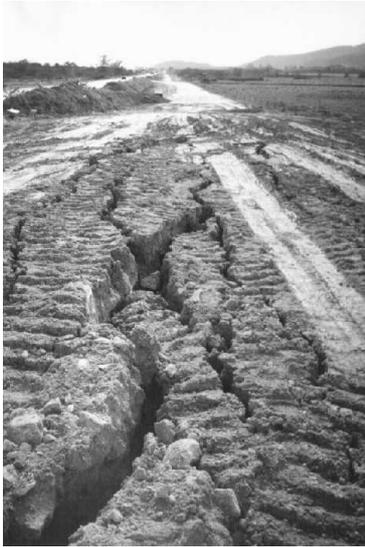
(a) Cracks on the embankment surface.

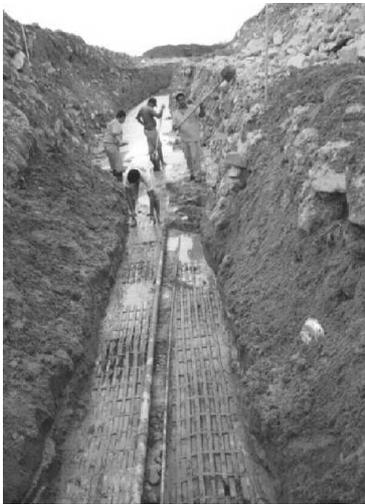
(b) Excavation to locate geogrid failure.

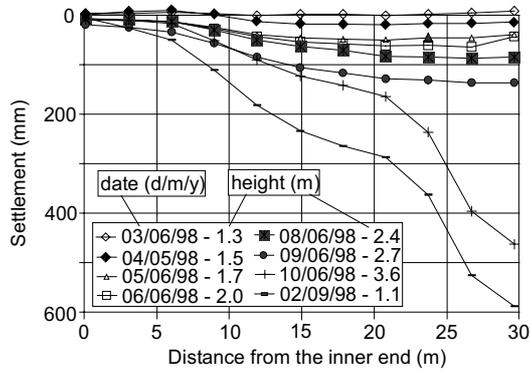
Figure 6. Embankment settlement along its longitudinal axis.

Figure 6 shows the evolution of embankment settlement profiles along the embankment axis at different construction stages, obtained from horizontal inclinometer measurements. A consistent pattern of settlement variation with time can be observed up to the embankment height of 2.4m. When the height of 3.6 m was reached a sudden increase of settlements was observed, caused mainly by the failure mechanism of the lateral slope. After almost 3 months after the reduction of the embankment height to 1.1 m, the settlements had increased 10% due to consolidation of the soft soil (Fig. 6).

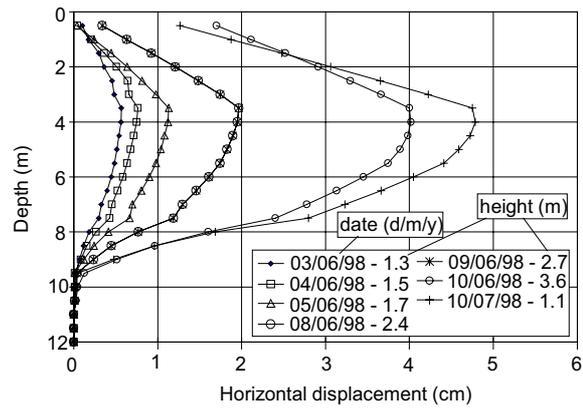
(a) Inclinometer I1.

Figures 7 (a) and (b) present the horizontal displacement profiles as measured in inclinometers I1 and I3 (Fig. 2a). The horizontal displacements beneath the embankment slope facing the river increased significantly after the embankment has reached a height of approximately 2.4 m (Fig. 7a). Figure 7 (b) shows that the horizontal displacements beneath the lateral embankment slope started increasing at a greater rate for embankment heights above 1.5 m. At the embankment height of 3.6 m the maximum

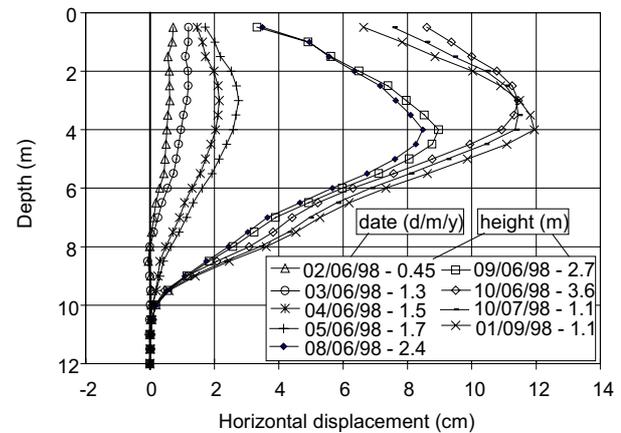
(b) Inclinometer I3.

horizontal displacement observed in the lateral embankment (weaker reinforcement direction) height was almost twice that value for the slope facing the river (stronger reinforcement direction). As expected, horizontal displacements of the foundation soil also increased due to consolidation.

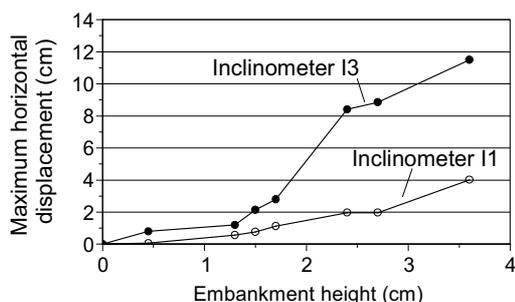
Figure 8. Maximum horizontal displacements in the foundation soil.

The variation of the maximum horizontal displacement in the foundation with the embankment height can be visualised in Figure 8. It is clear that a more significant yielding of the soft soil under the lateral embankment slope started after the its height reached 1.3 m, while a more steady and consistent evolution of maximum horizontal displacements with embankment height can be observed for the slope facing the river.

The results presented in Figure 8 also shows that the horizontal displacements in the foundation soil were considerably smaller in the stronger/stiffer reinforcement direction (embankment longitudinal direction). This suggests a significant effect of the combination of reinforcement and vertical drains in reducing lateral displacements of the foundation soil, which is particularly relevant in cases of presence of adjacent structures (bridges, for instance). The effect of the reinforcement on the reduction of lateral displacements of the soft soil for a similar case history is also reported in Palmeira and Fahel (2000).
