Forensic Investigation Of Geomembrane Liner Cracking: Premature Failure Or End-Of-Life?

Ian D. Peggs

I-CORP INTERNATIONAL INC., Ocean Ridge, FL, USA, icorp@geosynthetic.com

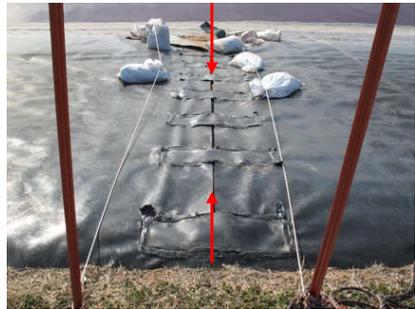
Discrete vertical splits, about 10 m long, had occurred on two side slopes of the pond from the water level up to the crest of the slope (Figure 1). The crack opening displacement was about 450 mm. Attempts had been made to “strap” the sides of the cracks together to prevent further wind-induced damage. Cracks were also found at subgrade stone protrusions at the crest of the slope (Figures 2 and 3) and along the edges of both fusion (Figure 4) and extrusion (Figure 5) welds – more on extrusion welds. At the time of the investigation the temperature was just above freezing and the liner was reasonably taut (Figure 6).

Figure 1 Cracking (arrowed) up side slope

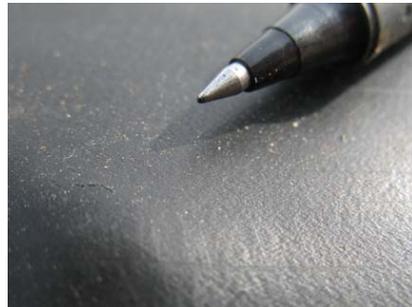
Figure 2 Small crack (circled) at subgrade stone protrusion

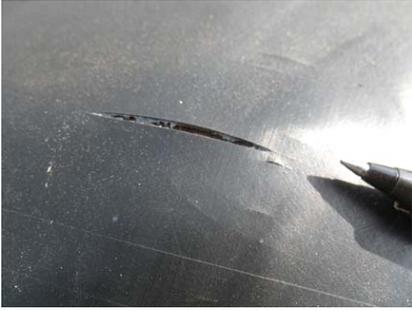
Figure 3 Long and short cracks on extrusion die lines at sub-grade stone protrusion

At the subgrade stone protrusions at the crest of the slope there were several straight cracks that had been initiated on the top surface of the geomembrane at faint extrusion die lines (Figure 3). These cracks were extremely sharp, brittle, and well-defined. They had propagated from the exposed surface down to the underside surface where the final ligament had failed in a ductile manner. These were perfect examples of stress cracks; slowly-propagating cracks at constant or cyclic stresses lower than the yield or break stress of the HDPE. The cracks along the welds were also stress cracks.

Therefore, the exposed surface of the geomembrane is more oxidized than the underside surface. When a subgrade stone protrudes against the geomembrane the exposed surface is placed in tension. The die lines concentrate the stress until a critical combination of tensile stress and oxidation initiates the stress cracking. As lower temperatures cause the geomembrane to contract the oxidation/stress situation at the manufacturing folds is shown in Table 2. Only the apex-down folds have the required combination of tensile stress and oxidation to initiate cracks, so they crack first.

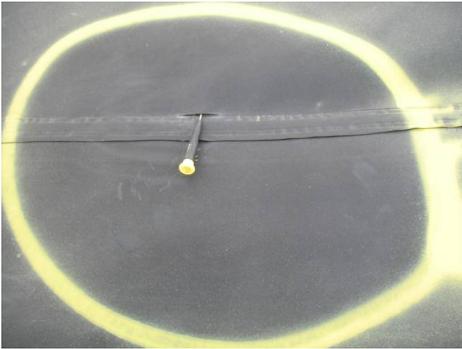
Figure 4 Cracking along edge of fusion weld

Cracks occur at welds due to both the stress concentrating notch geometries and the added oxidation that occurs during welding. Extrusion welds are more susceptible due to the presence of grinding gouges and in those locations where multiple weld beads are placed. In extrusion welds cracking invariably occurs at the edge of the bead in the lower sheet (Peggs, 2009A). This is due to the extra oxidation in the adjacent geomembrane, the notch geometry, and the internal microstructural transition “flaw” at the boundary of the heat affected zone and the melted and solidified weld zone. The weld zone is unoriented while the heat affected zone is still oriented (Figure 10). The sharper that transition band the easier it is for cracks to propagate into the geomembrane.

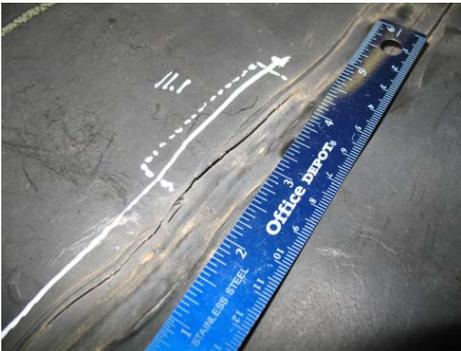
Figure 5 Stress cracks along extrusion weld

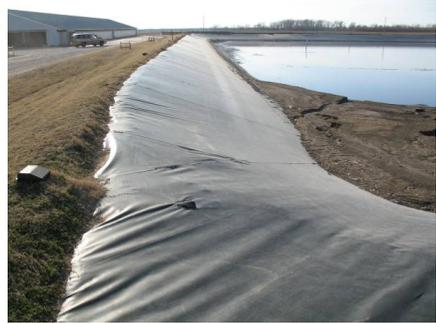
Figure 6 Taut liner at time of visit – temperature ~1°C.

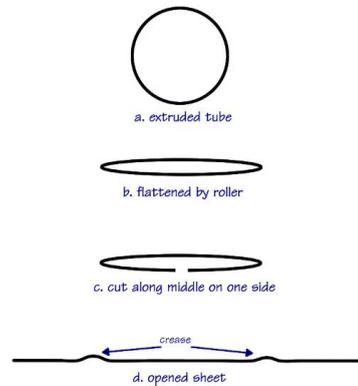
Close examination of the long splits revealed that they had occurred along the longitudinal manufacturing folds resulting from the round extrusion die (blown film) manufacturing process. At the top of the cooling tower the extruded bubble (tube) is flattened as it passes over rollers, then it is cut in the middle of one side and opened up leaving two slight folds at the one-quarter and three-quarter roll width positions (Figure 7). Conformance testing per-

Figure 7 Cause of folds during manufacturing process

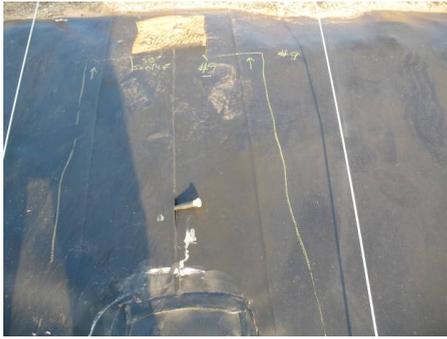
When all of the panels on the slopes were examined it was found that there was some degree of splitting/cracking in only a few of them, but that cracking only occurred in panels placed with the apex of the fold pointing down. There was no apparent cracking in any of the 72 of 90 panels placed with the apex pointing up. At one location (Figure 8) there were apex-up folds parallel to, and about 250 mm from, a central apex-down fold, but only the apex-down fold was cracked. It was also noted that the long splits were made up of many small cracks linked together (Figure 9).

Figure 8 Cracked apex-down fold between two un-cracked apex-up folds (inside arrows).

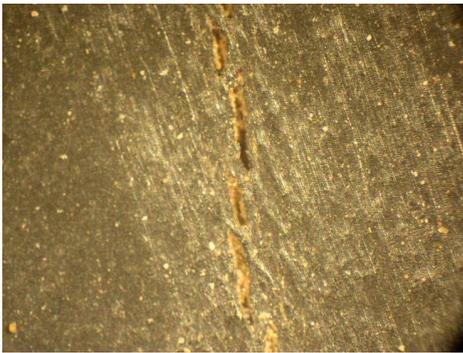
Figure 9 Long crack in fold made up of many small cracks

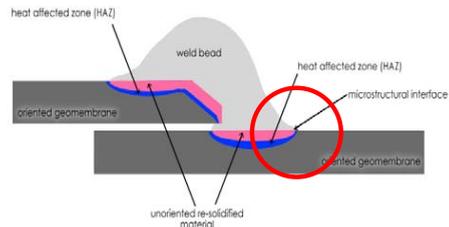
Figure 10 Microstructure at stress cracking at edge of extrusion weld (circled).
