CASE STUDIES OF IN-PLACE REHABILITATION OF FAILING MSE AND H-PILE WALLS

Andrew Ferguson and Colby Barrett, Geostabilization International, Grand Junction, Colorado, USA

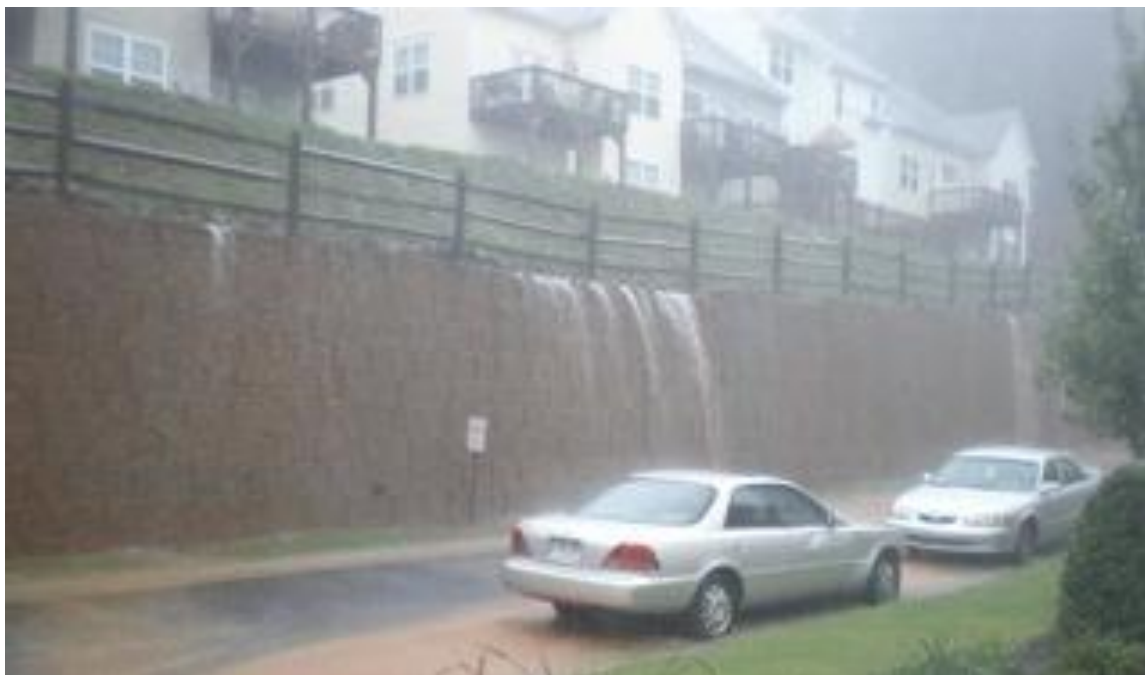
An existing MSE retaining wall constructed with geogrid on 30-in spacing using on-site fine-grained soils failed during a high rainfall event (Figure 1). Tension cracks formed approximately 24-ft behind the face of the wall for 114 linear feet and the central 80 linear feet of wall was experiencing facing failure. Figure 1 below demonstrates the inadequate wall drainage with the water flowing over the wall into the road way below and the vicinity of the wall to existing condominium units.

Figure 1: Inadequate Wall Drainage

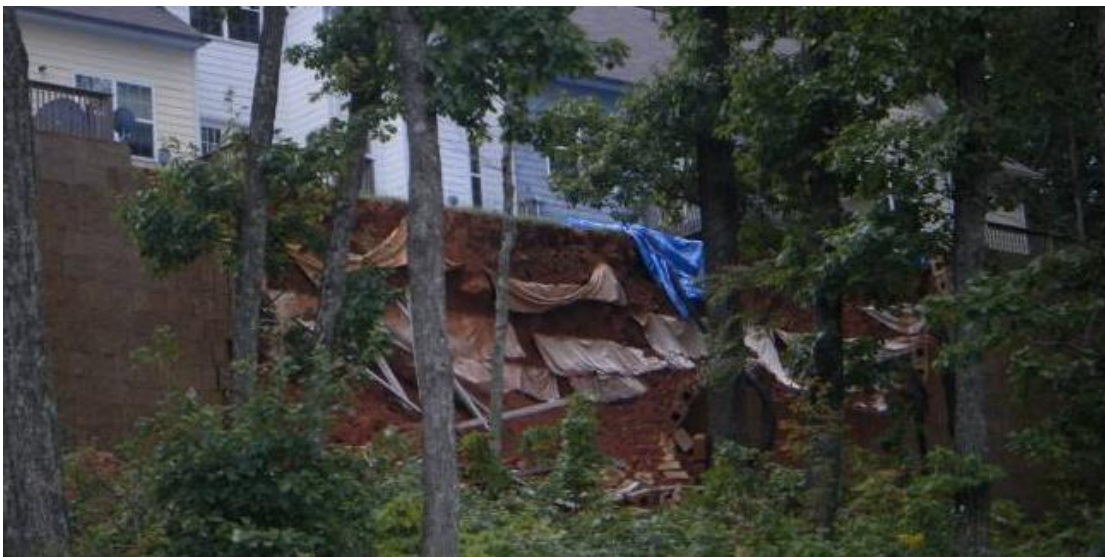
Figure 2 shows a picture of the failing section of wall. The failure presented an immediate safety concern for the residents living in the condominiums above the wall and for traffic and pedestrians using the roadway directly below.

A remediation plan was quickly developed to stabilize the failing wall and to prevent damage to the existing property above and the existing road below. A limit equilibrium stability analysis on the existing wall showed that existing conditions had a factor of safety of 0.3 when the existing reinforcement was eliminated. Typical design requirements necessitate the existing MSE Wall to be designed at a 1.5 factor of safety but the failure indicated that the structure was likely around a 1.0 just before failure with the reinforcement. The repair consisted of installing up to 55-ft long soil nails throughout the existing wall with the nail heads sticking out enough to provide anchorage points to attach galvanized steel plates and epoxy coated hex nuts. The bearing plates, set in sanded mortar, were tensioned against the block face of the existing wall by tightening the nuts which prevented further wall movement and increased the

Figure 2: Failing Section of Wall

factor of safety. In the sections where the wall had completely failed, the soil nails were anchored into a reinforced shotcrete back wall along the failure surface. Once the soil nails and shotcrete were installed, granular compacted backfill and blocks were installed on the original alignment allowing the repair to blend with the existing wall. The final repair brought the wall to a minimum factor of safety of 1.5. Drilling through the original wall proved to be difficult in places, as the fill contained everything from 18-inch diameter granite boulders to clay requiring a variety of drilling techniques to be used. Auger drilling produced ultimate bond strengths of around 3 psi; air rotary (open-hole) drilling produced bond strengths around 10 psi, and hollow-bar soil nails with continuous grout flushing produced bond strengths of around 19 psi.

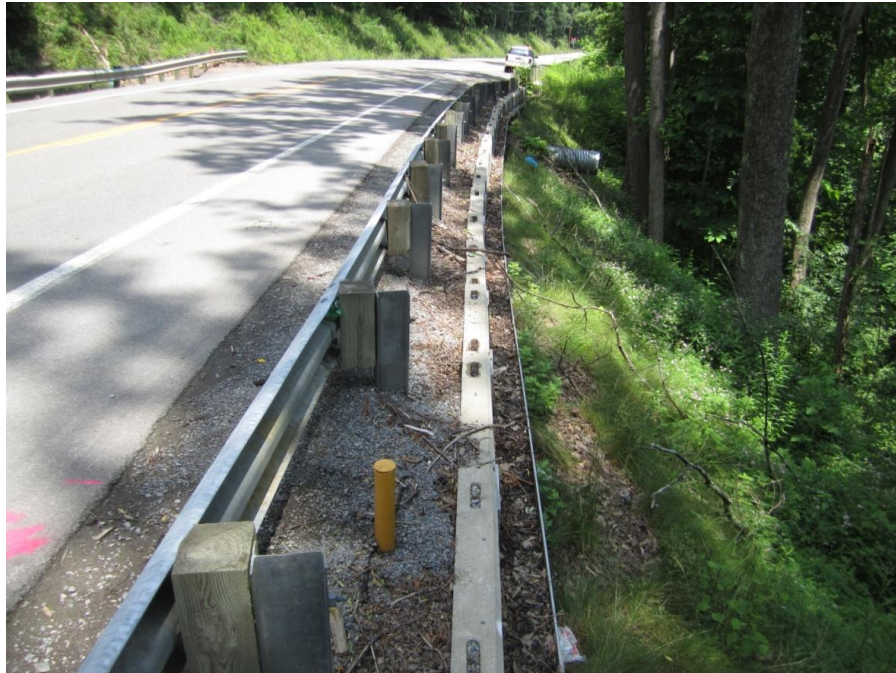
A mountain highway was originally constructed on loose fill that was inadequately drained. Continued roadway movement had been occurring for over 20 years. Many different type of traditional repairs had been attempted to stop the slide from progressing. The final repair, an H-pile wall with lagging and a horizontal waler to hold the material in place, began moving a few years after initial construction.

Figure 3: Failing Piling Wall

Because the piles had not moved significantly and were embedded into bedrock, the remediation plan included leaving the piles in place to retain their existing capacity and to limit the impact and time of construction. A 12-ft tall soil nail wall consisting of up to 70-ft long soil nails was installed between the existing piling to achieve 10-ft minimum embedment into bedrock on the inboard side of the roadway. Existing slope material in front of the piles was removed including material below the piles as necessary to achieve the necessary working face to install subsequent rows of soil nails. Reinforced shotcrete was installed in lifts to cover the existing piles and to secure the soil nails. Shotrock

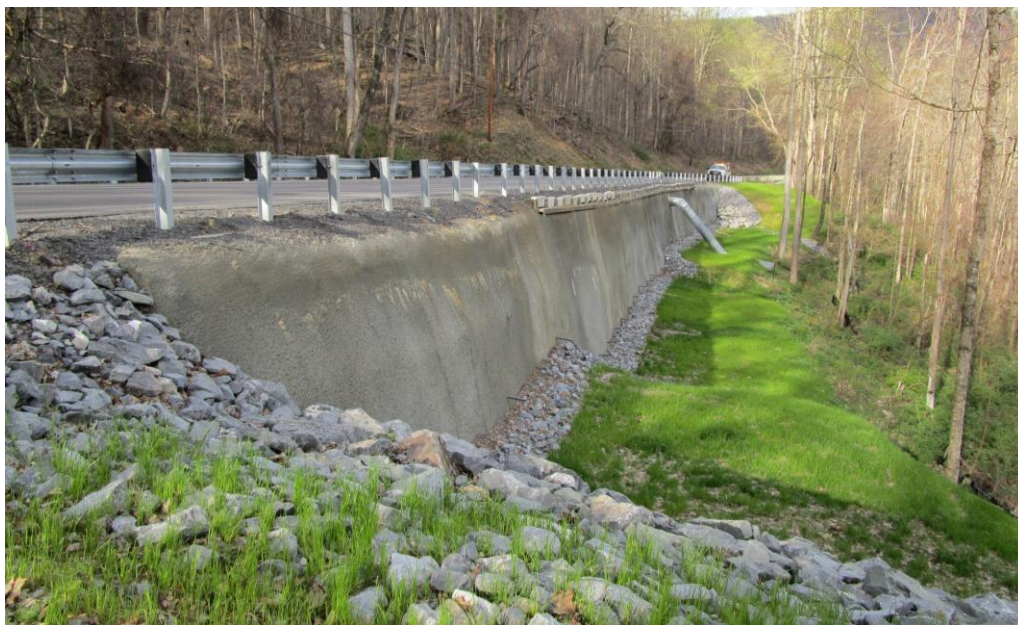
Figure 4: Soil Nail Wall Repair

and vegetation were installed at the base of the shotcrete to prevent potential erosion issues below the repair. Finally, drilled horizontal drains were installed to remove groundwater behind the wall as seen in Figure 4.

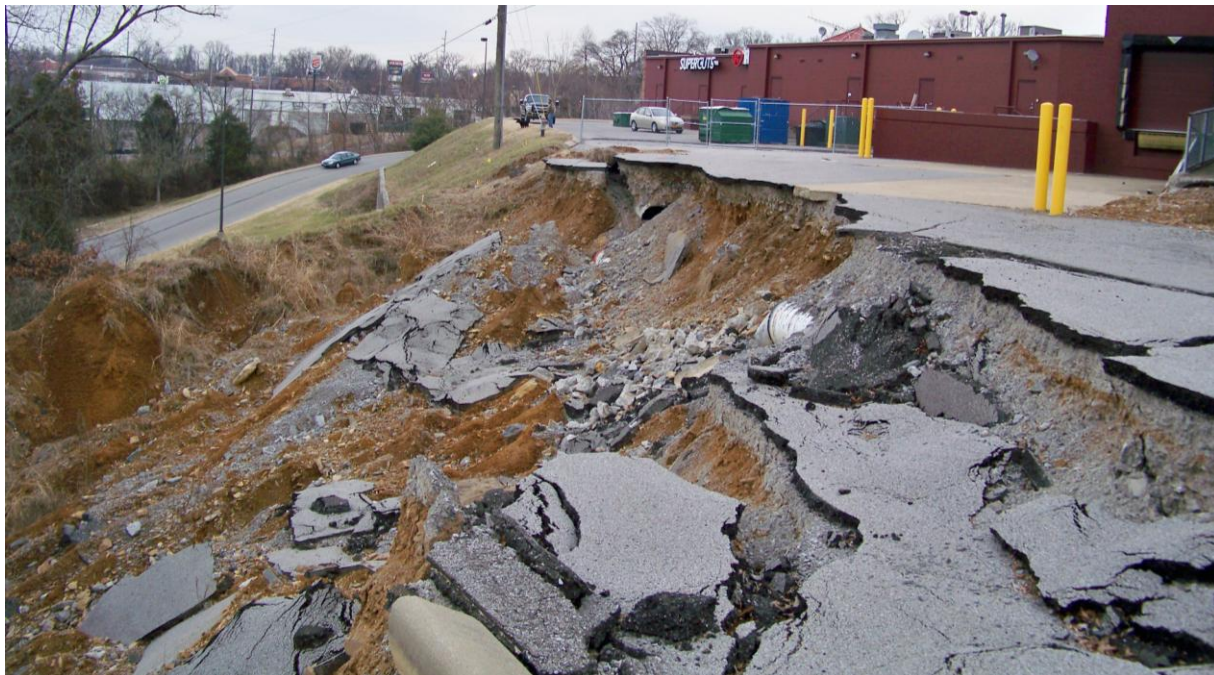
An MSE wall (constructed using uniaxial geogrid on 36-in spacing and on-site fine-grained soil) which supported the rear parking lot of a shopping center in Nashville, Tennessee failed catastrophically due to a bearing failure at the base of the wall. When the wall failed, the facing and soil translated to the slope below posing an immediate threat to the road surface located partially on the MSE wall for approximately 434 linear feet. An immediate repair was needed to ensure the stability of the slope and to protect nearby structures. Figure 5 below shows the failure of the MSE wall taken from the parking lot surface above. Note the separated pipe in the center of the picture.

Figure 5: MSE Failure

The repair required a new wall to be constructed in place of the existing one and would require two phases of construction. The first phase consisted of removing much of the failed wall system and constructing a temporary shoring system with up to 30-ft long soil nails and reinforced shotcrete, constructed in lifts. In areas where the existing MSE wall block face remained, nails were drilled into the existing block face. The 20,000 square foot temporary soil nail wall varied in height up to approximately 50-ft with a design factor of safety of 1.3.

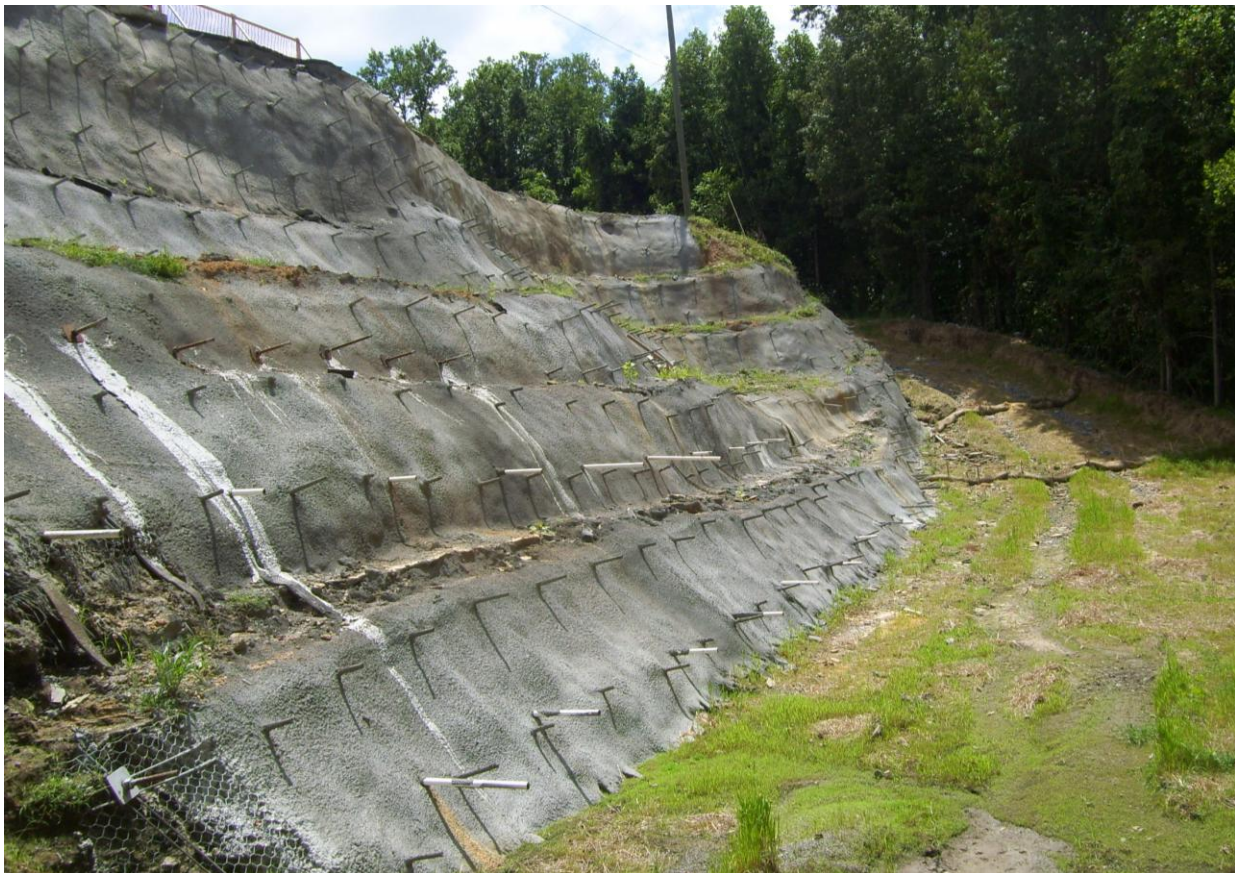
Figure 6: Temporary Shoring during Phase I

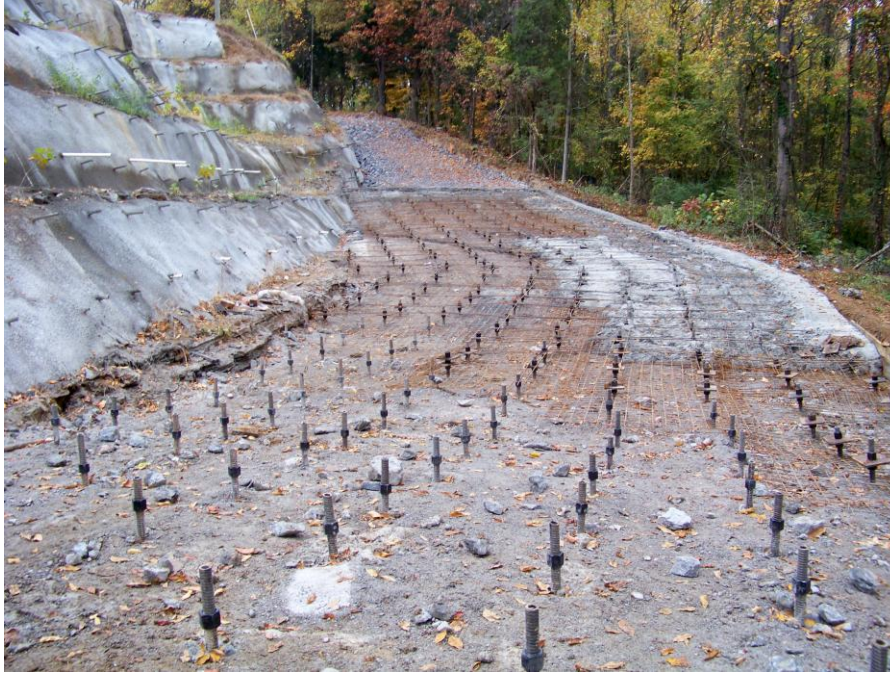
Figure 7: Micropile foundation during Phase 1

new wall, which consisted of an array of, 2-in diameter micropiles on 5-ft centers with a minimum 2-ft embedment into the underlying limestone bedrock. Actual installation depths varied between 5 and 30 feet, and the piles were then integrated into a reinforced shotcrete raft foundation.

Other foundation improvement systems were considered during the design phase, including rammed aggregate piers and caissons, but the small-diameter micropile array was chosen for the redundancy it provided – if any single pile were to fail in the varying karst formation, the surrounding piles would be able to take up the load. Figure 6 shows the temporary shoring system with horizontal drains, and Figure 7 shows the micropile foundation during installation. A shored Geosynthetically Confined Soil wall (using lightweight woven polypropylene geosynthetic on 8-in centers in a well-compacted granular backfill) was constructed on top of the micropile raft foundation and the overall global stability was increased to a factor of safety greater than 1.5.

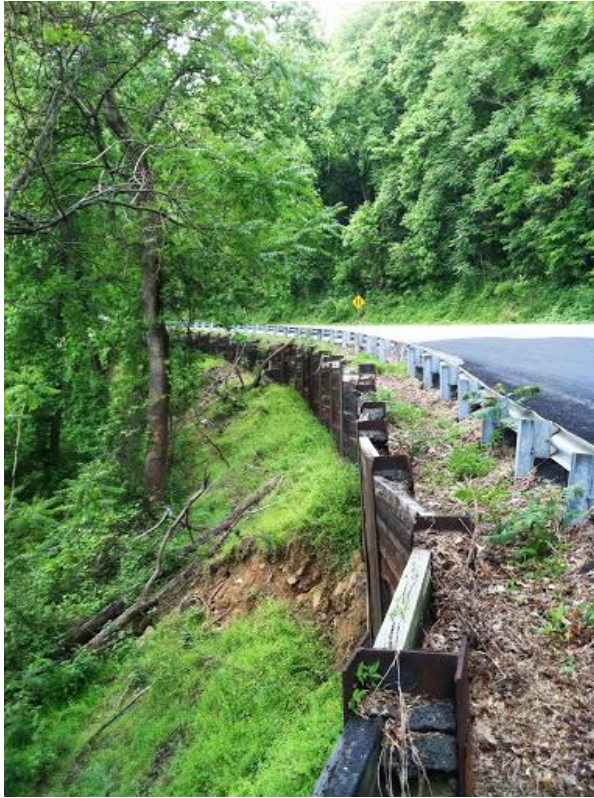
An unstable section US 21 near Sparta, North Carolina was stabilized previously using H-piles and timber lagging on the outboard shoulder of roadway for 237 linear feet. The piles were not embedded into bedrock, and had begun to both tip and translate. The roadway was showing signs of distress with tension cracks near the centerline and significant overall sagging. The piling wall was bulging in the center and a large scarp had formed at the base of the lagging wall. Large amounts of material had washed out below the slide. Figure 8a shows the scarp forming below the piling wall and the bulge in the lagging and Figure 8b shows the roadway distress occurring above the piling wall.

Figure 8a: Scarp formation

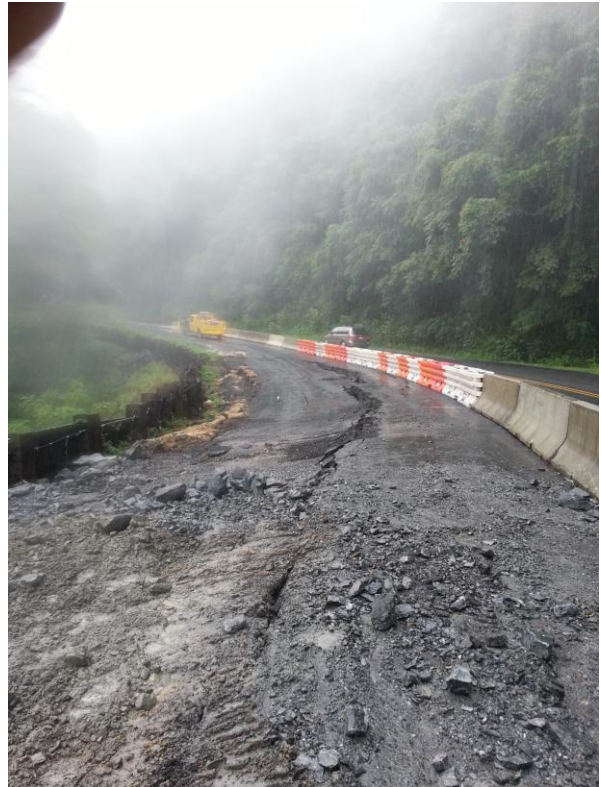
Figure 8: Failing Roadway Above Lagging Wall

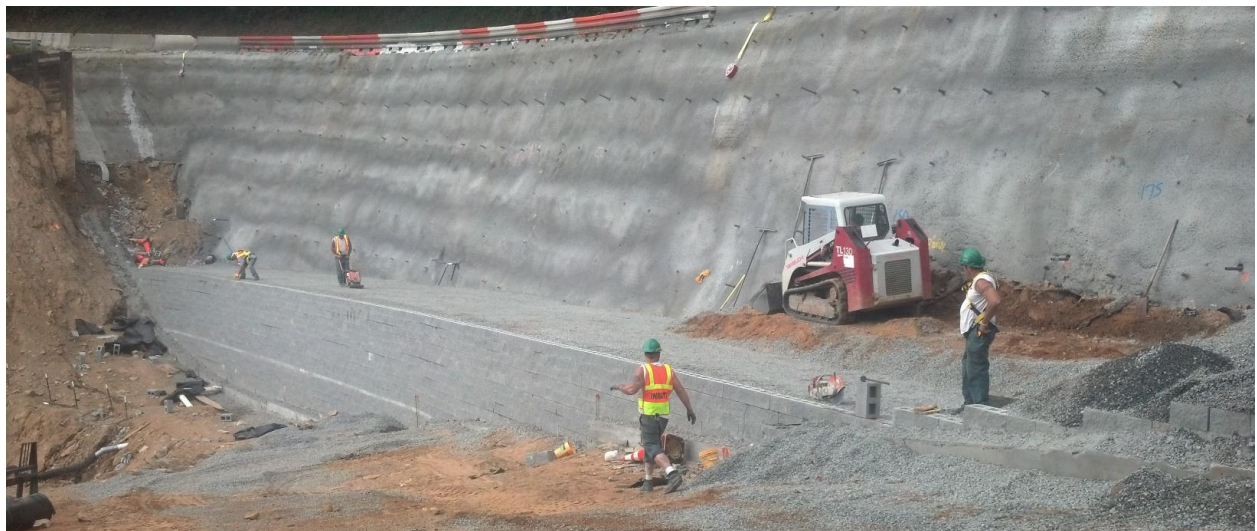
Figure 9: GCS® Wall Construction

The second, more economical, repair option was selected. The site was excavated along the scarp line running through the existing road surface for the length of the slide. Up to 30-ft long soil nails with reinforced shotcrete facing were then installed in lifts to protect the existing road platform and to prevent the slide from regressing into the remaining travel lane. Next, an up to 40-ft high Shored Geosynthetically Confined Soil (GCS) Wall was installed on an array of micropiles. The wall provided additional road width and replaced section of roadway lost in the landslide.

Upon completion, the final repair brought the existing slope to a global stability of 1.5. Figure 9 below shows the GCS Wall being constructed in front of the permanent soil nail wall.

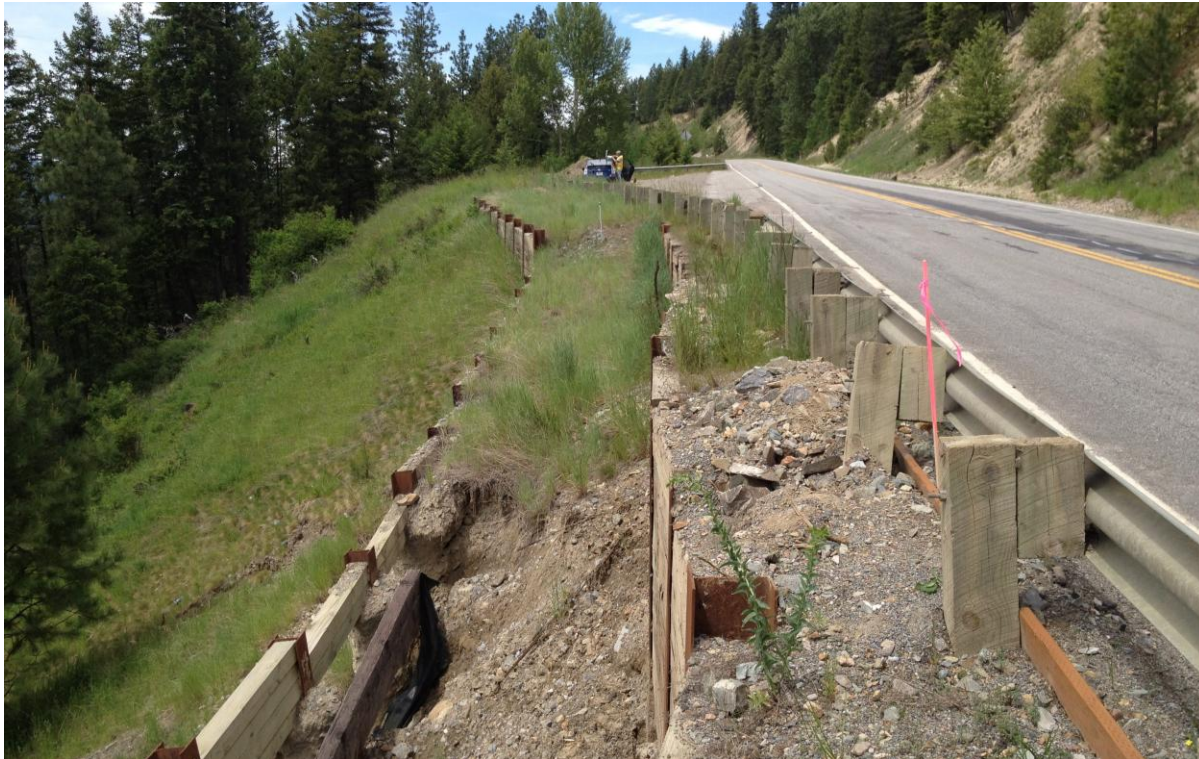
Figure 10: Failing Piling Walls

When the road continued to move, an additional piling wall was installed approximately 15-ft from the outboard edge of pavement with the piles embedded even deeper than the first wall. The lower piling wall had failed completely, the upper piling wall was showing signs of bulging, and soils were eroding from below the timber lagging. An additional piling wall was installed just Northwest of the two failing walls and it was observed that the landslide scarp was encroaching on that wall. The total repair area was measured to 185 linear feet.

Based on a site reconnaissance, boring logs, and a limit-equilibrium analysis, engineers determined that the slope was failing through the silt layer in the upper 20 feet of the formation. The failure was estimated to be just below the embedment depth of the lower piling wall. Further subsurface investigations showed that the bottom of the pilings were installed approximately 8-ft above competent bedrock.

The repair consisted of installing an array of up to 50-ft long soil nails at various angles to optimize the minimum nail lengths and ensure sufficient embedment into bedrock. The upper rows of nails were installed from the existing

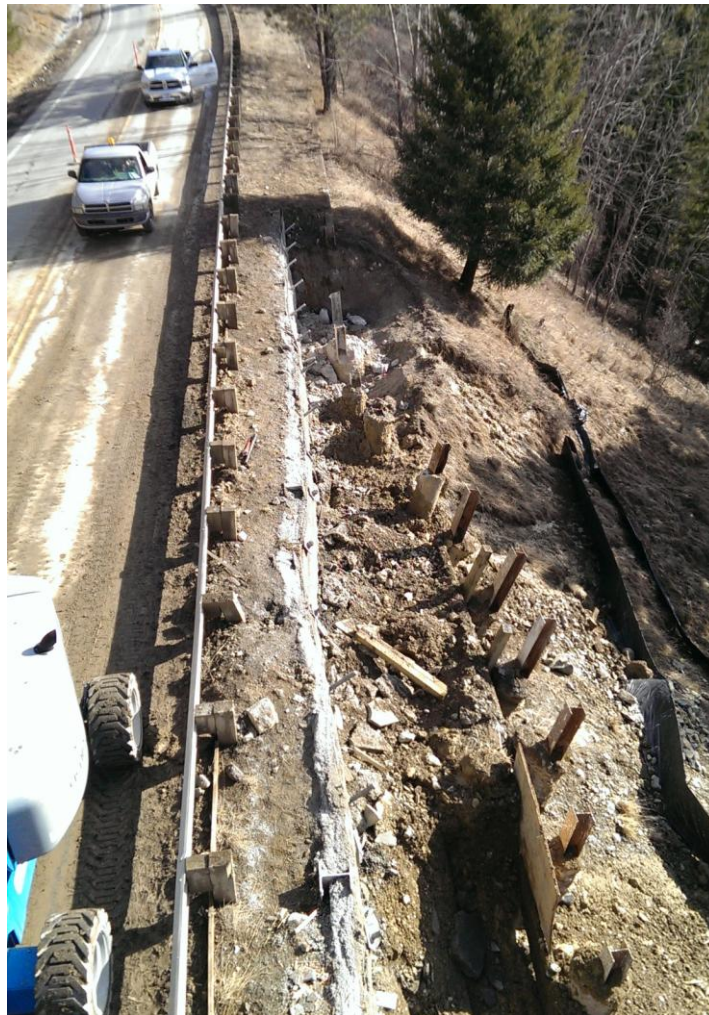
Figure 11: Existing Piling during Construction

roadway platform while maintaining an open inboard lane for traffic. The piling walls were torched and trimmed down during each excavation lift so that crews could install the soil nails and reinforced shotcrete facing. The lower rows of nails were then installed using a bench wide enough for equipment. The pilings were removed from the hillside once crews could access the final construction bench. The height of the soil nail wall varied up to approximately 26-ft in height and extended to the bedrock layer below to prevent soils from undermining the shotcrete facing. The final design provided a 1.5 factor of safety and was constructed in approximately 6 weeks.

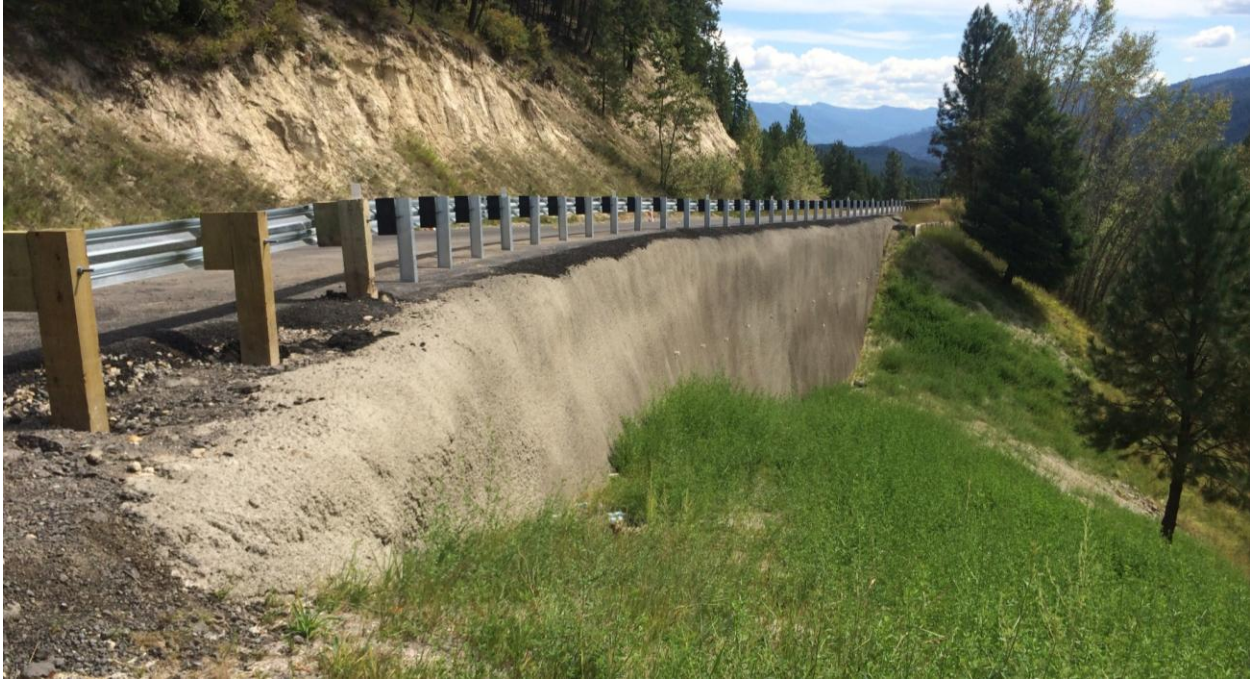
Figure 12: Completed Wall
