Geo-hazards and mitigation

Earthquake performance of reinforced earth embankment subjected to strong shaking and ground deformations

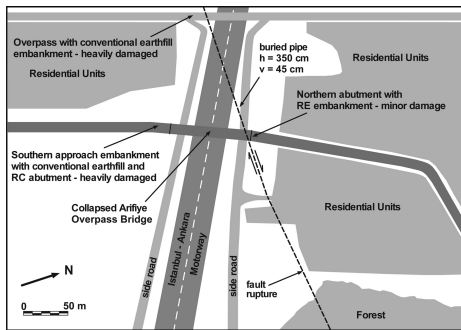
Figure 2. Plan view of Arifiye Overpass and the fault rupture.

approach abutments and three mid-span pier supports. The two wing walls of the northern approach embankment were constructed using Reinforced Earth® (RE) technology, whereas the southern approach was a conventional earth embankment with sloping sides. The site is located along the Trans European Motorway adjacent to the ruptured fault as shown in Figure 2.

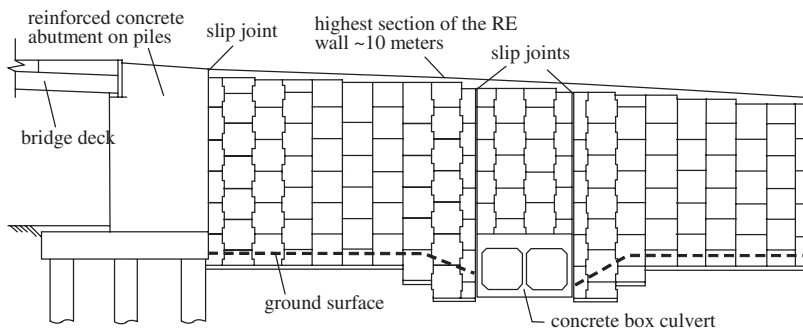
Figure 3. Side view of the Arifiye Overpass RE wall (northern approach embankment).

As shown in Figure 3, a reinforced-concrete culvert passed beneath the wall. The culvert is located in a creek channel that runs beneath the site. Suspected liquefaction in the creek-bed soils beneath this culvert led to significant earthquake-induced settlements in this area of the wall. Also, slip joints were used along the height of the wall on both sides of the concrete culvert, as well as between the RE wall and the reinforced concrete bridge abutment. These special joints were used to mitigate anticipated static differential settlements, but apparently played an important role in limiting damage from earthquake-induced differential settlements.

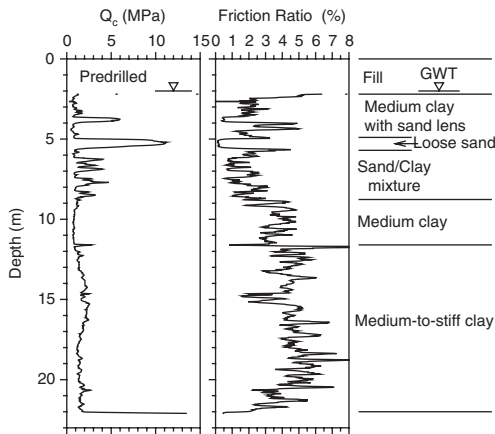
Figure 4. CPT sounding between the culvert and the reinforced concrete abutment.

The Arifiye Overpass site is situated within a deposit of Quaternary alluvial sediments consisting of alternating layers of medium clay/silt and loose sand with a shallow water table. The sounding from one of the Cone Penetration Tests near the culvert is shown in Figure 4. The upper 5 m of the profile consists of 2 m of silty/clayey sand fill underlain by a 3 m-thick medium clay layer with Q_c values of about 1.5 MPa. The clay is underlain by a 1 m-thick stratum of clean sand with an $I_c < 1.5$ and an estimated fines content $< 5\%$. Average value of normalized clean-sand-equivalent tip resistance ($q_{c1,CS}$) for the sand is 120. This layer is liquefiable under moderate levels of ground shaking. A mixed stratum of clay with lenses of interbedded sand is encountered below the sand between 5–8 m depth. Normalized clean-sand-equivalent tip resistance ($q_{c1,CS}$) for this stratum averages at 80. A medium-to-stiff clay stratum with an average Q_c of 2 MPa extends from a depth of 8 m down to 22 m where the CPT was terminated. The water table was encountered at a depth of about 2 m.

The sandy levels are potentially liquefiable under moderate shaking as evidenced by their low penetration resistance (Olgun 2003). Furthermore it was not possible to sample and test the clayey levels for a more detailed assessment of their cyclic vulnerability.

However the observed ground failure pattern and the surface cracks near the base of the embankment strongly suggests such a potential vulnerability with these soils.

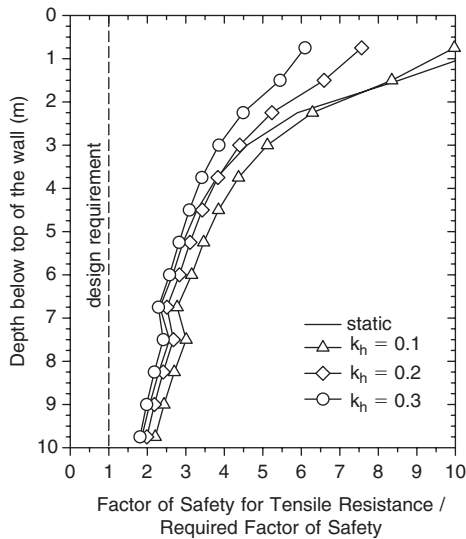
Figure 5. Ratio of the allowable tensile resistance (capacity) to that required for static and seismic design (demand).

reinforcement cross-section area per unit wall width were calculated at each elevation. Estimated design forces from the simplified approach and the allowable tensile resistance were calculated and comparison of these values are presented in Figure 5. It can be seen that the allowable capacity/demand ratio is well above 1.0, and is most critical at the lower reinforcement levels, ranging between 1.8–2.2 at the bottom reinforcement levels. The results suggest that the reinforcements should not have been stressed beyond their allowable strengths during shaking, but they were stressed much higher than the design values based on $k_h = 0.1$.

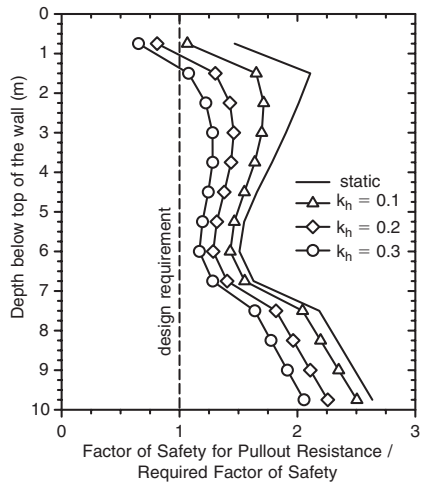
Figure 6. Ratio of the allowable pullout resistance (capacity) to that required for static and seismic design (demand).

Design guidelines recommend the use of a minimum 1.5 for the factor of safety against pullout at each reinforcement level. Similar to the tensile capacity calculations, 75% of the static design requirement is allowed for the seismic design against pullout. The pullout resistance is calculated using the friction coefficient and the surface area of the reinforcement anchored to the passive zone defined by design guidelines. The friction coefficient used for seismic design is 80% of the value used for static design. The extra allowance by the reduced factor of safety is more-or-less offset by the use of a reduced frictional resistance for seismic design. Comparisons of the allowable pullout resistances required by design (pullout capacity/required factor of safety) to the estimated forces at each elevation are shown in Figure 6. Although not shown above, the actual pullout factor of safety ranges between 2.2 and 4.0 along the height of the wall for the static case where 1.5 is the required minimum for design. Therefore, the allowable-pullout-capacity to demand ratio varies between 1.5–2.7 for the static case as shown in the figure. The values of allowable

capacity-to-demand ratio drop slightly to 1.1–2.5 for a seismic coefficient of 0.1 which was used for design. Thus, seismic considerations probably did not govern the design of the wall and caused little or no increase to the reinforcement amount in comparison to the static case, as noted by Sankey and Segrestin (2001).

Values of allowable pullout capacity/demand ratio drop to a range of 0.8–2.3 for seismic coefficient of 0.2, and 0.7–2.1 for a seismic coefficient of 0.3. The values of allowable capacity to demand ratio for the reinforcements at the top 6 meters are only slightly above 1.0. The results suggests possible problems with pullout resistance at $k_h = 0.3$, the level suspected to have been induced during the earthquake.

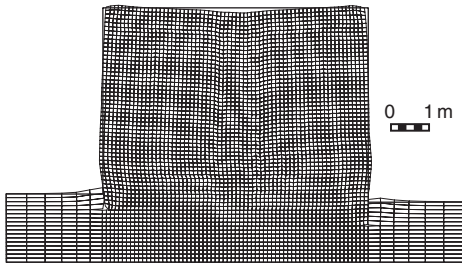
Figure 7. Deformed shape of the model wall (deformations at 1x, no exaggeration).

In addition to the simplified seismic analysis, numerical analyses were also performed to better understand the seismic behavior of the structure (Olgun 2003). Using FLAC (Itasca 2000) with a two-dimensional analysis, we were successful in closely predicting the observed earthquake-induced deformation pattern and displacement magnitudes of the embankment. The deformed mesh shape from the seismic analyses is provided in Figure 7. For brevity purposes, the numerical analysis details are not provided, but the main findings are summarized:

1. A maximum earthquake-induced lateral wall displacement of 12–14 cm was predicted, compared to an observed value of 10–15 cm, and the predicted backfill settlement was 27 cm, consistent with the observed value of 25–30 cm.
2. The observed lateral wall bulging was due mainly to seismic shaking, whereas the backfill settlement and panel misalignment were due mainly to the differential ground distortions from liquefaction- and fault-related movements.
3. The earthquake-induced forces in the strips were on average 1.5–2 times larger than the design values. These higher than design values indicate that the reinforcements were most likely overstressed in the field during the earthquake.
4. Intolerable serviceability problems due to significant distortion of the structure, such as panel misalignment and significant backfill settlement, were likely to occur long before internal failure.
