FAILURE OF A REINFORCED EMBANKMENT ON AN EXTREMELY SOFT PEAT CLAY LAYER

Marcio de Souza S. Almeida,¹ Maria Esther S. Marques,² Bruno T. Lima¹ & Felipe Alves¹¹ COPPE-UFRJ (e-mail: almeida@coc.ufrj.br).² Military Engineering Institute.

Abstract: A case study of the failure of a reinforced embankment on soft clay is back analysed. The site consists of an 11 m thick very soft clay deposit. Measured (uncorrected) vane strengths vary in the range of 2 kPa on the ground surface to 20 kPa at 10m depth. The top 3m peat clay layer with water content as high as 900% showed some erratic high strength values due to the presence of fibres which misled the measured vane strength. The water content decreased rapidly with depth, displaying values of around 100% for the depth range from 3 to 6m, and around 50% for greater depths.

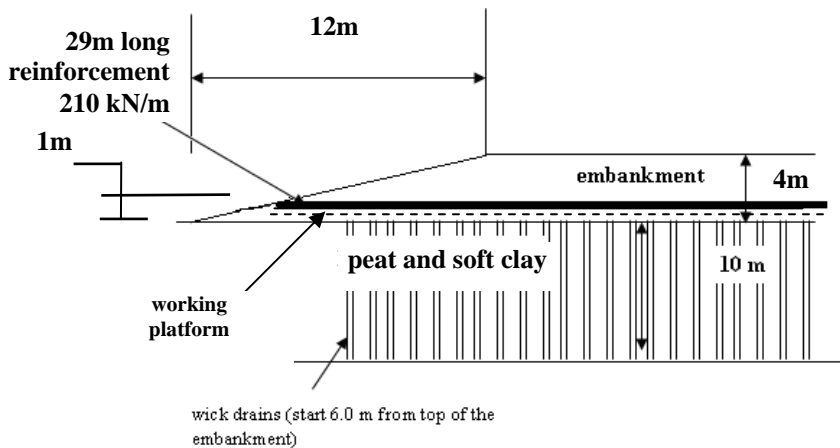
Figure 4. Border of the embankment: reinforcement and slope.

Field evidence showed that the fissure observed in the embankment was quite close to the end of the geogrid, as shown in Figure 5. Therefore, the back analysis carried out herein assumes that the failure surface developed outside the geogrid. Field evidence showed a translational movement of the embankment, and inclinometer readings (Figure 7) indicated the lowest failure surface 2.0 m below the base of the embankment, i.e., involving essentially just the peat layer. Therefore, a planar-block type of stability analysis was assumed, similarly to the design phase.

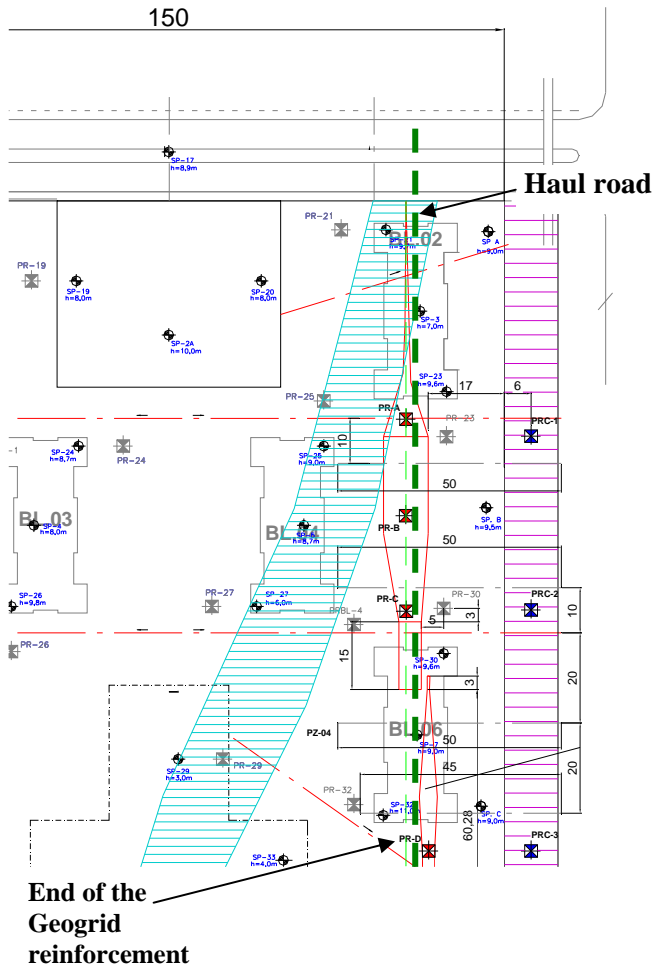
In July 2006, about three months after construction started, a failure occurred. The location of the failure was parallel to the left border, as shown by the fissures indicated in Figure 6. The fissure shown in Figure 6a was located at the end of the geogrid. Elevation of peat in the neighbouring area was noted and the border fence was displaced by approximately 2m.

Figure 6 also shows the haul road used by the trucks to transport fill material in the site, quite close to the fill fissure. Investigation borings performed in the embankment fill later on indicated that the thickness of the fill along the haul road could be as much as 8.0m, supporting the hypothesis that this may have triggered the failure in this area. The estimated fill thickness below the haul road at the time of the failure was 6.0m. In March 2006, at the beginning of the construction, as soon as the working platform was being placed, a localized failure occurred and the peat rose laterally. This occurred at the entrance close to the haul road (see Figure 6), thus contributing to the disturbance of the clay in this region.

Figure 6. Embankment failure: (a) location showing the haul road (b) fissure developed at the embankment.

In order to remediate the embankment failure, a number of measures were implemented. These included filling the fissure with fill and the installation of two layers of 20m wide 25kN/m strength geotextile patches through the failed area. The slope was also repaired and a berm was constructed to increase the factor of safety. To monitor the local behaviour, additional instruments were installed: in particular, three inclinometers at the top of the slopes, two at the left border, where the failure took place, and one at the right border.

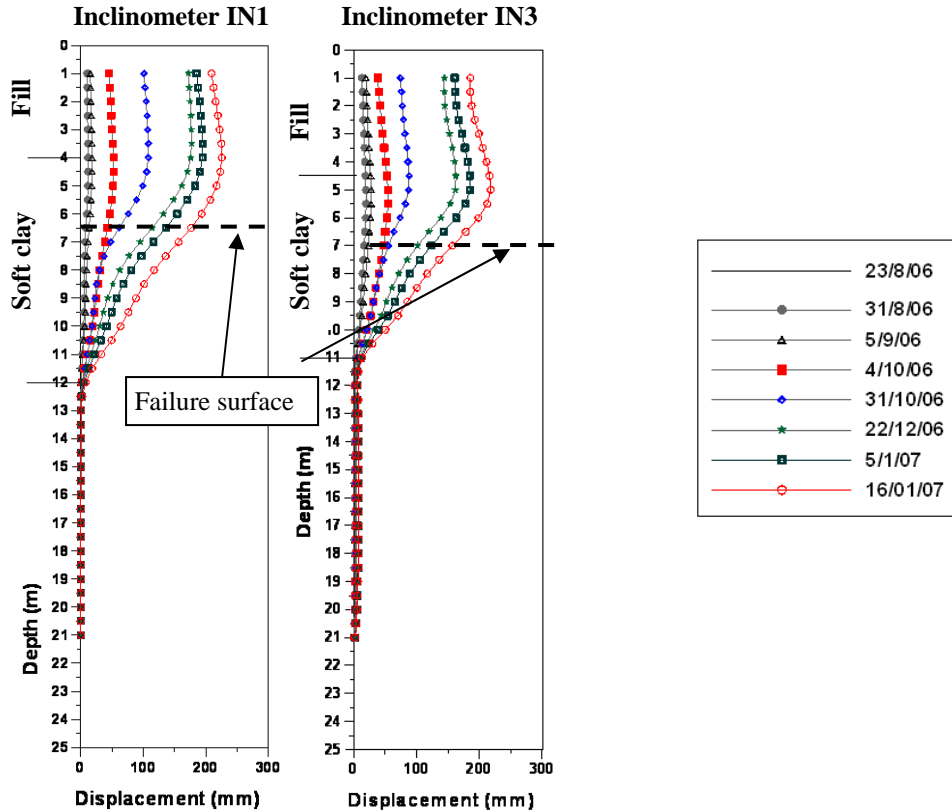
Figure 7 shows the results of IN1 and IN3, both installed one month after the failure at the left border. The analysis of these inclinometers showed that the movements were still occurring along the mobilized failed surface, which is located about 2m below the fill, at the peat–soft clay interface.

Figure 7. Inclinometer readings shortly after failure.

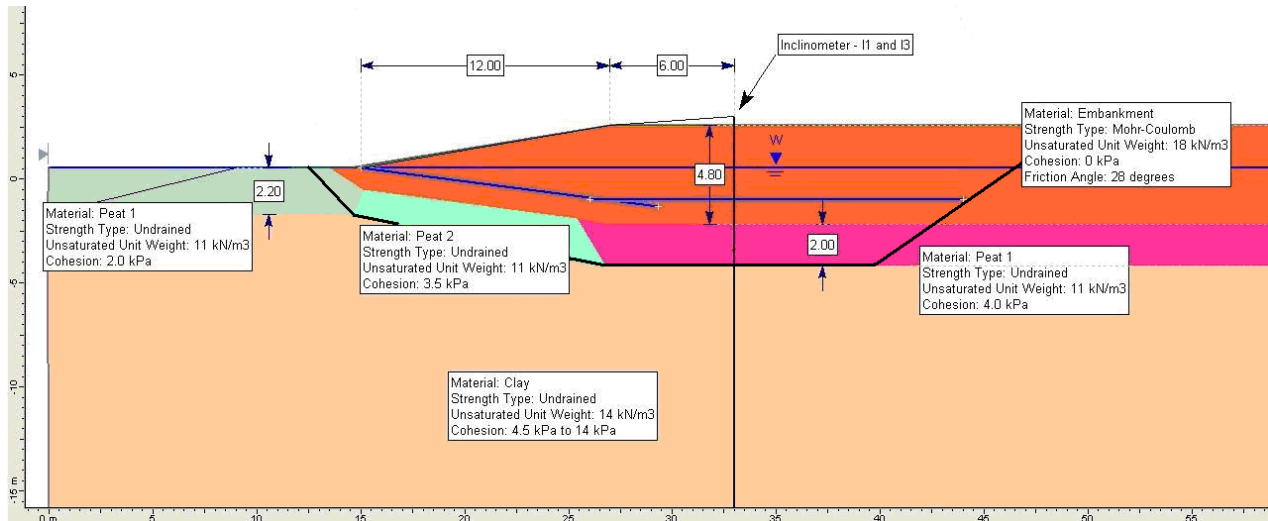
Figure 8 shows the embankment geometry at the time of the failure. At its highest point, the embankment was 4.8m thick and was 2.7m below the water table. At that time, the settlement plates showed settlements of about 1.9m. In the failed region, the soft soil was originally 3.0 m peat layer followed by 5.0 m of very soft organic clay layer, i.e., typically 8 m overall thickness. Considering the CR values presented in Figure 2, the estimated layer thicknesses at the time of the failure were approximately 2m for the peat layer and approximately 4.1m for the soft clay layer.

Two scenarios were considered for the back analyses carried out herein: (1) a lower limit S_u value given by the geometry shown in Figure 8; (2) an upper limit S_u value resulting from the active thrust behind the line of the geogrid reinforcement, due to the trucks' traffic on the buried fill.

Figure 8. Geometry of the slope.

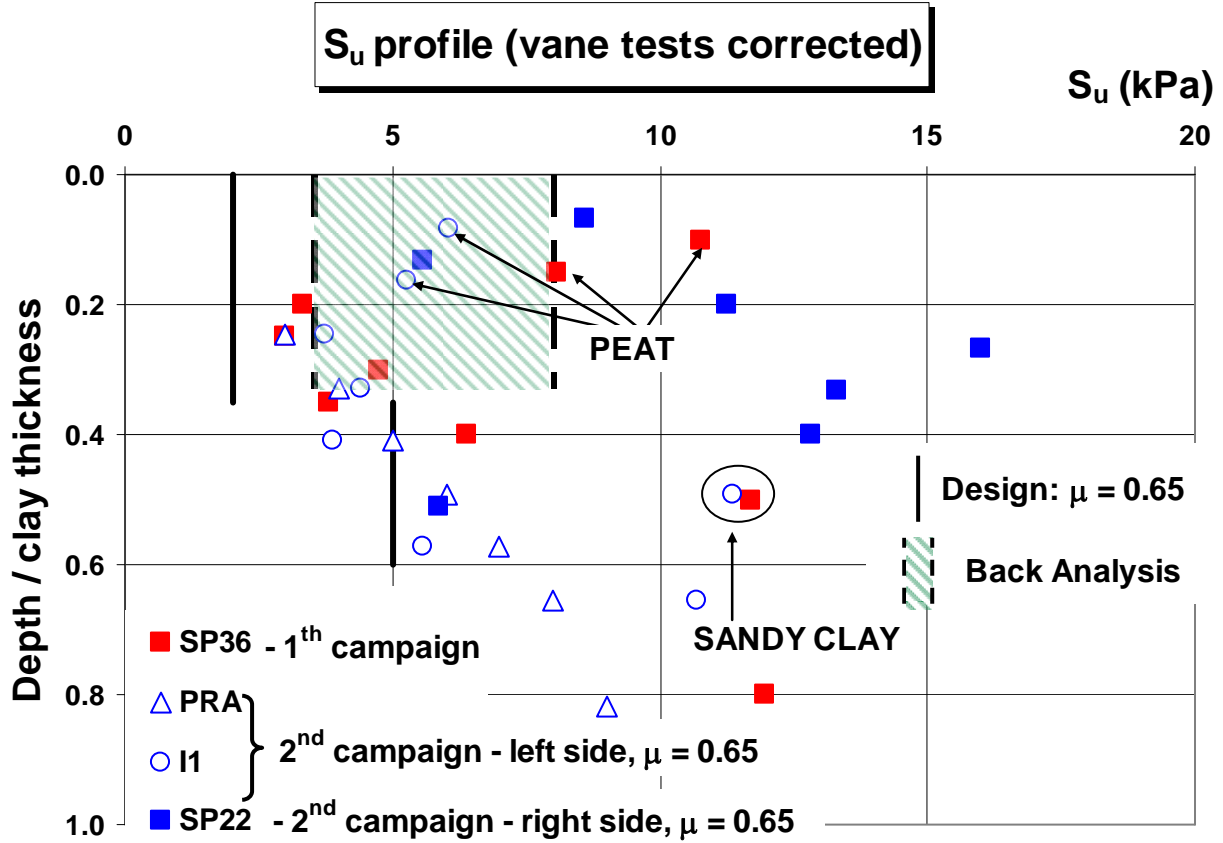
The back-analysed values for the scenarios (1) and (2) described above are 3.5 and 8.0 kPa , respectively. These values are plotted in Figure 9 using normalized depth in order to take into account the decrease of the clay thickness due to settlements. Figure 9 also shows the values used for the design (first-stage construction) and measured post-failure values (2nd campaign), with Bjerrum correction applied. The values measured in the left border are in the range of the back-analysed values and support the estimated $S_u = 5.0 \text{ kPa}$ with gain in strength. Values of S_u at the right border are much greater than S_u values at the left border and showed a greater gain in strength, which is in accordance with the case history (Almeida et al., 2001) of Barra da Tijuca soft ground deposit, the top peat layer of which showed much greater gain in strength than that given by $\Delta S_u = 3 \text{ kPa}$.

Therefore, the overall data shown in Figure 9 support the hypothesis that the failure was caused by the active thrust due to the embankment buried inside the peat layer.

Figure 9. S_u profiles for normalized depth: design values; back-analysed values; measured values just after failure.

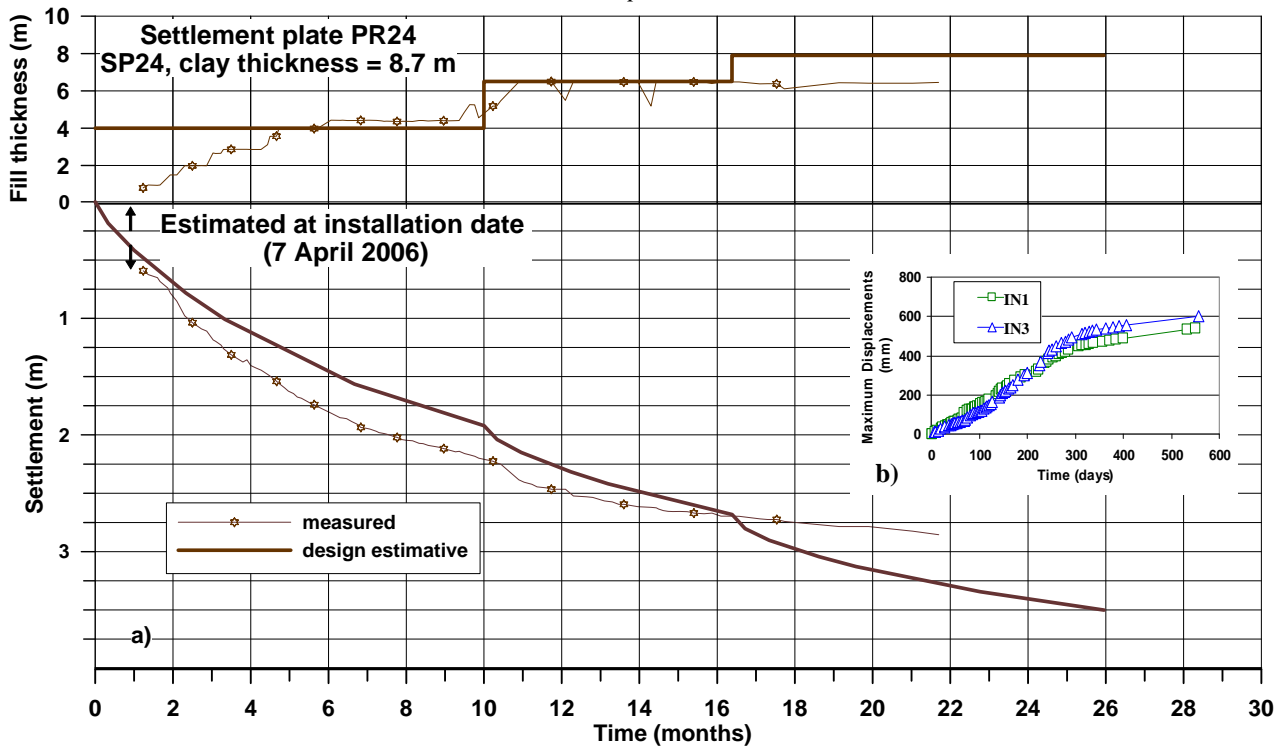
Regarding the lateral movements at the left border, Figure 12 shows the maximum horizontal displacements for the remainder of the three-staged construction. It is clearly seen that the horizontal displacements showed a stabilized trend, even with the two additional stages of fill construction.

Figure 11. Long-term displacements: (a) typical settlement plate data; (b) long-term maximum horizontal displacements for inclinometers at the left border.

After the failure was noted in part of the left border, there was some concern about the performance of the vertical drains of the embankment at the left side, since there were two buildings to be constructed in this area. In order to improve the drainage at the front of the site, pumping wells were installed and the pore pressure was monitored. The measurements taken showed that the settlements were well within the expected range, as shown in Figure 11. Settlement plate PR24 in Figure 11 was installed at the centre of the area, where the fill thickness was 3m at the time of rupture.
