Study on the performance of a reinforced earth wall during earthquake based on Tottori-ken Seibu earthquake event

K. Watanabe

Hirose & Co., Ltd, Osaka, Japan

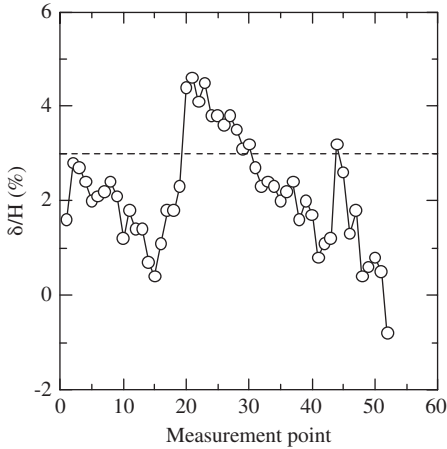
Figure 5. The measuring result after the main shock.

As for one reinforced earth wall, because to have been built by the steep slope part, looseness on the slope in the front was seen. Also, opening in the vertical joint part was seen at the part, which is close to the other wall. As for another reinforced earth wall, damage to the wall was hardly seen but a partial hanging was seen. Therefore, the two reinforced earth walls were judged to have to be investigated in detail.

In this report, investigated Result of which the hanging in the seen one and it is on is described. In the amount of displacement at the wall, hanging a plumb bob from the wall upper end, it measured a distance from the plumb bob to the wall with the detailed investigation. It implemented measurement in the position of the upper and lower end of the panel near the vertical joint at the wall.

of the horizontal direction in the back filling surface position in wall height of the ground level. As for the measuring result, it is shown in the Figure 5. The meaning of Measurement point shows the part that was measured in the vertical joint from the edge in the wall to the direction of the extension. In the interval, it is 1.5 m. The vertical axis shows a gradient. The gradient is the one to have divided a horizontal direction amount of displacement by the height. Here, it does the central part finding of the thing that the hanging is big nearby.

The part that exceeds 3% of the construction management standard value had the gradient of the wall facing and the wall decided to plan reinforcement. In case of selection of the reinforcement, it considered the following two. It decided to select from the inside of the reinforced earth method, which adopts the same mechanism and it adopted soil nailing of construction which is one of the reinforced earth methods. Because it becomes the structure which can resist the earth pressure of reinforced soil mass, being made from the reinforced concrete with 14 cm thickness, not to have a bad influence on the wall material by the reinforcement vs. Also, because it didn't range over the whole reinforced earth wall, the implementation section of the reinforcement decided to secure the system of the outward appearance. As for the design of the reinforcing rod insertion, the design earth pressure to use for the effect of the reinforcement without considering a stiffening effect by the strip in the reinforced earth wall uses the design earth pressure of the reinforced earth wall method of construction.

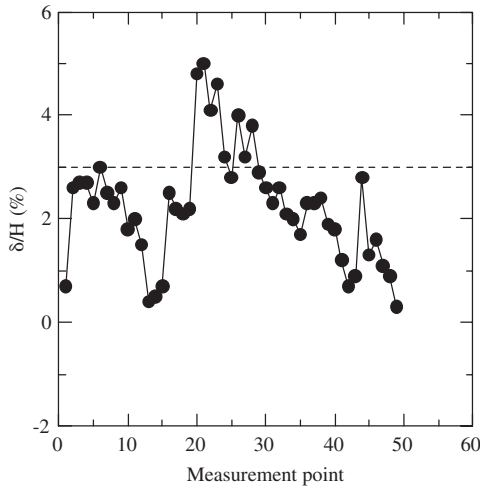
Figure 9. The measuring result after the aftershock.

bob like the after the main shock it. At the visual examination, specifically, a change was observed with after the main shock when there was not it. Here, this time, a measuring result is shown in the figure.

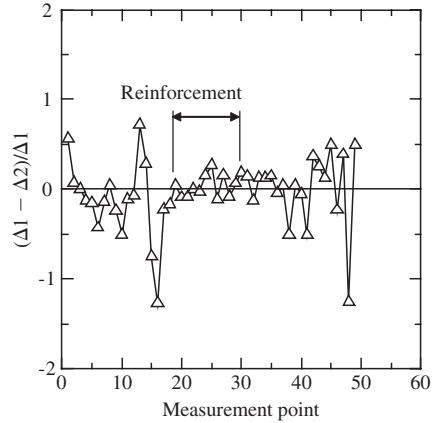
Figure 10. Variation of the gradient.

The change of the vertical degree in the direction of the wall extension is shown in the figure. When the change quantity is positive, it shows that a wall is inclined on the side of the front. Oppositely, when the

change quantity is a negative, it shows that a wall is inclined on the side of the mound.

As for the section that was reinforced by the soil nailing range, there is not a change in the gradient before and after the aftershock. However, that the change has occurred to the vertical degree in the section that isn't reinforcing is confirmed.
