Behaviour of reinforced earth structures founded on soft silt deposit in seismically active hilly terrains

ABSTRACT: The reinforced soil walls for Quazigund to Baramulla project, while under various stages of construction, experienced earthquake of magnitude about 7.0 on Richter scale with epicenter about 150 km away from the site, in Pakistan. The equivalent magnitude of tremor on Richter scale at site was 5.4. The character of the titled paper is to bring forth a unique case for reinforced earth wall construction on soft clayey silt deposit with settlements of large magnitude and share the experience of performance under actual seismic activity vis-à-vis other structures in the vicinity of the project, as constructed in difficult terrains and climatic conditions.

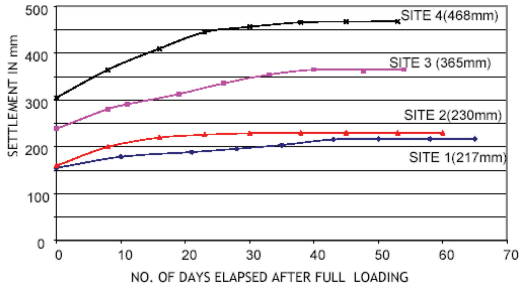
Figure 5. Recorded settlement at trial embankment constructed using sand bag.

Test embankments were constructed at four places to determine the magnitude and rate of settlement in the embankment. The observed settlements are shown in Table 2 and in Figure 5. It is very clear from Figure 5 that the settlement is not increasing with time and the curve has become asymptotic after about 45 days after full loading. Some features observed during actual testing are:-

- a) 65 to 70 % of total settlement took place during construction stage of embankment.
- b) Post construction settlement became stable beyond 40–45 days.
- c) No heaving was observed on either side of the test embankment.

The settlement in test bank (Figure 5) is higher than the measured settlement in actual construction inspite of the fact that the earth is well compacted in actual banks whereas the test bank has been constructed by heaping sand bags without any compaction. This is due to the fact that the panel with steel strip reinforcement settles less than the fill and also use of basal geogrid reinforcement in the foundation has distributed the load over larger area and hence less settlement.

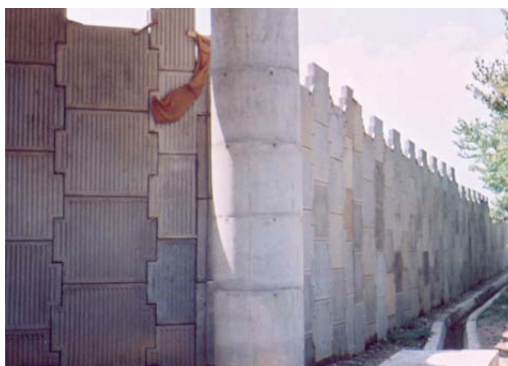
All the reinforced earth structures on Baramula – Quazigund section has experienced the impact of this earthquake without any damage in the wall. The vertical alignment, individual panel joints, vertical and

Photo 1. Reinforced earth wall for bridge no. 127.

horizontal gap between the panels were found to be intact. No bulging, differential movement between the panels, sapling or any damage in the panels was observed after the earthquake (Photo 1). The constructed height of the wall was 6 m during this period. However, many residential structures in the vicinity were collapsed or damaged due to earthquake (see photos 2 & 3).

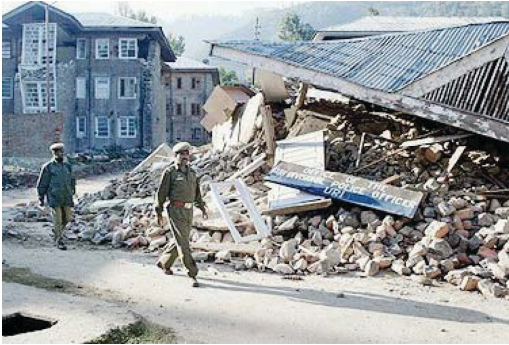
Photo 2. Damaged building at Uri about 30 km from the construction site.

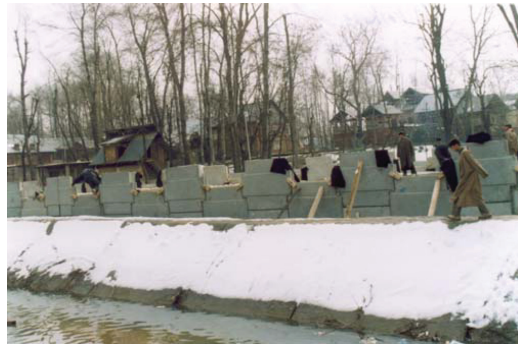
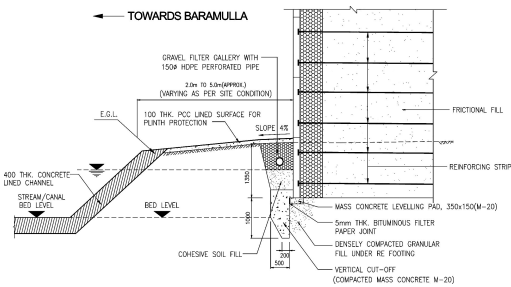
One structures was adjacent to the existing canal running parallel to the approach retaining wall. The toe of the structure was 2 m away from the canal (see Figure

Photo 4. Reinforced soil wall running parallel to the canal.

Figure 7. Typical toe detailing adopted for reinforced earth wall near canal.

7 and photo 4) and the top of the pad was above the base level of canal. To avoid seepage and any chance of toe erosion for long-term performance, a concrete cut-off wall was provided.

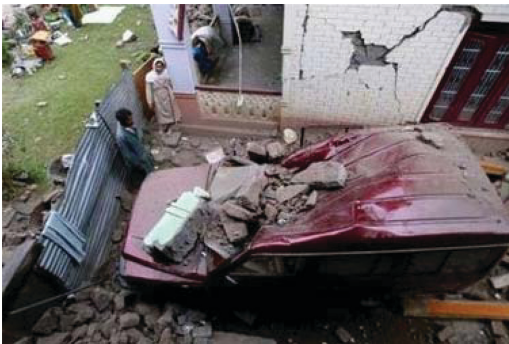
Photo 3. Damaged building near the construction site.

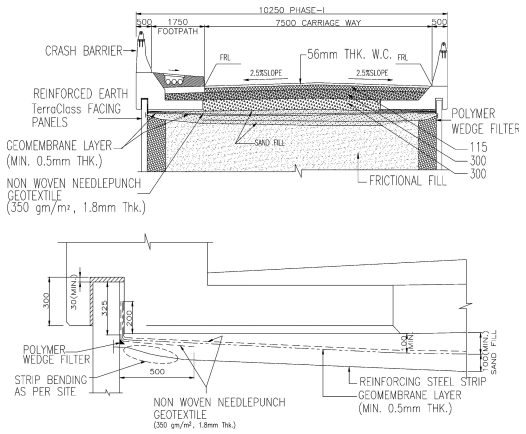
Figure 8. Geomembrane detailing at top to prevent salt percolation and corrosion steel strip.

is anticipated. To prevent the steel reinforcement from corrosion, an impervious barrier (one layer of geomembrane) beneath the pavement structure and just above the reinforced fill zone was provided. Sand drainage layer was adopted above the membrane layer to drain-out the seepage water from sub-surface layers (see Figure 8).
