WHAT TO DO IN THE EVENT OF A GEOSYNTHETICS FAILURE?: AN ACTION PLAN

Ian D. Peggs¹ & Juan Pablo Duhalde²

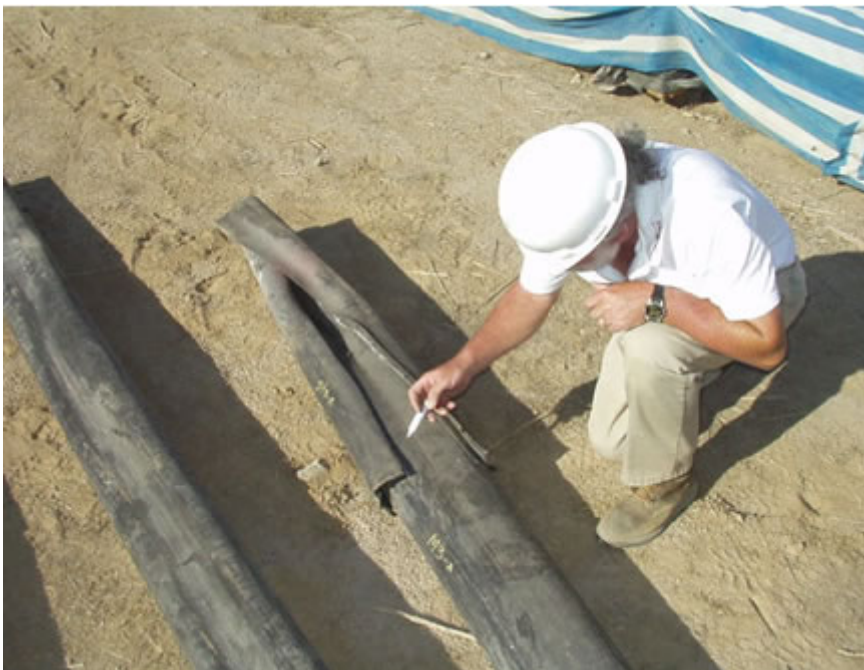
Figure 1 shows what appeared to be a section of liner overlapping another section of liner. Attempts to pull the overlapping piece off, even with a pick-up truck, were unsuccessful. The overlap was cut and the two pieces were found to have been welded together by an overlap weld not a butt fusion weld. It appeared that the outside of one piece had been heated then pushed inside the other piece (of the same wall thickness and diameter) and been expected to make a satisfactory joint. However, the inside piece had collapsed under the compressive hoop stresses, thereby causing the joint to leak and to allow slurry to access the interface between HDPE liner and steel pipe. Such a situation could have caused the liner at other locations to collapse. It was difficult to believe that this piece had come out of the steel pipe.

Figure 1. Marking overlapped liner before separating

With reference to the overlap weld, it was proposed by other parties that friction welding had occurred during service as the liner broke circumferentially and the upstream part was forced into the downstream part. However, in the dirty wet slurry environment, with equal hydrostatic pressures on both sides of the HDPE liner (after the liner broke), it is inconceivable that even a poor friction weld could be achieved. That being said, it is still difficult to see how a partially successful insertion overlap weld could be made under controlled conditions.

Due to the lack of information and samples the adjuster was very close to denying any claim at all. For the same reason the final report could not be conclusive. The final opinion was expressed that the overlap weld, made during construction (and therefore not claimable under operations insurance coverage) leaked and was responsible for the nearby “beak” break, partial liner collapses, and more serious flange collapses. Some of these features had probably been present prior to the blockage event. The more distant (several hundred metres) upstream mangled liner blockage was a separate event probably resulting from a local partial collapse of the liner and accumulation of a large plug of scale (this was the most upstream feature). It is possible the service pressure upstream of the plug caused the blockage to move down the pipe and to take the adjacent liner with it. Friction between HDPE and steel would be considerably reduced with slurry in the interface and equal pressures on each side of the liner. However, it is also possible that the higher forward and reverse pressures used to try to relieve the blockage were responsible for the break in the liner and its movement to the location where it was found. This could only be clarified by finding and examining the source of the mangled piece. It was a serious omission of the first investigation not to find this location.

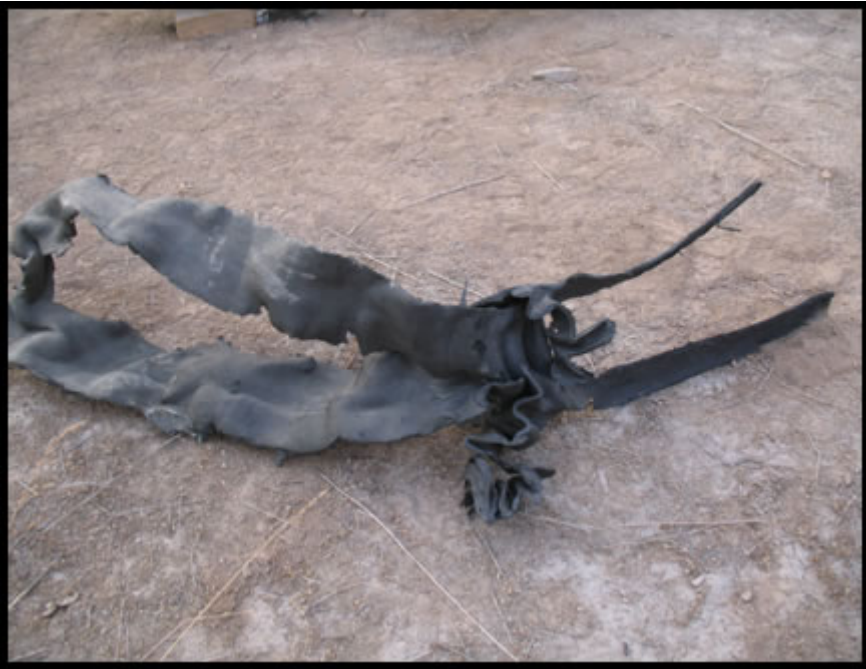
The mangled liner (Figure 2) was examined. It appeared that the two long “ears” at one end had been inverted from their original positions alongside the main body of the mangled plug. Clearly this piece had torn out of the liner from somewhere else in the pipe. However, no search had been made for such a location.

Figure 2. Large piece of broken HDPE liner that caused blockage

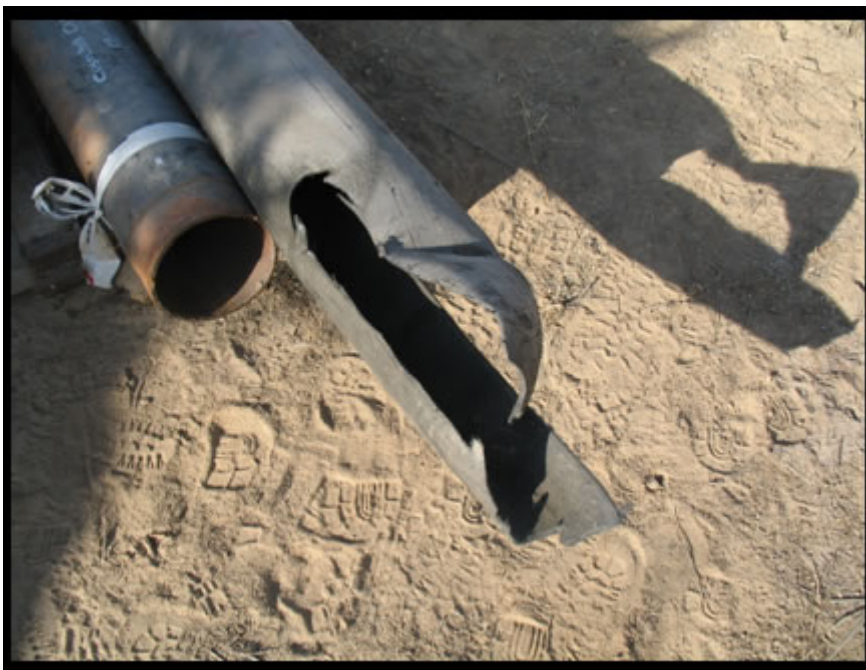
An unusual “beak” section of liner was found, with no markings (Figure 3). It had been present in the pipeline in this condition for some time since there were slurry and scale abrasion marks on the outer surface. However, no matching part to this piece was sought or found.

Figure 3. “Beak” fracture in HDPE liner

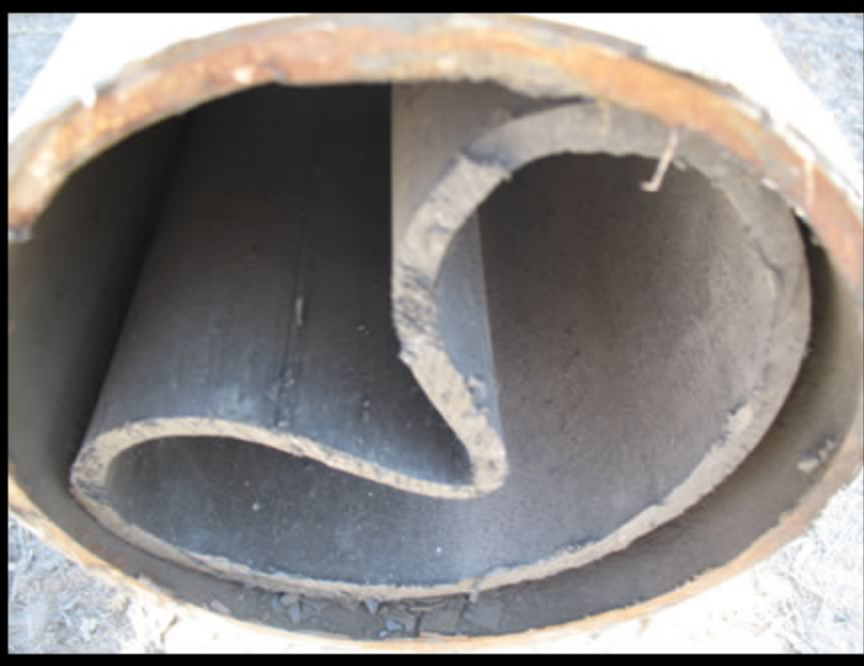
There were photographs of collapsed liner at flanges between steel pipe sections but there were no samples found or made available in this first site visit. Many sections of partially collapsed almost completely collapsed liner were also seen, as shown in Figure 4.

Figure 4. Collapsed HDPE liner

It was evident that there had been leaks through the liner, that slurry behind the liner had probably resulted in the liner collapsing, and that in one case a large piece of liner had torn away and caused the main pipe blockage. All of these features were present in a relatively short length of the pipeline which also happened to be the lowest elevation of the pipeline, and just before it rose (downstream) to the highest elevation. All features probably occurred sequentially during the failure event, which happened very quickly, and which caused a rapid shutdown of the pipeline. Thus, most materials were in the same abraded condition that they had been at the time of the blockage. However, their geometrical profiles were either as they were at the time of the failure or as modified by the higher applied forward and reverse pressures when trying to break down the blockage. Thus, it was very important to know exactly the locations where each feature was found and which end of the sample was upstream and which was downstream. It was clearly extremely important to know from where the mangled piece of liner originated, and whether it moved in one direction or another, or both, during the pressure events
