In situ failure test of high water content soft clay embankments reinforced by GHDs

M.Kamon
Kyoto University, Japan

ABSTRACT: To apply newly developed geosynthetic horizontal drains (GHDs) to reinforced embankment, full scale in situ failure tests were carried out. The GHDs consist of geosynthetic materials which have improved fabric parameters for permeability and reliable strength. Four kinds of GHDs were selected and a very soft clay with a high water content was used for the filling material. In this paper, the properties of GHDs used were introduced and the design procedure for the reinforced embankment including drainage by GHDs was discussed. Highly critical values for safety of the embankments were selected. The filling frame was made with sandy soil and the soft clay soil embankments was designed to be 3m high with a 1:0.5 slope angle.

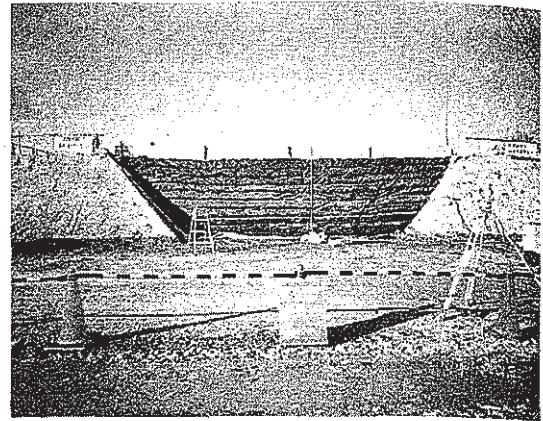
Photo 2 Completed filling in Section 2

The filling works were carried out smoothly in Sections 1 and 2. However, in Sections 3 and 4, the slope displacement increased during filling of the 8th layer, and especially in Section 4 cracks appeared on the crown of embankment (at a point approximate 5m from the slope shoulder) immediately after completion of the 8th layer. Therefore, filling was stopped at the 8th layer due to the visibility of cracks at the crown. Photo 2 shows the embankment after the completion of filling in Section 2.

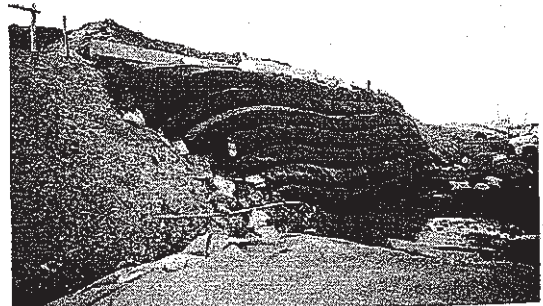
Photo 3 Failure pattern in Section 1

The failure of test embankments in each section occurred under different thicknesses of additional load. In Section 1, where nonwoven fabric reinforcement was laid over the whole surface of embankment, displacement occurred across the whole slope as if it was pushed out forward and collapsed after the second layer covered the first layer. In Sections 2 to 4 where GHDs were set up using a staggered arrangement, the center part of the slope was pushed out as the thickness of the additional load increased and collapsed after the higher layer covered the lower layer. Afterwards, cracks occurred at the wrapped part of the covering

material. Photos 3 and 4 show the failure patterns of test embankments in Sections 1 and 2. On the surface of the additional load in all Sections after the collapse, the main scarps appeared at cross section A as indicated in Fig. 3. The thickness of additional load and the height of the main scarp are summarized in Table 3. The deformation of 10m long GHDs which were placed on top of the 10th layer was observed in all Sections after the additional loading was removed when the failure test was completed. By this observation, it was confirmed that GHDs were broken in Sections 1, 3 and 4 at the filling frame right under position A as indicated in Fig. 3. GHDs in Section 2 were pulled out without any breakage.

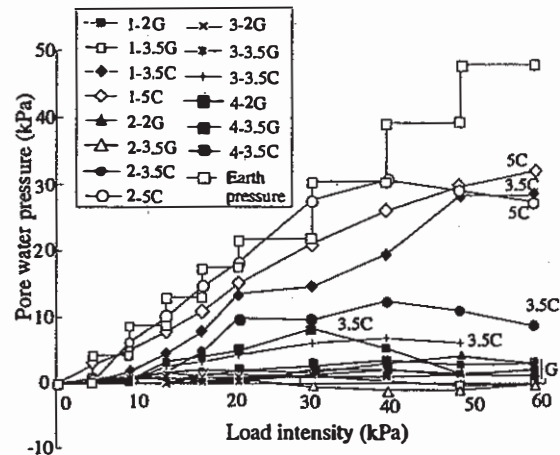
Fig. 5 Behavior of pore water pressure

Figure 5 indicates all the results of measurement of excess pore water pressure which were obtained in soft clay and were attached to GHDs. The pore water pressure meter attached to GHDs was measured at an approximate maximum of 19.6kPa pore pressure, and maintained a definite and unchanging value with more than 29.4kPa of additional loading. In comparison with these values, pore water pressure in soft clay did not dissipate due to that approximate 70 to 80% of earth pressure. However, pore water pressure in soft clay between GHDs demonstrated values similar to approximately 50 to 60% of the value of earth pressure. The differences in pore water pressure between the two areas can be considered due to the drainage by the GHDs.

*G shows the sensors attached the surface of GHD
 *C shows the sensors installed in the clay layer
 *2, 3.5, 5 mean the distance from the surface of slope.
 Unit; m

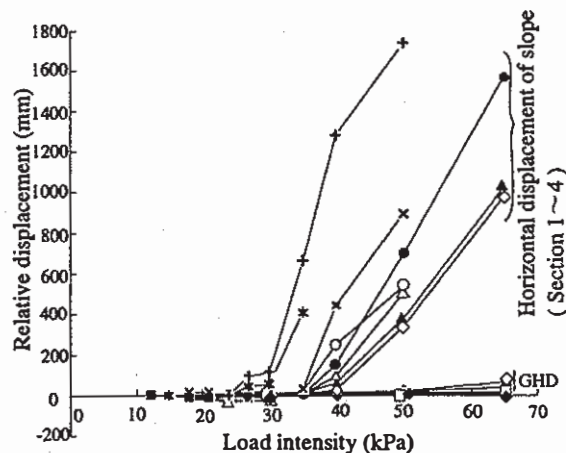
Fig. 6 Relative displacement of embankments

Figure 6 indicates a change over elapsed time in the relative displacement around sliding surfaces and horizontal displacement at the slope of the embankment. Although the horizontal displacement at the slope came to more than 1m, the elongation of GHD showed only 1 to 2cm of relative displacement. This result clearly indicates the

sliding surfaces in soft clay where outside of the GHD area as expected in our design.

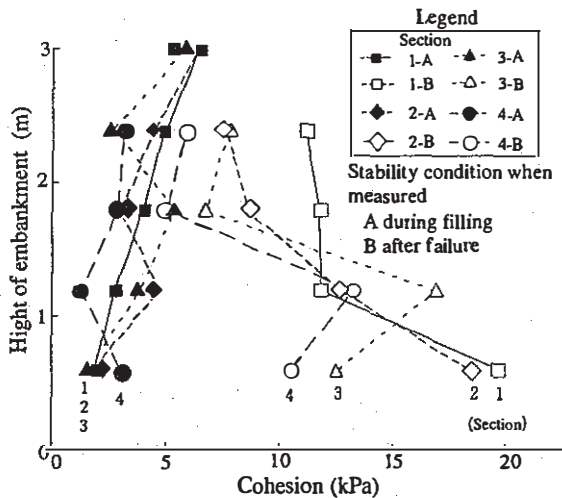
Fig. 7 Strength increase promoted by GHDs

Figure 7 shows the strength increase in the clay due to GHDs. Cohesion (c_u) at the time of filling was assumed to be 2.9 to 4.9kPa, and these values were slightly larger at the upper part of the embankment because of the lower water content. The value of c_u after the failure test became 9.8 to 21.6kPa and was relatively small at the lowest layers in Sections 3 and 4 although the c_u was calculated as 14.7kPa based upon the strength increasing ratio ($c_u/p=0.3$). This finding explains the relatively large deformation in Sections 3 and 4.
