Lessons learned from a 6-year-old geosynthetic reinforced segmental retaining wall

C. S. Yoo, Sungkyunkwan University, Suwon, Kyong-Gi Do, Korea

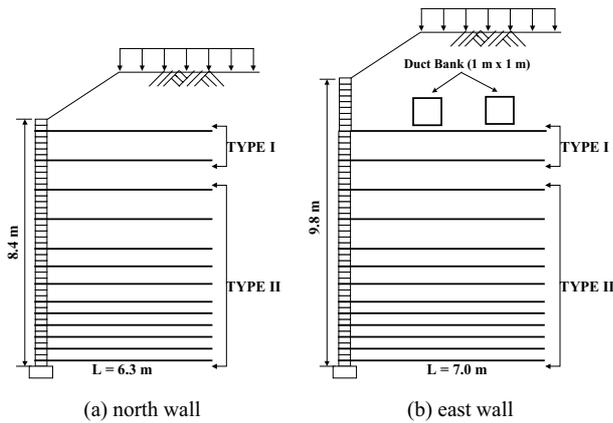
Figure 2. Typical sections of north and east wall

The wall was constructed using modular blocks (520 × 460 mm in plan and 200 mm in height) having a compressive strength of 21 MPa and geogrids available on the market. Although no detailed design documents were available at the time of investigation, available construction documents suggested that the original wall design required a pre-batter of 1/16 (3.5 degrees) through the automatic set-back of the incremental facing blocks. Fiberglass alignment pins (13 mm in diameter and 135 mm in length) were used to transmit shear between the facing courses. Figure 2 illustrates two typical sections of the original design, each for the north and the east walls. Note that the east wall has alternating 8.4-m-high and 9.8-m-high sections in order to accommodate access stairs. As seen in this figure, the primary reinforcement layers of a polyester geogrid (TYPE-I and TYPE-II) with a uniform length of 0.7~0.75 times the design wall height (H) were installed. TYPE-I and TYPE-II reinforcements have an ultimate tensile strength of 55 and 80 kN/m, respectively. A salient feature of the original design for the east wall is that a significant upper portion of the east wall was left unreinforced in

order to accommodate 1 × 1 m duct banks for utility lines running parallel to the wall. No provisions were made to protect the unreinforced zone by any means in the original design. After encountering problems during construction described later in this section, the original design of the east wall was modified.

In an attempt to evaluate the adequacy of the original design, two typical sections, shown in Figure 2, each for the north and the east walls were analyzed based on the limit equilibrium-based design/analysis approaches. The results are presented under subsequent headings.

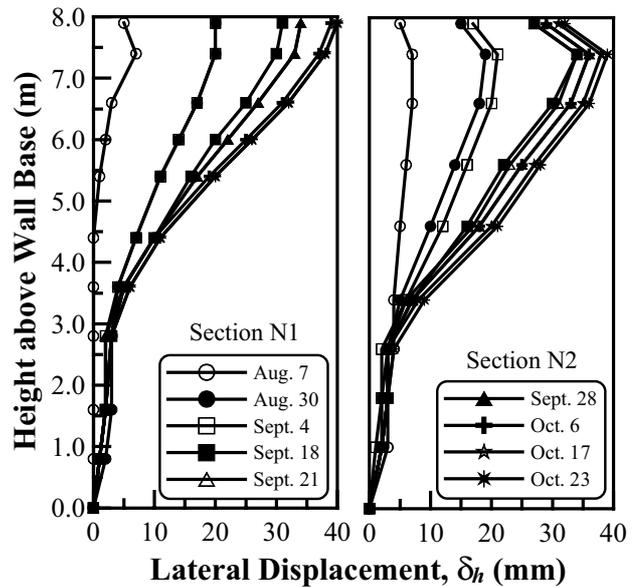
Figure 3. Lateral wall movement profiles of north wall

In August 2000, several years after the wall completion, the owner noted significant wall movements along a 20-m-long section of the north wall, for which no significant problems were reported during and after construction. Two sections, N1 and N2 on the north wall shown in Figure 1, were therefore closely monitored using plum bobs. Figures 3 and 4 show the patterns of wall movements and the records of maximum wall movements with respect to time after the start of monitoring, respectively. Also shown in Figure 4 are the possible geogrid strain levels inferred from the measured wall displacements assuming that no slip between the geogrids and the backfill had occurred.

As seen in Figure 3, the lateral wall movement profiles essentially follow a cantilever type with a maximum value of approximately 40 mm occurring at the top. The wall movements increased almost linearly with time for a 1.5-month period, after

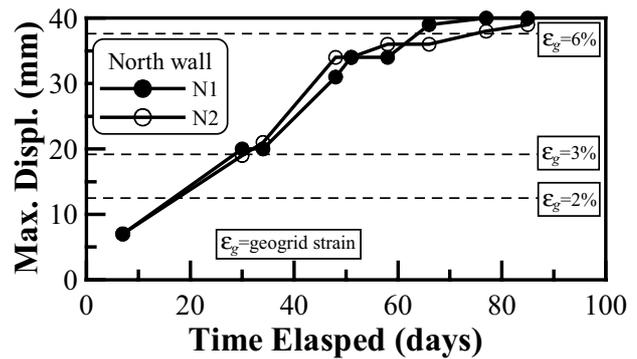
Figure 4. Evolution of max. lateral wall movement with time

Note that these movements were measured over a three-month period until the movements appeared to have been ceased and do not include displacements that had occurred during construction. The actual strains developed in the reinforcements might therefore be much higher than those indicated in Figure 4.

which the movements leveled off, as illustrated in Figure 4. These movements can also be visually seen from the photographs taken at the site shown in Figure 5. As one can notice, significant movements at the top are manifested by the out-of-alignment of the column of the access-stair attached to the wall. Although no additional movements were recorded approximately three months after the start of monitoring, the prospect of further movement of the wall and the long term stability was a concern to the owner, prompting this investigation.

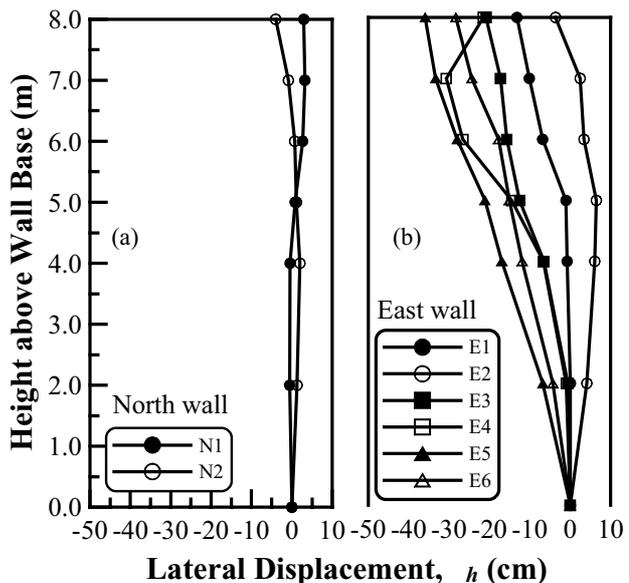
Figure 7. Out-of-alignment of north and east wall sections

Figure 7(a) illustrates the inferred wall movements for the north wall sections. Also shown in this figure is the wall face with a batter angle of 3.5 degrees. As seen in this figure, it appears that these two sections, which showed a sign of distress

most recently through the excess wall movements, moved approximately 500 mm at the top, assuming a fixed condition at the base of the wall. A maximum geogrid strain on the order of 8% would be anticipated for that magnitude of wall movements. Considering the strain at rupture of 12% for the geogrids used in the wall construction, the inferred levels of strains appear to be excessive even though possible slip between the geogrid layers and the backfill are taken into consideration.

Figure 7(b) illustrates the inferred wall movements of the various sections for the east wall. As seen in this figure, the results of the wall profiling suggest that significant wall movements, as great as 400 mm, occurred in section E2. Sections E3-E6 exhibited relatively smaller wall movements compared to other sections. Although the east wall sections did not show significant post-construction movements, the strain levels in the geogrids were also believed to be high.

The profiling results presented above may not exactly represent the actual wall movements due to possible modifications to the original design during construction and errors involved in profiling. Nevertheless, given the circumstances, it appeared that significant wall movements had occurred during and after construction in the entire wall sections, and that strain levels in the geogrids were undesirably high. And therefore, the likelihood of additional wall movements was considered to be quite high due possibly to any changes in environmental conditions, such as creep of geogrids, water pressure due to seasonal rainfalls, among others.

Although this investigation was initiated in response to the recent north wall movements, the rest of the wall sections also appeared to have experienced significant wall movements. Since the entire wall sections appeared to be unstable according to the current design criteria, the recent excessive movements, and the profiling results, remedial measures were provided to ensure both the short-term and long-term stability. Selection of remedial measures was highly influenced by the site condition in which a number of utilities and pipelines are buried at shallow depths. Suggested remedial measures include reconstruction of upper 1/3 of the wall using either a segmental retaining wall or a reversed L-shape concrete retaining wall. Also suggested is to provide a means of external support onto the entire wall sections with a reversed L-shape concrete retaining wall.
