Lining of industrial water reservoir with HDPE geomembrane

ABSTRACT: ABC Refinery complex is having a surface water reservoir to feed to various process and power plant of the complex. The capacity of the reservoir is 260 000 cum(approximately). The area of the reservoir is approximately 60,000 sqm. Initially the reservoir bed was lined with concrete and laid subsequently with bituminous felt membrane. However over a period of operations of the water reservoir for 7 years, the bituminous felt developed cracks and the water started leaking through the concrete. The situation aggravated to such an extent that the unit had to be closed down in dry periods due to shortage of water which coupled with huge evaporation losses. The estimated water loss per day was 3500 cum/day. A complex Lining and anchoring system was designed and implemented to eliminate the water loss as well as ensure the hassle free operation of the Lining System.

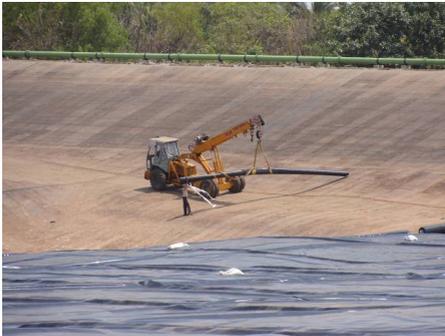
The reservoir structure has 19 sides and each side having different profiles varying from very gentle slopes to medium slope of 1:1.25 and at places concrete parapets. The depth of water storage across the surface of the reservoir also varying from 0.2 m to 8.5 m at the lowest contour where the intake well is existing causing severe drag down force. The drawn out water is taken through the pipelines mounted on small foundations running very close to the slope termination points and the lowest point of the pipe is very close to the bed of the embankment. This posed several challenge for the anchoring of the pipes. The indicative details of the explanation could be seen from the Photograph below.

It was felt that the soil below the pipe lines and across to be excavated and a lean concrete of 1:3:6 of 0.2 m needs to be laid before the liner is taken over the surface. This was more essential as some boulders were existing on the embankment was ready to puncture the membrane. Subsequently the membrane was covered with similar grade of concrete with higher thickness to keep the system in place and without any expected sliding force. To be very safe, the liner was also taken over the termination point of the outer slope line to avoid emergency stress on the run out membrane. The drawing shows the system developed to take care of the existing complexity of the structures.

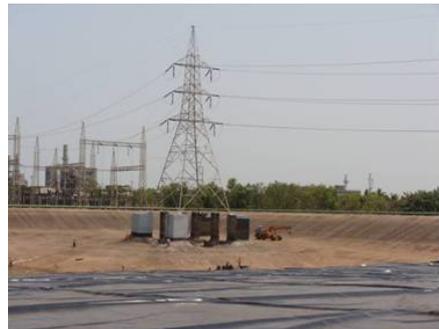
It was also observed that a HT Tower is existing inside the reservoir having pile on. It was necessary to imagine that the lowest contour of the reservoir was not far away from this structure and also observed that the whole pile on gets submerged when the water is full at the spill way level. It was important to have some system designed so that there is no leakage as well as stress around this structure.

The other aspects was the steel coming out of the foundation pile on which needs special joints at the intersection.

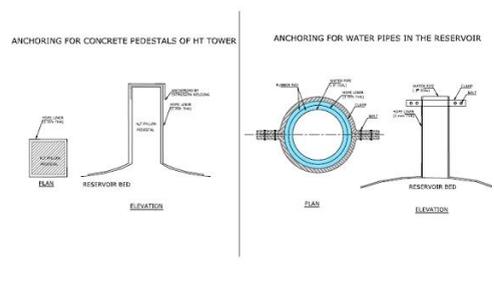
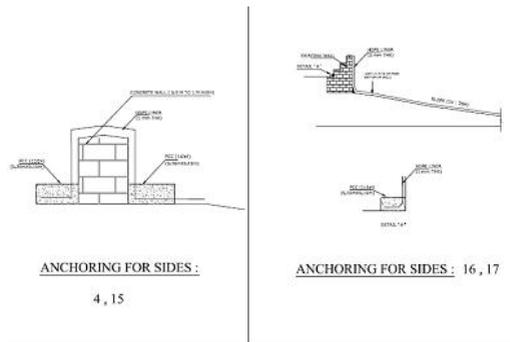
Efforts were made to understand the vertical load and the drag down forces on the membrane during fill condition.

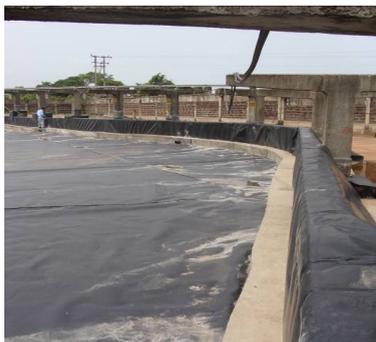
One of the biggest obstacle was to look at a very robust lining system is also the existing projected pipes inside the reservoir to release any water rising through the ground surface. They were also lined as major existing liner failure was observed during the initial site walkover survey.

Secondly on the opposite side of the spill way, parapets were constructed of height varying from 1.5 to 3.0 m to stop ingress of water from the adjoining small tank. In fill condition, the water level at the parapet was 0.5 m from the top ht kept as free board.

It was felt that two levels of anchoring were essential to reduce the stress on the membrane which was laid on a sloped surface till the parapet. The first was to keep adequate frill on the laid out membrane and keep a small concrete anchoring system to keep the stress up to that point balanced out and subsequently take the membrane over the parapet wall and keep a run out 2 m in excess of the height of the wall to take care of future tension if at all arise due to the hydrostatic head as well as the drag down forces.

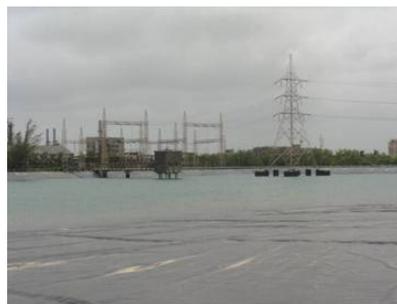
The biggest difficulty for laying the liner was the intake well columns and bars as well as the supporting columns with height up to 9m. As this was the lowest point and the industry wanted that no leakage should happen because of the force anticipated at this point is highest as well as the anticipated stress developed in the membrane is the maximum.

It was decided that the laid on membrane will not stick to the concrete wall and neither the bolting system will eliminate the annular space between the wall and the membrane. Secondly the column's height was too high to take out the stress from the membrane and it may fall out on its own stress over a period of time and may get ruptured.

Hence for the intake well columns, an aluminum clap was fabricated and water repellant epoxy resin was applied to the mouth of the membrane and sealed. It was observed that the idea worked and the mouth came out to be complete water proof.
