Long-term performance of non-woven geotextile wraparound walls

I.C. HULSE & P. PHILLIPS, Geofabrics Australasia Pty Ltd, Australia

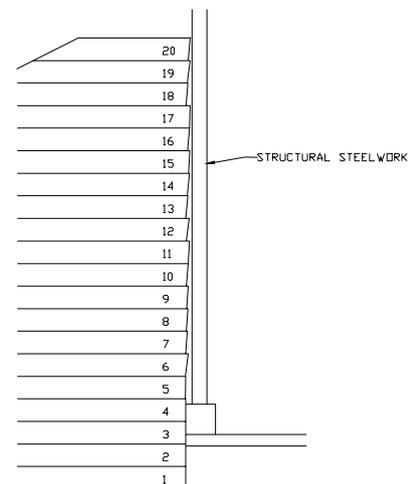
Figure 3. Detailed survey of the first wall built showing the forward rotations of the facing panels.

Table 1 shows the rotation of the facing boards. This was the first wall built and although it looks like there has been substantial movement of the wall, overall the forward rotation is 65mm. This is not considered as a major problem and is kept under surveillance, as are most walls on the ADI site.
