# Performance of reinforced soil structures during the 1995 Hyogo-ken Nanbu Earthquake

**ABSTRACT:** The performance of a number of mechanically stabilized earth retaining walls and nailed slopes during the 1995 Hyogo-ken Nanbu earthquake is reviewed. The behaviour of the reinforced soil retaining walls is compared with that of the conventional retaining walls. Some lessons from the case histories and limitations of the current seismic design methods are discussed. Reconstruction of damaged structures by soil reinforcing techniques is also presented.

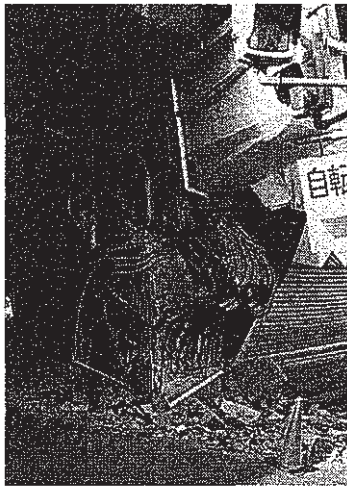
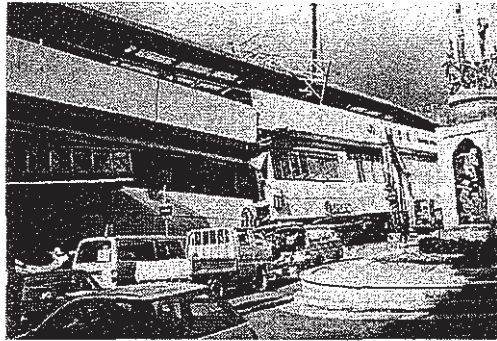
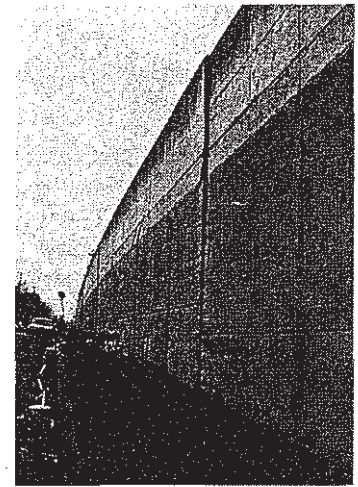
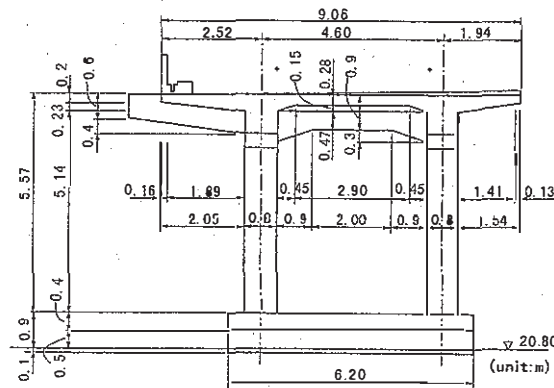
- 2) The elevated RC frame structures had no overall bracing and no diagonal steel reinforcement in each column (Fig. 1a). They were, therefore, basically not well prepared for large tensile loads acting in the diagonal direction caused by lateral seismic loads. The damaged RC columns were prone to shear failure, mainly due to over-estimation of the shear strength of concrete in the design and an insufficient amount of stirrups. Shear failure of RC columns occurs in a rather brittle manner, easily resulting in total collapse. Recent RC columns are, therefore, designed not to fail by shear failure but by bending failure, based on the design code specified in 1983. Note that many of the independent RC piers supporting steel or RC girders for elevated highways located inside and outside the most severely shaken areas were also seriously damaged, mainly by shear failure, and some of them were totally collapsed.

Fig. 7 a) Damaged RC frame bridge abutment and b) damaged Rokko-michi Station consisting of elevated RC frame structures, c) typical dimensions of elevated RC frame structure, and d) inverted T-shaped RC RW adjacent to Rokko-michi Station.

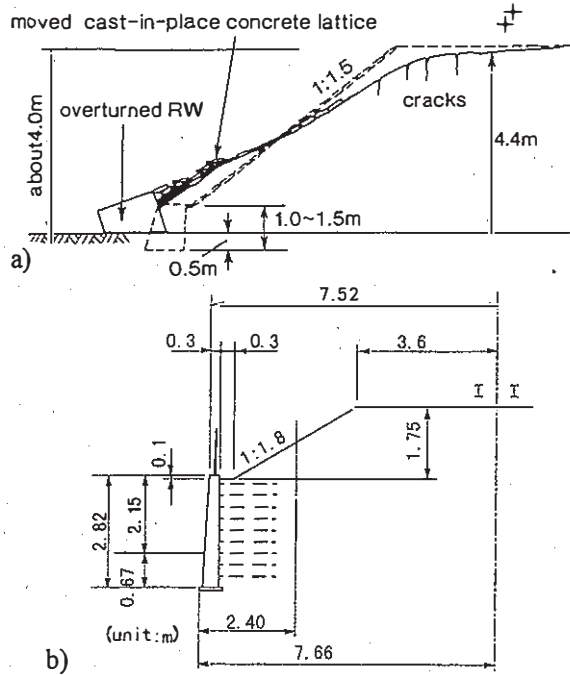
For a length of about 600 m between Setsu-motoyama and Sumiyoshi Stations (see Fig. 4), the north side slope of embankment was retained by leaning-type unreinforced concrete soil RWs constructed around 1938. The RWs were either broken at the ground surface level and the upper part overturned completely to the ground surface or overturned about the bottom, resulting in the back face facing up (Fig. 10a). This damage was perhaps triggered by large horizontal seismic loads acting on the RW structure itself and large seismic earth pressure imposed on its back face from the backfill. It seems, however, that the former factor should be the major factor for complete overturning of the RW.

Fig. 8 Cross-sections of a) a typical damaged south slope of the embankment and b) a GRS-RW by reconstruction, between Setsu-motoyama and Sumiyoshi Stations, JR Kobe Line (ES1 in Fig. 4).

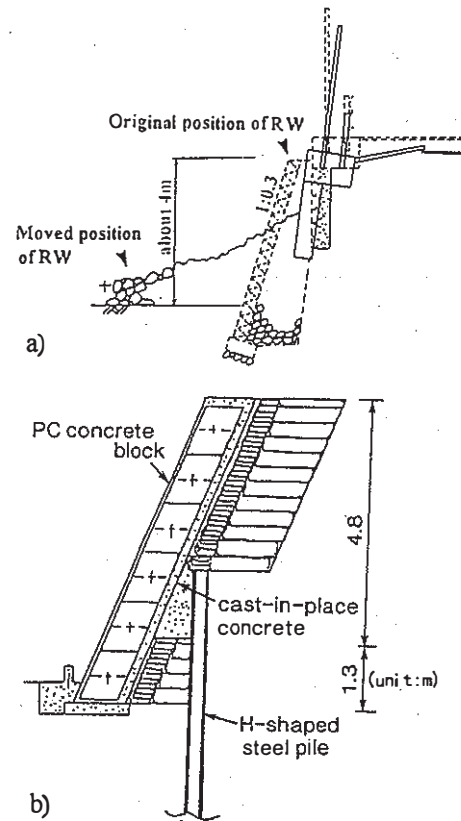
The oldest type of RW is masonry RWs. They were constructed more than 70 years ago without aseismic design. They were most seriously damaged among different types of RWs. Most of the masonry RWs located in the areas where the JMA scale was equal to seventh or higher were more-or-less damaged as typically shown in Fig. 9. Many masonry RWs supporting the backfill behind the RC bridge abutments moved outward, resulting in large settlement of the backfill relative to the pile-supported RC bridge abutments.

Fig. 9 Cross-sections of a) a typical damaged masonry RW constructed in around 1925 (MS1 in Fig. 4) and b) a GRS-RW by reconstruction (the facing consists of PC concrete blocks, which were fixed afterwards to each other and to the backfill), between Setsu-motoyama and Sumiyoshi Stations, JR Kobe Line.

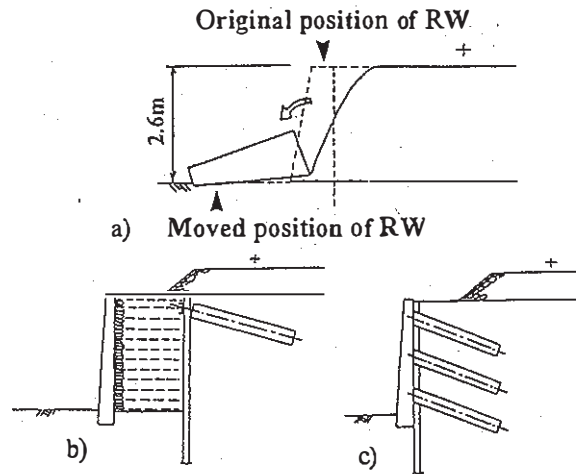
Fig. 10 Cross-sections of a) a typical damaged leaning-type RW constructed in 1937 (LT1 in Fig. 4), and b) a GRS-RW and c) a nailed RW by reconstruction, the north side slope of the embankment between Setsu-motoyama and Sumiyoshi Stations, JR Kobe Line.

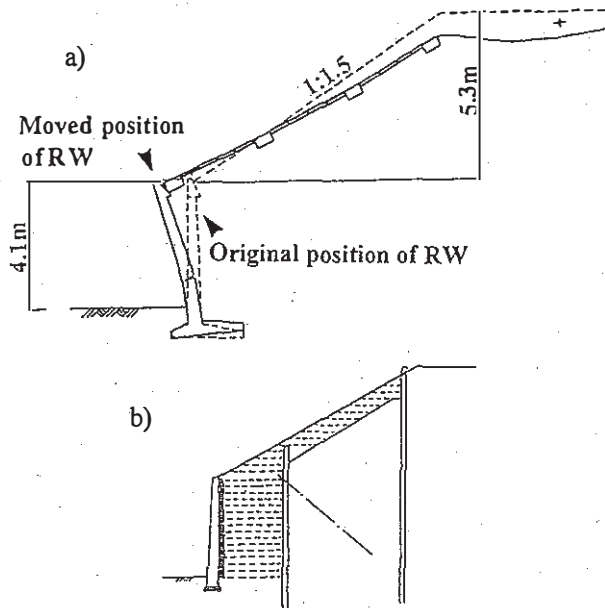
Shin-Nagata Station of the JR Sanyo Line was constructed around 1965 on the crest of a sloped embankment. Both sides was supported by cantilever-type (or inverted T-shaped type) RC RWs for a total length of about 800 m (Fig. 11a). The walls were aseismic-designed using  $k_h = 0.2$ , but it is

very likely that they were not supported by piles despite a weak subsoil. Most of these RWs considerably tilted and slid outward at the bottom inducing large settlement at the top of the railway embankment. It seems that the damage was due to insufficient values of both the bearing capacity in the subsoil beneath the wall and the sliding resistance at the wall base. The most serious damage was cracking in the facing, probably due to extra-ordinary large seismic earth pressure from the sloped backfill (Fig. 11a).

Fig. 11 Cross-sections of a) a typical damaged cantilever-type RC RW without a pile foundation (CL2 in Fig. 4) and b) a GRS-RW by reconstruction, at Shin-nagata Station, JR Sanyo Line.

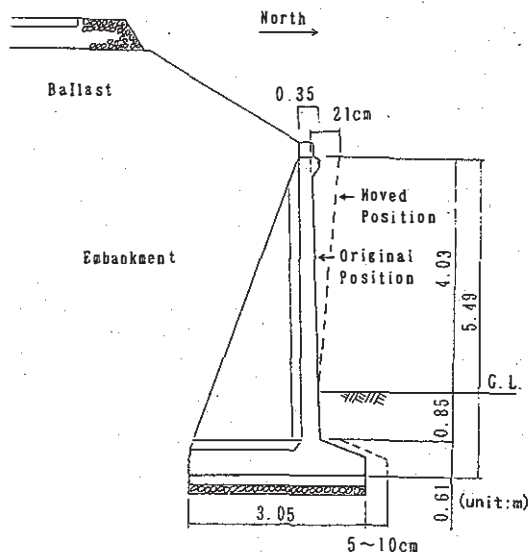
Inverted T-shaped and buttressed RC RWs which was constructed around 1938 at Shioya Station of the Sanyo Dentetsu Line, running in parallel to the JR Sanyo Line (see Fig. 4), were also seriously damaged (Fig. 12, CL11 in Fig. 3). There were no piles. Although the wall did not totally collapse, most part tilted largely for a length of about 360 m, and some part of the wall structure ruptured. Similar to the RWs at Shin-nagata, the strength of the wall structure itself and the bearing capacity of the supporting subsoil below the wall were seemingly not sufficient to prevent, respectively, the failure of the wall structure and the large tilting of the wall. The walls were removed after the earthquake.

Fig. 12 Typical cross-section of damaged buttressed RC RW without a pile foundation (CL11 in Fig. 4), Shioya Station, Sanyo Dentetsu Line.

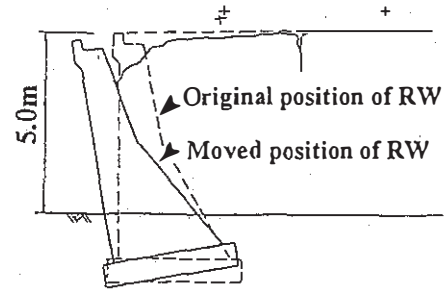
Gravity-type unreinforced concrete RWs is another old type. They were constructed more than 60 years ago. The walls at the Ishiyagawa Station of the Hanshin Line (Fig. 13, GT1 in Fig. 4) were most seriously damaged, although these walls were aseismic-designed by using  $k_1=0.2$ .

Fig. 13 Cross-section of the seriously damaged gravity type unreinforced concrete RW at Ishiyagawa Station (GT1 in Fig. 4), Hanshin Railway Main Line.

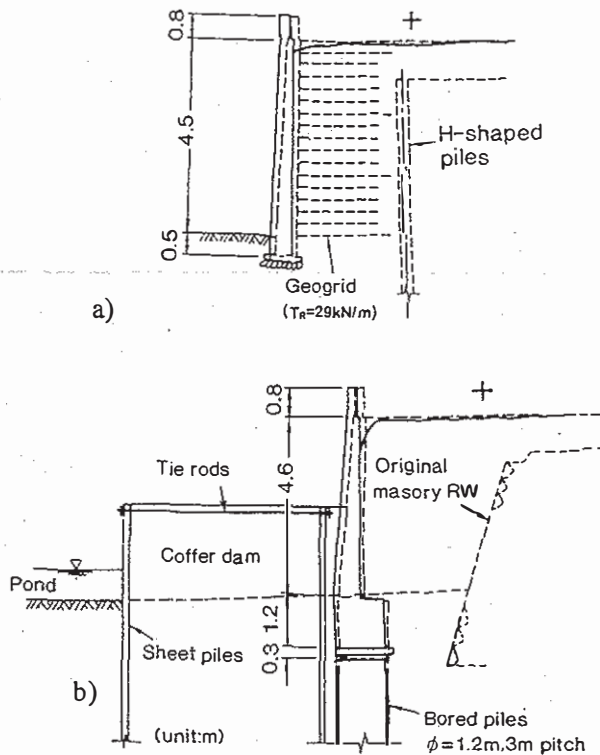
The bottom of the wall moved outward on average about 5 cm relative to the supporting foundation subsoil, pushing the subsoil in front of the wall laterally. At the highest part of the wall, which was in contact with a RC box culvert structure crossing the railway embankment, the largest outward displacement occurred, which was 26 cm at the top of the wall and 10 cm at the ground surface level (Fig. 24a).

Fig. 24 Deformation due to the earthquake of a) GRS-RW and b) RC RW with piles at Tanata.

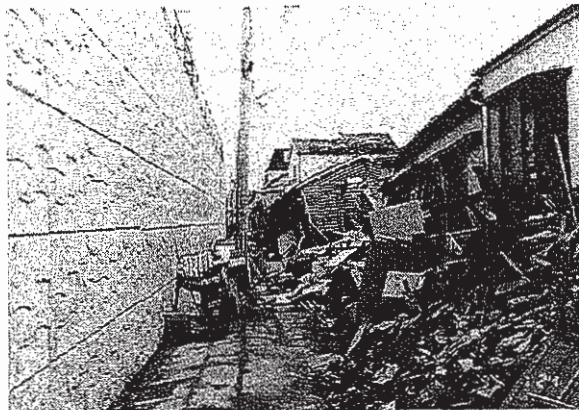
Fig. 25 View in front of the GRS-RW immediately after the earthquake

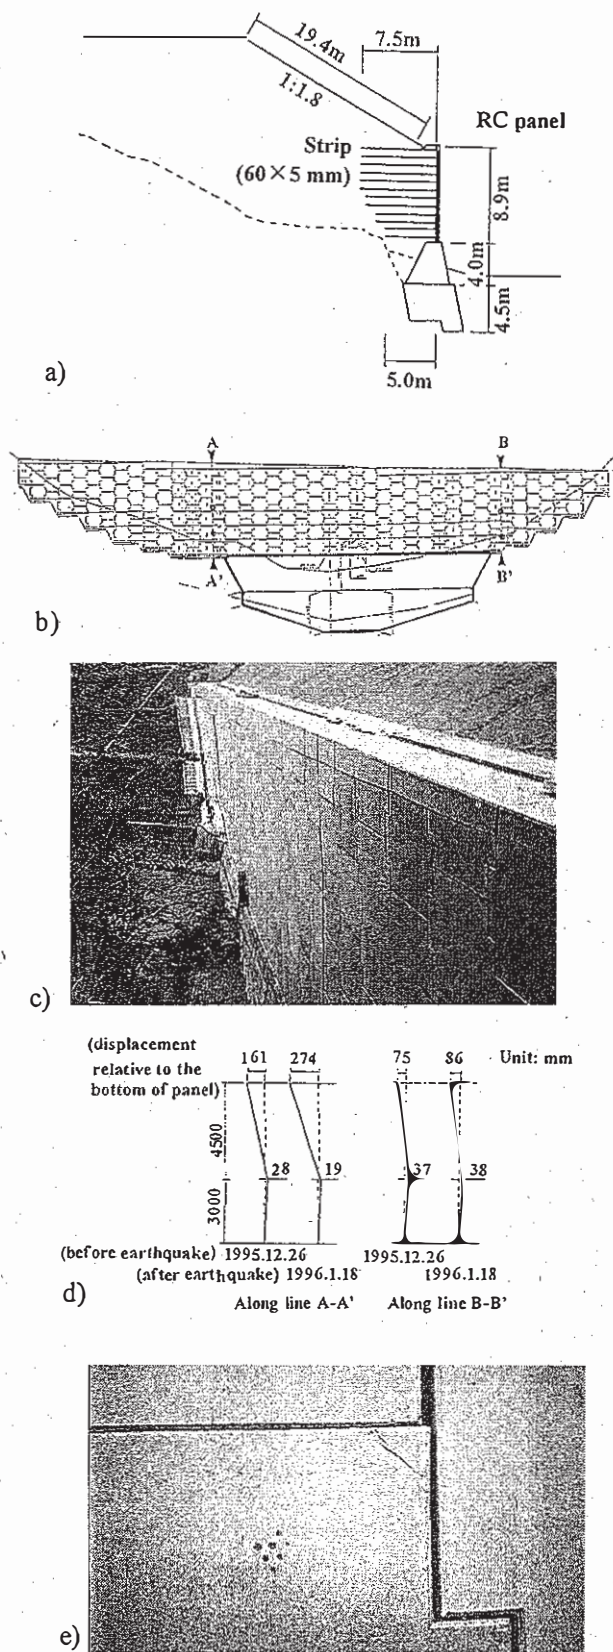
Fig. 27 shows a relatively large scale *Terre Arme* RW that was completed in January 1994 in Awaji Island (TAI in Fig. 3) as a part of the approach road

Fig. 27 a) Cross-section, b) front view, c) general view, d) wall deformation and e) cracking at the corners of RC panel, Terre Armee wall in Awaji Island (TA1 in Fig. 3) (JTAA, 1995).

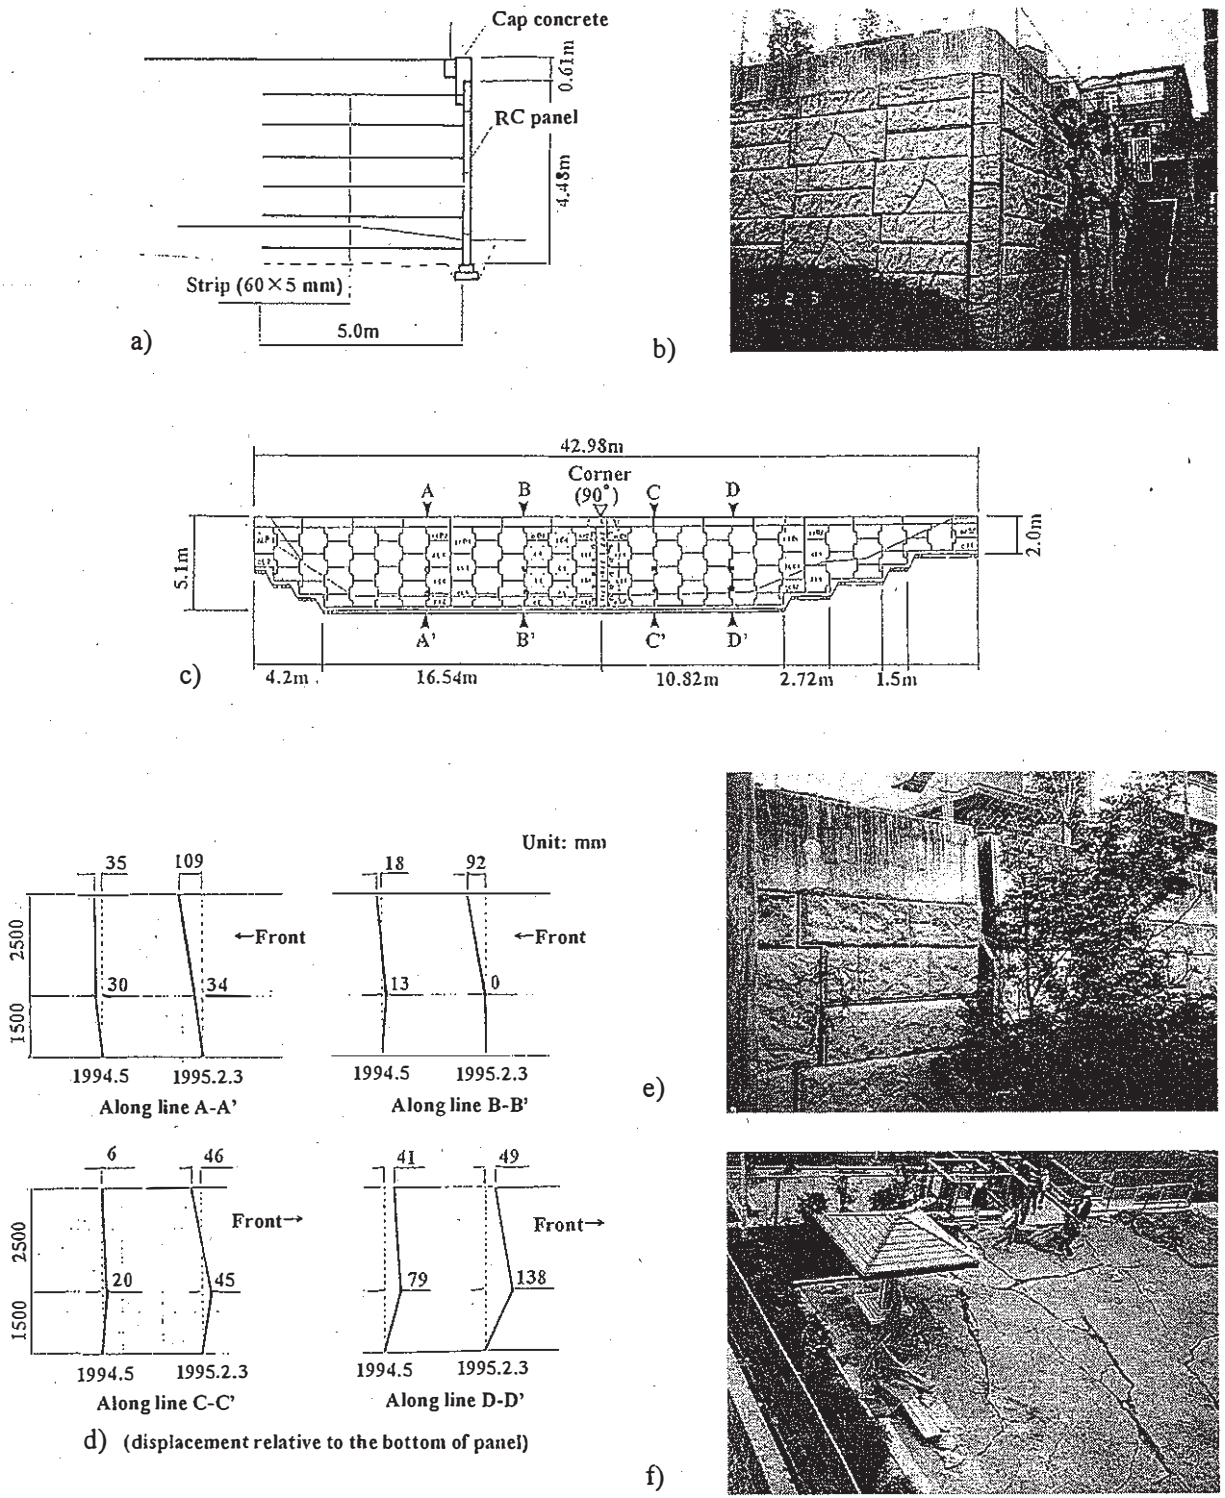
Fig. 28 a) Cross-section, b) general view, c) expanded front view, d) wall deformation, e) opening at a vertical construction joint and f) cracking on the embankment surface, Terre Armee wall for Hosiga-oka Park, Kobe City (TA2 in Fig. 3) (JTAA, 1995).

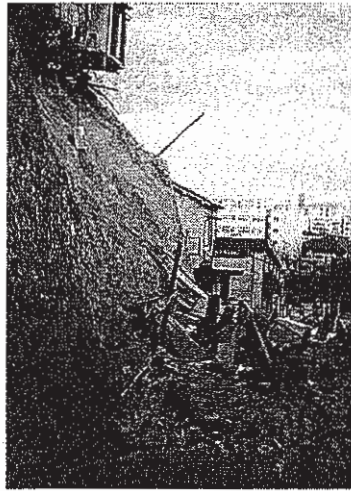
Fig. 29 A collapsed masonry wall located near the Terre Armee wall TA2 (JTAA, 1995)

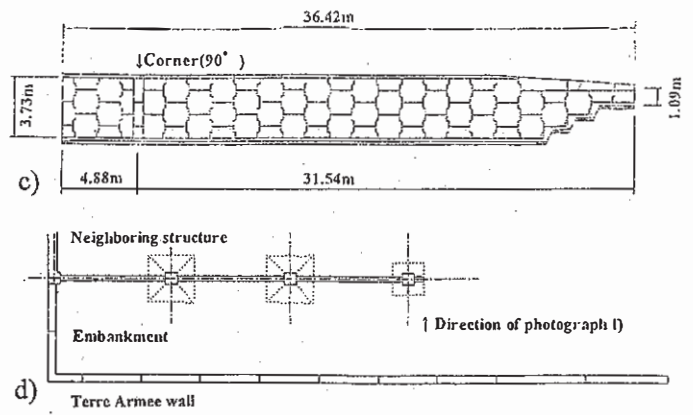
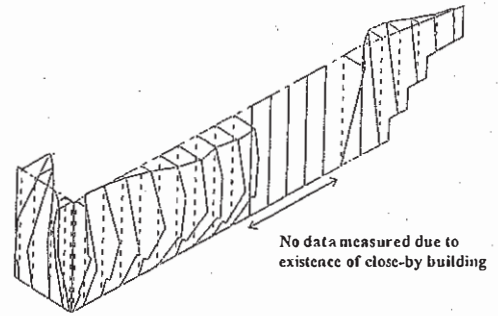
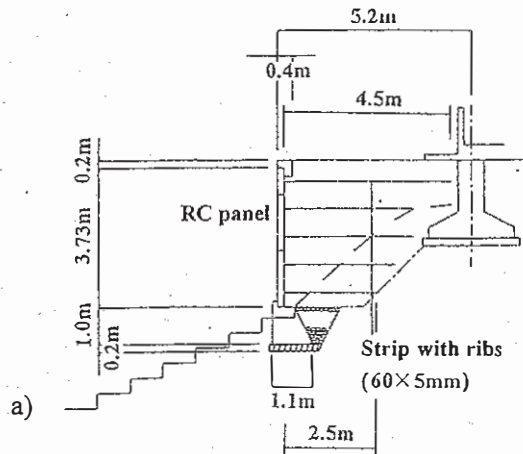
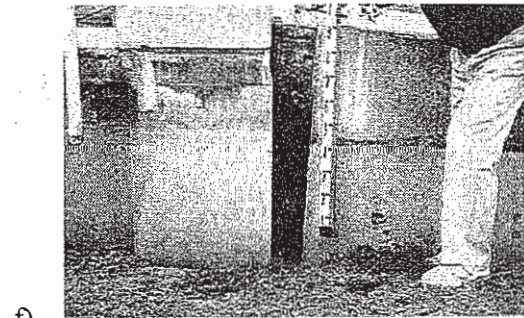
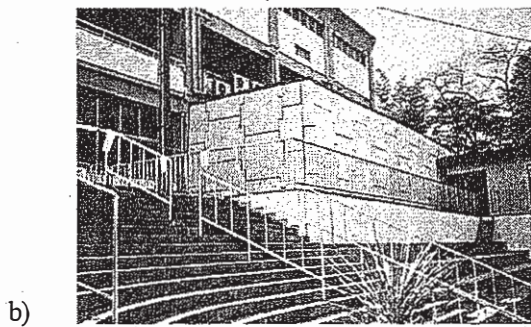
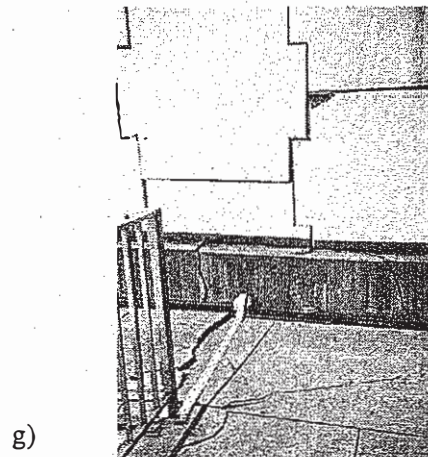
Fig. 30 (TA3 in Fig. 3) shows another permanent Terre Armee RW which exhibited relatively large deformation (JTAA, 1995, Matsui et al., 1996). This wall was completed in June 1980, having a largest wall height of 3.27 m and a total wall area of 120 m<sup>2</sup>. The top of the wall moved outward 94 mm at the largest. However, considering the fact that the top surface of the backfill settled 20 cm to 100 cm, it is very likely that the base of the facing also moved outward to some extent. Also for this wall, corner portions of some RC panels cracked (Fig. 30g).

Fig. 30 a) Cross-section, b) general view, c) expanded front view, d) plan, e) wall deformation, f) settlement of embankment relative to the neighboring structure, and g) cracking of the corner of RC panel, Terre Armee wall at Itami City (TA3 in Fig. 3) (JTAA, 1995, Matsui et al., 1996).

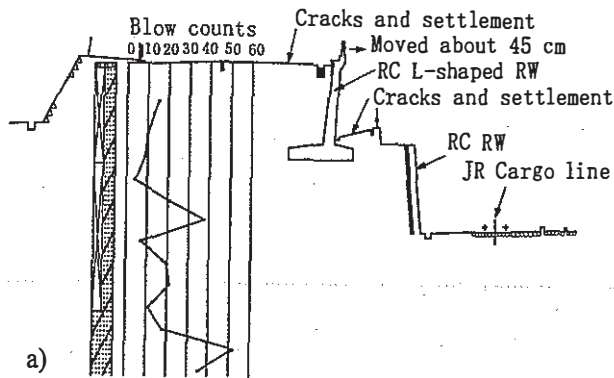
Fig. 56 a) Damaged RC cantilever RW for road embankment and b) Terre Armee wall by reconstruction, south of Nada Station, JR Kobe Line (Kobayashi and Ohtani, 1996).
