Performance of synthetic geomembranes used in waterproofing of Spanish reservoirs

A. LEIRO, M. BLANCO & G. ZARAGOZA

Centro de Estudios y Experimentación de Obras Públicas, Ministerio de Fomento, Madrid, Spain

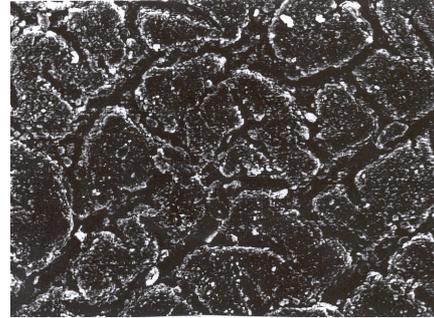
Figure 1 presents the aspect of the sheet of polypropylene installed in the reservoir of La Contraviesa after six years of their placement. The " scanner " technique showed the existence of a remarkable alteration of the material to their natural ageing.

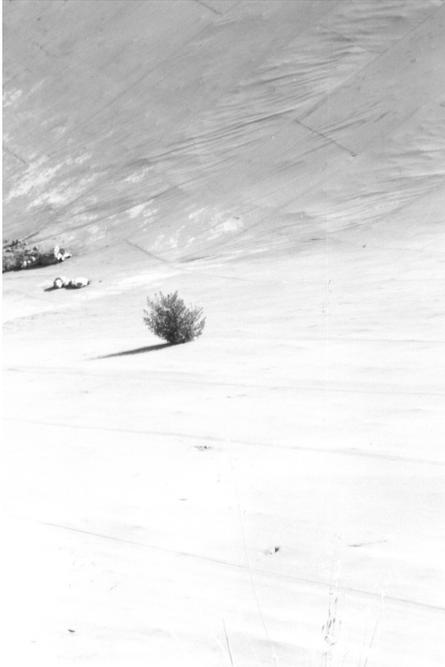
In the figure 2 the perforation is presented to vegetation in the bank of a reservoir waterproofed with PVC-P (Aguiar et al. 2001).
