WANDSCHNEIDER H.P.

Reinforced Earth Company Ltd, Canada

THIBAUT P.

Reinforced earth - a case history

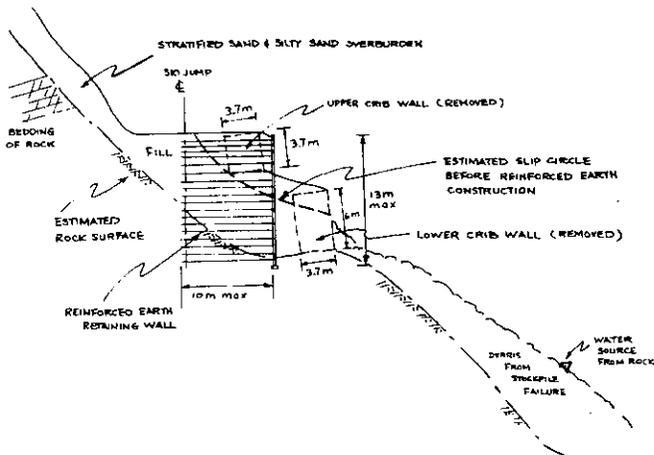
In the fall of 1977, two timber crib walls, were constructed approximately 6 m and 4 m high, separated vertically by about 2 m of fill and at a slight angle to each other in plan. (See Figs. 1 and 2.) During construction, a temporary stockpile, placed some 30 m above the level of the lower crib, failed during a heavy rainstorm. This transformed the material, which was primarily granular, into a semi-liquid mass which flowed down and over the crib wall. It came to rest on the slope in front of the crib and built up to cover

Fig. 2. Cross section through jump shows relative positions of removed crib walls and reinforced earth wall.
