Reinforced earth walls withstand Northridge Earthquake

ABSTRACT: The Northridge Earthquake occurred in Los Angeles, California on January 17, 1994 causing severe damage and collapse of significant highway and commercial structures. There are 23 Reinforced Earth structures within the affected area of the earthquake. There was no structural damage to any of these walls and only one was found to have minor concrete spalling.

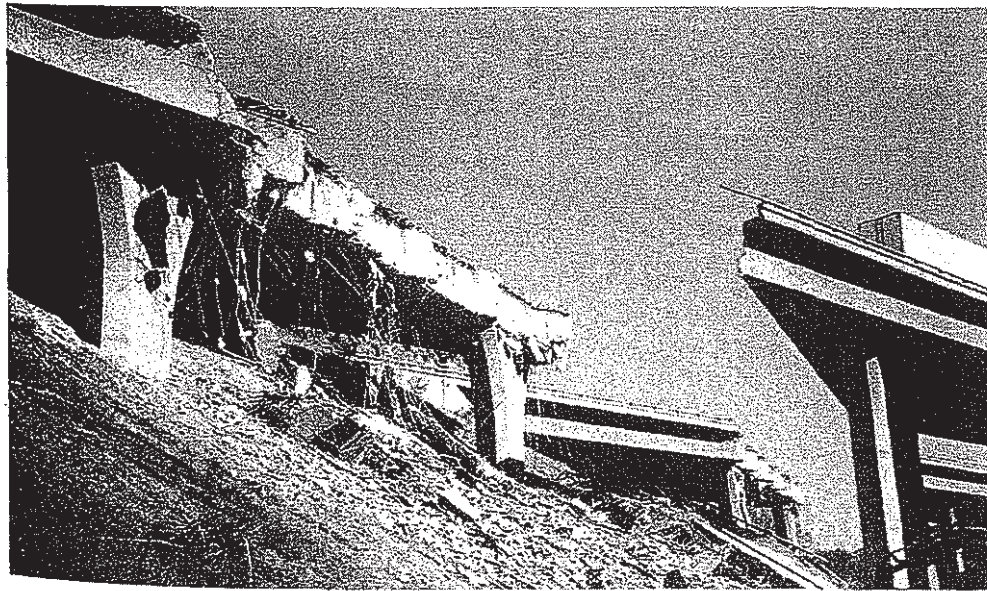
Figure 1. Collapsed Bridge on Interstate 5 at Gavin Canyon 2 km from Lyons Avenue Reinforced Earth Wall (Civil Engineering, March 1994)

Lyons Avenue, 16 km from the epicenter. The Lyons Avenue wall shown in Figure 3, supports the southbound exit ramp from Interstate 5. Nearby collapsed structures include 3 freeway bridges on Interstate 5 at Gavin Canyon (2 km from the Lyons Avenue wall) as shown in Figure 1 and the Interstate 5/Route 14 Interchange (6 km from the Lyons Avenue wall).

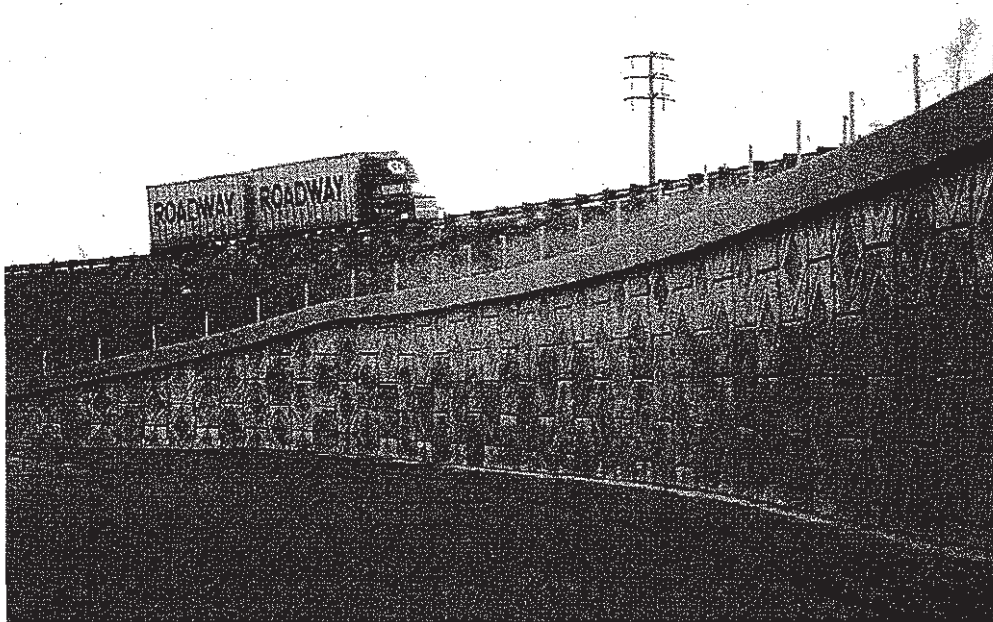
Figure 3. View of Reinforced Earth Wall at Lyons Avenue after the Northridge Earthquake

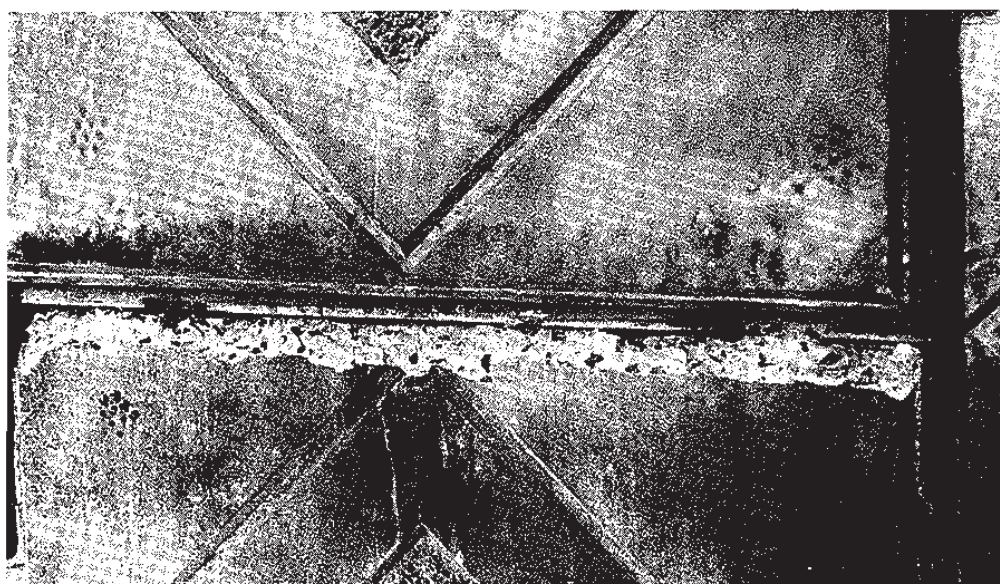
Figure 4. Spalling of bottom panel restrained from movement by embedment (Lyons Avenue)

The Lyons Avenue Reinforced Earth wall suffered superficial damage (concrete spalling) of some of the lowermost panels as shown in Figure 4.

The panels are 1.5 m wide x 1.5 m high, 14 cm in thickness and consist of 28 MPa (4000 psi) reinforced concrete. The 2 cm thick EDPM Rubber Bearing Pads located between each of the panels appeared to be flattened by seismic motions at the spalled panel locations. Recorded ground accelerations, ranging from 0.63 to 0.91 g horizontal and 0.35 to 0.62 g vertical, were high enough to cause the wall panels to move up and down. The duration of strong shaking is recorded to be 10 seconds within this area. It appears that since movement of the bottom panels was restricted by embedment, the second row of panels literally "bounced" against the top of the lower panels causing the spalling. Although enough movement occurred to cause spalling in some panels, the wall panels remain in alignment. The building next to the wall suffered severe structural damage and was posted "Unsafe" to enter after the earthquake.
