## Repair at Winscar bituminous concrete facing rockfill dam

A.M. SCUERO, Carpi Tech S.A., Chiasso, Switzerland  
G.L. VASCHETTI, Carpi Tech Italia S.r.l., Arona (NO), Italy

**ABSTRACT:** Winscar is a reservoir for potable water supply. Since 1970, when the rockfill dam was built, there were leakage problems. In summer 2001, the bituminous concrete facing was rehabilitated with a PVC geocomposite, mechanically anchored and drained. The paper describes the problems, the criteria that lead to the selection of the waterproofing solution, and the installed system with the performance data available to date.

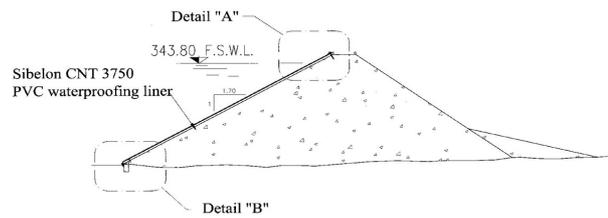
The waterproofing membrane is installed on the upstream face, in exposed position (Fig. 1), and is anchored mechanically at the periphery and along vertical tensioning lines on the upstream face.

Figure 1. Cross-section of Winscar dam. The waterproofing liner is installed in exposed position on the upstream face.

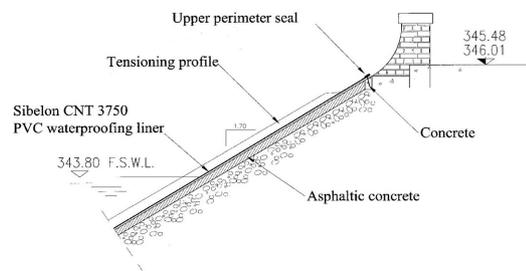
The upper perimeter seal is made in the concrete at the base of the parapet wall and is watertight against rain, snowmelt and waves (Fig. 2).

Figure 2. Detail A. The upper seal and stratigraphy of the waterproofing system.

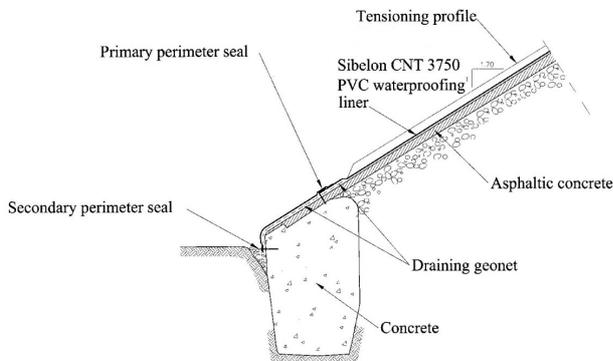
At toe, a double perimeter seal anchors the PVC liner. The primary seal is of the insertion type and is positioned at the bottom of the asphaltic membrane. The secondary seal is of the mechanical type, achieving watertightness by compression, and is positioned on the vertical side of the concrete toe beam. The secondary seal reduces the head on the primary seal. The two seals form separate drainage compartments to allow ascertaining the source of any future leakage.

Figure 3. Detail B. The two watertight seals at toe.

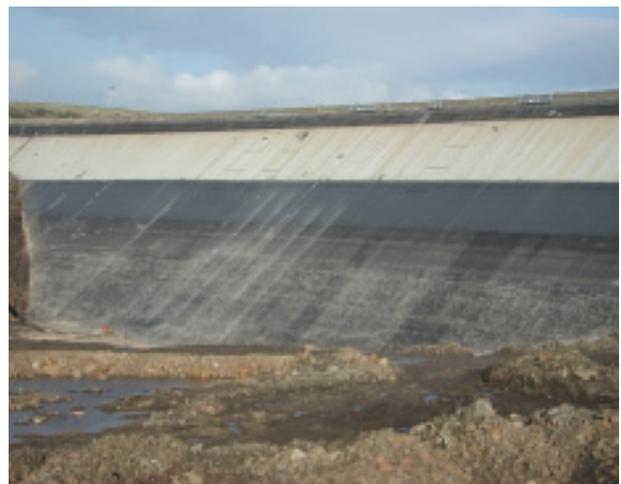
Surface preparation consisted in clearance of debris, in removal of sharp edges, puncturing and smoothening of blisters, edge preparation of the asphaltic membrane above the toe beam, and repair of a limited section of the toe beam. The first profiles of the anchorage assembly were fastened to the asphalt membrane with anchor rods embedded in resin (Fig. 4).

Figure 4. The vertical anchorage profiles are fastened to the face of the dam at regular spacing.

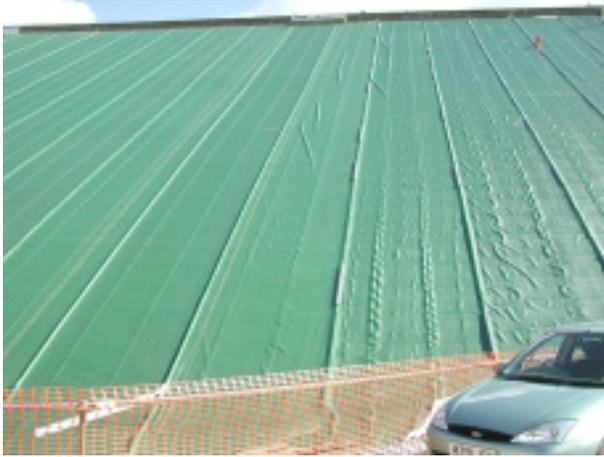
The second profiles were installed over the panels in correspondence of the first profiles already fastened to the dam face. The coupling of the first and second profiles achieved anchorage and tensioning of the PVC liner. The second profiles were then covered with a PVC geomembrane strip welded with single-track manual welding guns and controlled for watertightness. Figure 5 shows the tensioning effect produced by the patented vertical profiles that have already been installed and waterproofed on the left part of the photo, while the panels on the right have not yet been tensioned.

Figure 5. The panels on the left have already been tensioned by the patented tensioning assembly; the panels on the right are waiting for completion of the assembly.

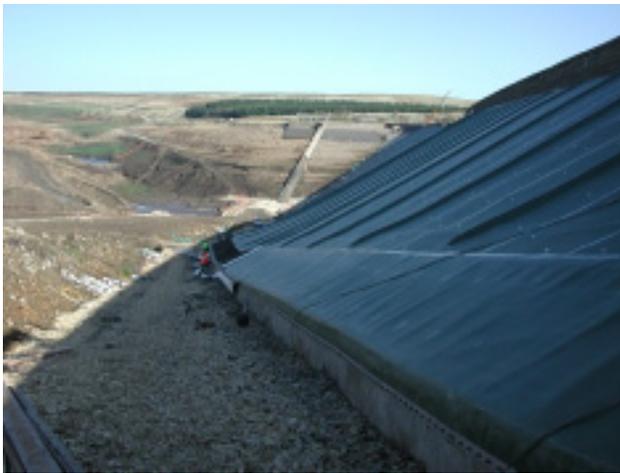
Figure 6. Detail of the secondary perimeter seal at right abutment.

Flow from the secondary compartment, which covers the toe beam between the primary and the secondary seals (Fig. 6), is greater, as it can come from various sources, including toe beam waterstops, and imperfectly filled grout holes. This flow, which has non-linear relationships in respect to water level, was less than 0.6 l/s at half depth.

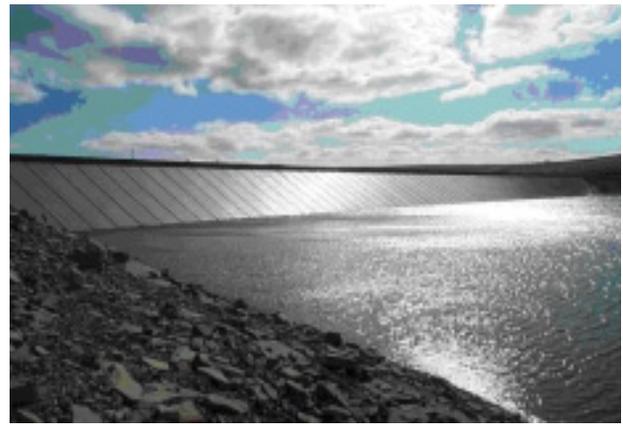
The geocomposite has performed extremely well. Total flow from the first compartment, which covers the entire original asphalt membrane, is less than 0.02 l/s at  $\frac{3}{4}$  full reservoir head.

Figure 7. Total leakage from the 25,000 m<sup>2</sup> upstream liner is less than 0.02 l/s at  $\frac{3}{4}$  full reservoir head.
