Revetment damage as a result of geotextile colmation by flocculated ochreous products and possible repair methods

H.-U. ABROMEIT, Bundesanstalt für Wasserbau (BAW), Karlsruhe, Germany

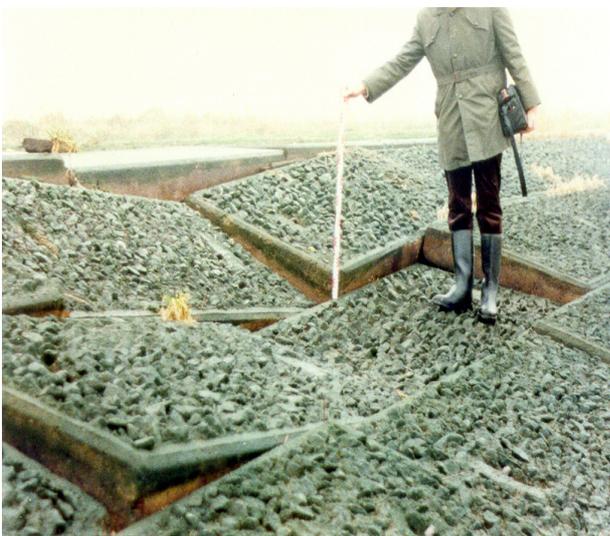
In 1982 a bank revetment of the German tidal river Weser, consisting of ferro-concrete slabs on a bitumen bound sand-filter layer, built in 1967/69, was destroyed completely on its whole length of more than 3 km by a tidal wave (Fig. 1).

The main reasons for failure had been the slabs' low unit weight per area in connection with a low system permeability and the breakdown of the sand filter which had lost its bitumen binding and subsequently could be eroded through the small joints existing between the slabs.

Figure 1. Ferro-concrete slab revetment damaged by tidal wave in 1982

In 1983/84 the slab revetment was restored completely in a slightly modified manner, using now a geotextile instead of the bitumen-bound sand filter, being installed directly upon the present slightly compacted sand. At the same time the permeability and drainage capacity of the cover-layer system were enhanced considerably. The toe of the revetment was protected the same as before by a sheet-pile wall of 7 m length, tied in the ground with a length of about 6 m.

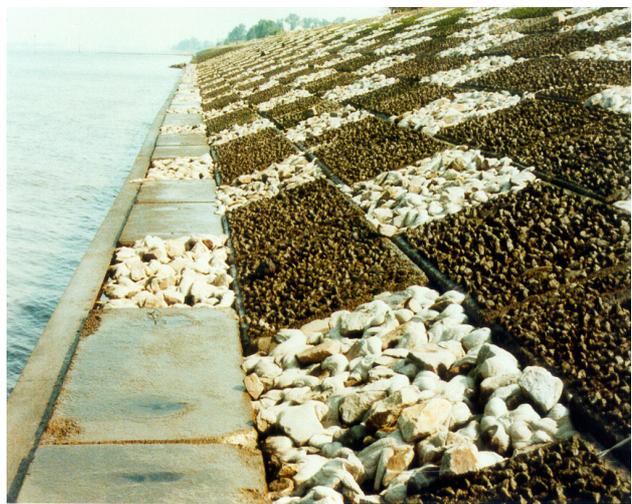
The remaining uncovered chipping areas of the drainage layer were closed by mortar-grouted armourstone, maximum stone length 10-30 cm, to act as drainage openings (Fig. 2). The mortar-grouting mass was confined to max. 40 l/m² to leave armourstone drainage openings of sufficient permeability

Figure 2. Ferro-concrete slabs with drainage openings (mortar grouted armourstone) after revetment restoration 1983/84

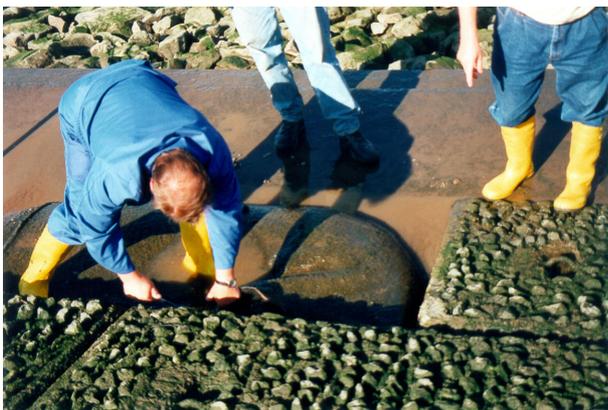
In March 1992 at some few drainage openings (grouted armourstone) in the toe section of the slope were broken up by the pressure of a large geotextile bubble filled with water and thus acting like a hydraulic jack (Fig. 3).

At the beginning, this damage concerned only the toe bench and the adjacent first slab row of the slope, i.e. the zone of the highest tidally influenced gradients. Later on a few drainage openings situated a little higher were affected too. It was apparent that in all cases the geotextile filter layer had become nearly impermeable and geotextile and seepage water not flowing off were discoloured rusty brown.

Furthermore the grouted armourstone cover of the adjacent drainage openings at the same level, one to the right and one to the left, also already showed some signs of uplifting and slight mortar damage, while the contiguous ferro-concrete slabs were lying without any visible change.

Figure 3. Geotextile/water bubble in a damaged drainage opening

Damage to drainage openings was caused only by the extremely high reduction of nonwoven permeability of 99,5 % (see 3.2) due to blocking and clogging (colmation) of flocculated iron-ochre products from seepage water, accumulating on the underside of the geotextile and in its structure to a rusty brown slime. Because of this, the residual permeability of the geotextile has apparently become too low with regard to necessary drainage of seepage water during the ebb-tide phase, which is important for stability reasons (see 1.1).

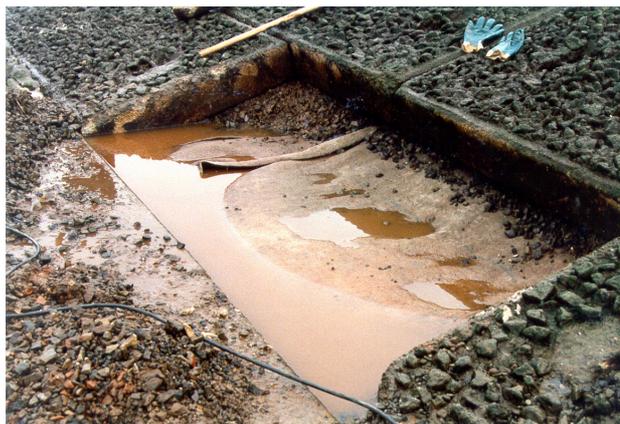
In one of the totally damaged drainage openings with significant signs of geotextile colmation, the overlapping geotextile was exposed. Both the geotextile and the overlying drainage chippings were discoloured rusty brown (Fig. 4). When lifting the geotex-

tile, a rusty brown slime became visible, which had accumulated on the underside of the fabric. The surrounding seepage water emerging from the subgrade was discoloured rusty brown as well.

Figure 4. Ochreous drainage opening prepared for sampling

i.e. a reduction of 99.5 %. In fact, the permeability reduction of the geotextile had surely been higher, because part of the slime accumulated on the reverse has been washed away when cutting out the sample. In contrast, the permeability of the nonwoven sample taken from the intact drainage opening was unchanged.

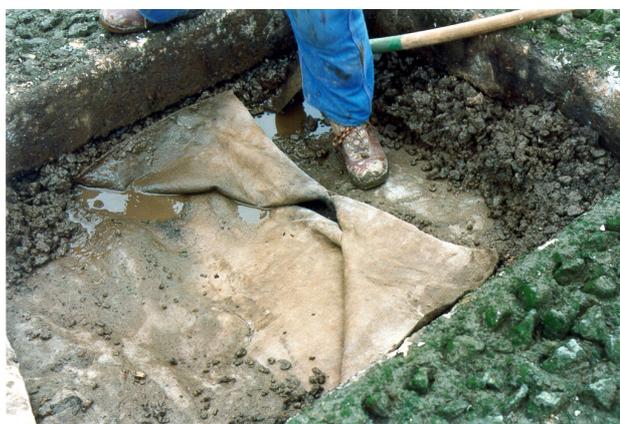
For comparison purposes an intact non-ochreous drainage opening two rows above was opened (Fig. 5). Neither the drainage chippings nor the geotextile showed any marks of slime accumulation or discoloration.

Figure 5. Non-ochreous drainage opening prepared for sampling
Samples were taken from the nonwoven and the seepage water from both drainage openings. Afterwards the holes left by

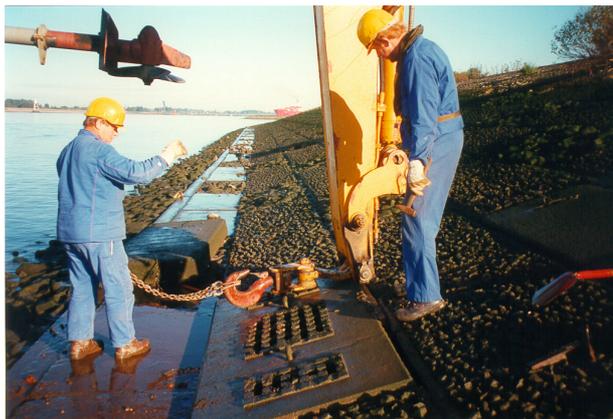
Figure 6. Closure of the pilot drainage opening with a specially fabricated permeable ferro-concrete slab

- the chippings were completely discoloured to a rusty brown.
- Seepage-water flow from the chipping layer seemed to be unchanged compared with installation state.
- the sand present in the subgrade did not significantly migrate into the chipping voids, if a very small mixed zone of the interface because of inevitable impacts caused by chippings installation was disregarded.
- flocculated ochreous products were found as a liquid slime in the inferior part of the chipping layer.

A second inspection to assess the efficiency of the pilot filter project was carried out after 6 years in autumn 1998. Drainage efficiency was unchanged. The surrounding ferro-concrete slabs lay without any significant heave or tilting. The further observations were the same as in 1993.

- excavation of about 0.20 m of subgrade
- installation of chippings 8/32 mm for the required drainage and filtration function, layer thickness 0.30 m
- closure of the drainage opening with a specially fabricated permeable ferro-concrete slab, which could be relifted for filter-control purposes (Fig. 6). Depending on slab's opening size a geogrid can be placed upon the chippings for its erosion control if necessary.
