# Slope stabilization with woven geogrids in San Bernardo Hill

**ABSTRACT:** As a result of the rains that occurred during the summer of 2008 in Salta city, an important stretch of the access road to the top of San Bernardo hill was affected by debris sliding which produced an important landslide of the road in one part and the destruction of it in another. Although the importance of this road, because of being the only vehicular access to one of the most important and most visited touristic places in Salta, it had to be closed for security reasons and the impossibility of circulation for larger vehicles, causing major economic losses and important trouble to tourism. The developed project allows solving a serious problem of slope stabilization with a very low cost, even lower than any other conventional solution, with a very important advantage, specially for this moments, that is to build up a low environmental impact wall using the non-conventional bagged stone wall alternative, with soil reinforcement elements made with double twist hexagonal mesh and additional reinforcement. In this case we use woven geogrids fabricated with polyester yarns, in the range of 40-60 KN/m ultima

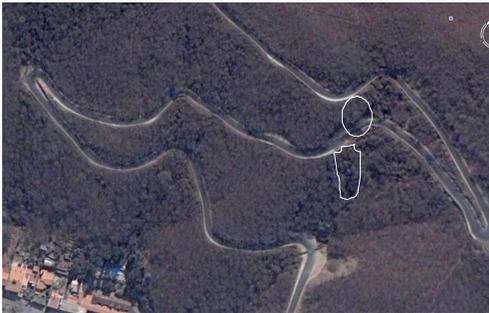
Figure 3. Satellite Image - Landslide D1 y D2

As a result briefly above, in February 2008 due to intense rainfall (70 mm in one hour) maintained after several days, there were two landslides (D1 y D2) that hit the slopes and part of the asphalt surface in the access road to San Bernardo hill (D1 and D2).

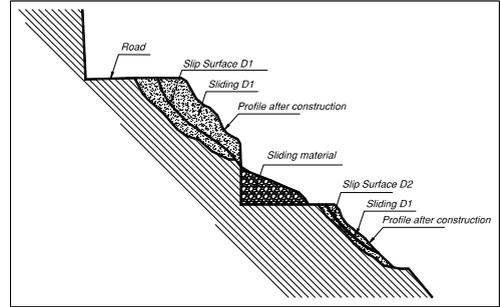
Figure 4. Profile after landslide

This place showed an accumulation of sliding debris over rocks with a sliding angle in the direction of the slope, the state of the rock that conforms the original outcrop, totally fractured

shales, runoff is not controlled properly, allowing water pass through the cracks formed in the asphalt, which caused the saturation of the material below. All this factors were responsible for the displacement of loose material from the slope to the road, and accumulate on it.

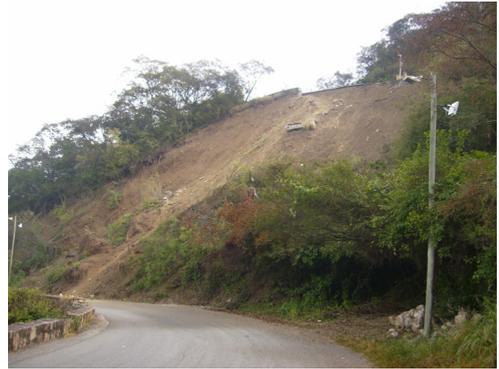
Figure 5. Sliding D1

Due to the landslide the material was deposited on the road. For this reason the pavement was destroyed and the route had to be closed. Both landslides were generated for the same reasons, the difference was due to the volume of material moved.

In the case of the largest slip (D1) for the volume of the material involved, should be added the presence of a small depression where the water drains and accumulates in a micro basin developed on the slope of this sector. By the effect of the accumulation of water in a short-term, the basin overflows. Therefore, this fluid contributes to the erosion of the loose material of the slope.

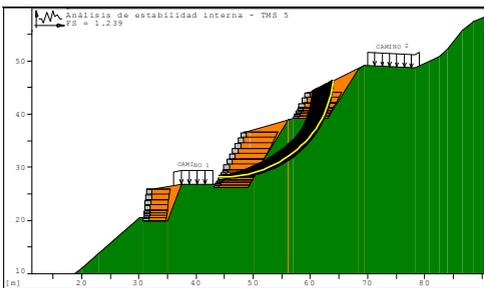
Figure 9. Software analysis – Compound stability

Type of analysis	Seismic FS min	Surcharge FS min	Design FS real
Global stability	1.2	1.3	1.17
Compound stability	1.2	1.3	1.17
Direct Sliding	1.5	2.0	1.79

In all cases critical surface was appear in seismic analysis, but they are greater than the minimum required values.
