The performance of reinforced earth structures in the vicinity of Kobe during the Great Hanshin Earthquake

ABSTRACT: The Great Hanshin Earthquake caused widespread damage on 17th January, 1995, particularly in the Kobe area. The magnitude was measured at 7.2 on the Richter scale and the seismic intensity reached 7. Maximum horizontal ground accelerations greater than 0.8g and vertical accelerations greater than 0.4g were recorded. More than 120 Reinforced Earth structures were inspected, which were close to the main fault line. Of these, 70% were higher than 5 metres. The damage to the Reinforced Earth structures was minimal. Only 8% showed minor cracking of isolated concrete panels and 2% demonstrated some relatively minor movement of the structure. No structures failed. Inspections of the Reinforced Earth structures have confirmed their strength and flexibility. Pseudo-static analyses of selected structures has indicated that present design methods may be very conservative as the structures were likely to have withstood conditions greatly in excess of their design condition.

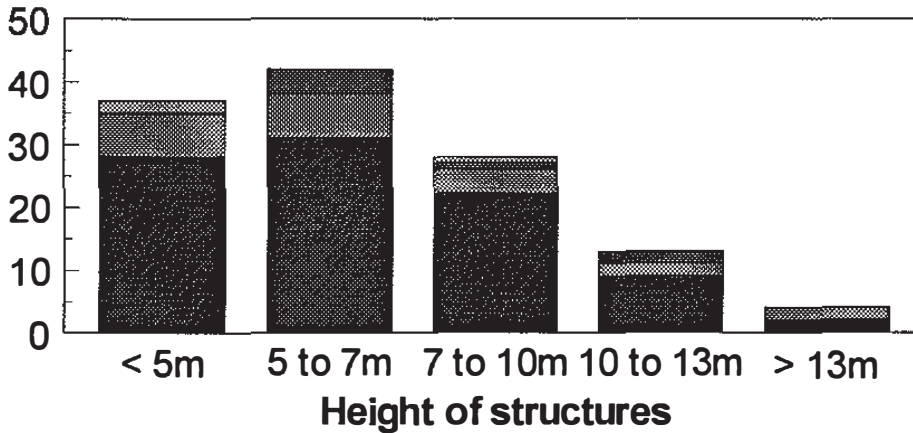
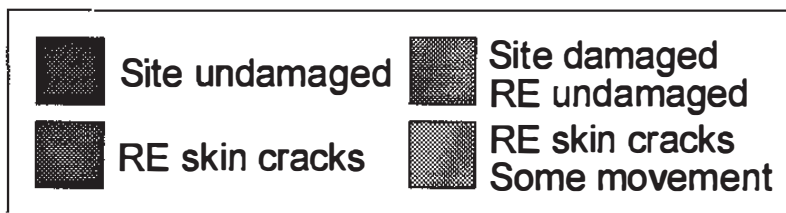
Figure 2. Summary of damage

- 3 structures (2%) indicated some damage to the wall facing and movement of the wall and adjacent ground
- 7 structures (6%) indicated some damage to the wall facing and to the adjacent ground
- 22 structures (18%) indicated no damage to the wall despite some damage to the adjacent areas.
- 92 structures (74%) indicated no wall or adjacent area damage

- displacement of the concrete panels
- cracking in the concrete panels
- opening of the vertical joints
- damage at connections to other structures
- damage to foundation or capping structures
- subsidence and cracking of the ground surface

The relationship between the degree of damage and the wall height is shown in Figure 2.

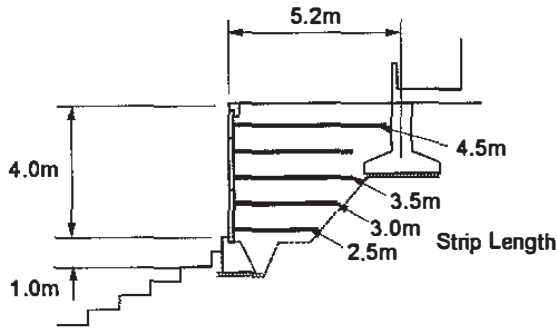
Figure 3 Structure A, Section

This structure forms an embankment for a housing lot platform in the City of Itami (Hirose, 1995). It is approximately 40m away from the epicentre, but which is situated along the fault line in an area subject to seismic intensity 5 to 6 (approximately 0.08 to 0.40g acceleration). The height of the wall is only 3.75m with reinforcing strip lengths between 2.5 and 4.5m. A section of the structure is shown in Figure 3.

Pseudo-static analysis indicated lower, but adequate, factors of safety for base sliding and reinforcement tension, despite a potential increase in reinforcement tension by a factor of 2.3 (top layer) reducing to 1.2 (base layer). Despite marginal friction capacity indicated in the top layer, there was no observed loss of pull-out resistance.

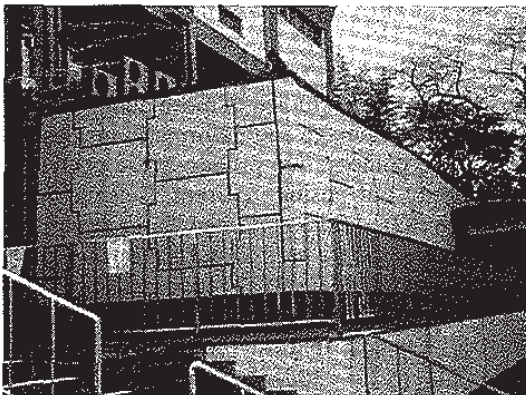
Figure 4. View of Structure A

The wall face deformed up to 94mm in the middle, corresponding to only 2.5% of the wall height. This is less than the normal construction tolerance.

Cracking was observed in 19 panels, or 35% of the total number surveyed. The locations of the cracks were usually in the vicinity of the dowels or the corners where the panels were constrained during oscillations.

Up to 180mm opening of joints with adjacent structures was observed and cracking of the foundation was observed in several places. One joint in the capping concrete had opened by 37mm (at the place where the forward inclination of the wall was the greatest). Other joints with an opening of 10mm were also observed.

Subsidence of the upper ground surface ranged from 200mm to 1,000mm, presumably due to a shakedown phenomenon from the earthquake.

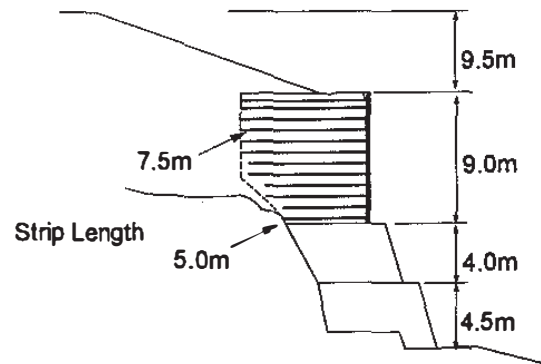
Figure 5 Structure B, Section

This structure forms an embankment for a roadway in Hokutancho, Awaji Island, approximately 13km from the epicentre (Kawasho, 1995). It is in an area subject to significant damage and a seismic intensity of 7 (greater than 0.40g acceleration). The wall is a maximum height of 9m supporting a 1 in 1.8 slope approximately 10m high. Reinforcing strip lengths vary from 5 to 7.5m as shown in Figure 5.

Pseudo-static analysis indicated potential low base sliding factors of safety (reducing to 0.8), however, the minimum reinforcement tension factors appeared

to reduce only from 2.0 to 1.7 despite a possible increase in reinforcement tension by a factor of 2.0 (top layer) to 1.2 (base layer).

This was a more critically loaded structure due to the sloping embankment which significantly increased the calculated dynamic load applied to the structure and effected the external stability calculation.

Internal stability was maintained due to the increased frictional resistance available from the longer reinforcement strips and the depth of overburden due to the slope.

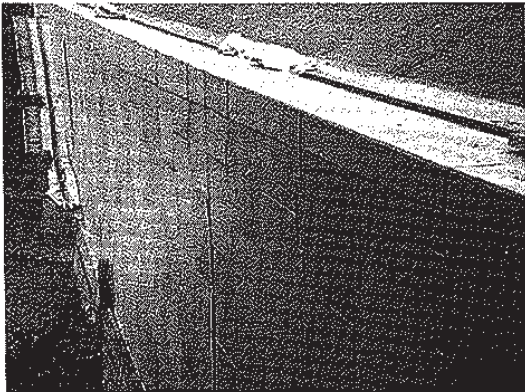
Figure 6. View of Structure B

The deformations of the wall face relative to the toe of the wall were measured before the earthquake and three weeks after (on 8th Feb 1995). The maximum forward movement at height 7.5m was measured at 109mm at the higher section (1), and 55mm at the lower section (2). At a height above the base of 3.0m, the forward movement was generally less than 20mm. The relative (tilting) movement was, however, less than 1.5%.

Some cracking at the corners of concrete panels was considered to be the result of panels knocking against each other during the motion (particularly pitching).

Damage of the concrete infill between the wall face and the side gutter resulted from differential movement and some displacement was observed between the capping and facing panels.

An adjacent blockwall structure was observed to have displacements of 500mm, while another displayed large cracks.

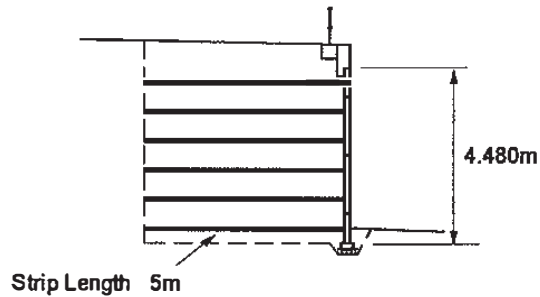
Figure 7. Structure C, Section

This structure forms an embankment for a parking site in Tarumi-ku, near Akashi City, approximately 6km from the epicentre (Kawasho, 1995). Seismic intensity in the area is estimated at 6 (approximately 0.25 to 0.40g acceleration). The wall is 4.5m high supporting a horizontal surface, with reinforcing strip length of 5m (Figure 7).

Pseudo-static analysis indicated similar factors of safety for base sliding and reinforcement tension factors as Structure A. Reinforcement tension is more uniformly increased by a factor of 1.7 (top layer) reducing to 1.4 (base layer) but the minimum factor of safety appeared to remain over 3. Reinforcement friction capacity appeared to be possibly exceeded in the top layer. (minimum factor of safety 0.8) .

The more uniform increase in tension in the reinforcement and the higher stability factors of safety than Structure A were likely due to the uniform section (reinforcement strip length).

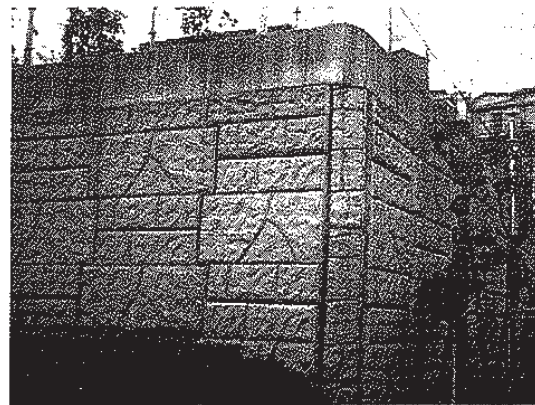
Figure 8. View of Structure C

In this site there is an almost centrally located corner panel sandwiched between a front and a lateral face, forming an 'L' shape in plan. As a result of the earthquake, the entire lateral face has been displaced outward by up to 100mm. This appears to be main cause of the observed damage.

The deformations of the wall face relative to the toe were measured at four locations along the wall, three weeks after the earthquake (on 7th Feb 1995). The forward movement at height 4.0m varied up to 74mm, while at height 1.5m, the movement varied up to 59mm. The relative (tilting) movement was less than 2%

Cracking of the facing panels was observed in several places on the lateral face. The vertical joints between the panels have opened up by as much as 200mm, due to the relative displacement of the front and lateral walls. Large cracks measuring up to 150mm occurred in the top ground surface, due most

likely to the forward displacement of the face. The cracks occurred only within the range of the upper part where there was no strip reinforcement.
