Use of reinforced earth walls in canals**Utilisation de murs en terre armée pour des canaux**

Kakrapar weir scheme in Gujarat has the Ukai right bank main canal off-taking from Kakrapar right bank canal as shown in Figure 1. Design for the canal is made for 45 cumecs at its head and after its run for a distance of 35 km. Kosamba branch off-takes from this canal and the capacity gets reduced to 22.6 cumecs. Typical problem of stability of slopes for this canal was noted in its range from 35.05 km. to 37.65 km. wherein the canal has a maximum depth of cutting of 12 m. The dimensions of the canal for this reach reveal bed width of 8m. and initial side slopes of 2:1 changing to 1.5 : 1 above the berm. Canal gradient is 1:6000 with $n = 0.0225$ and full supply depth of 2.8m. Borehole details at the site revealed top 1.5m. black layer of silty clay, layers of silty sands, silty clays and sandy silts. Typical details for the site bore hole are shown in Figure 2 and the shear characteristics of a few selected soil samples are given in Table I.

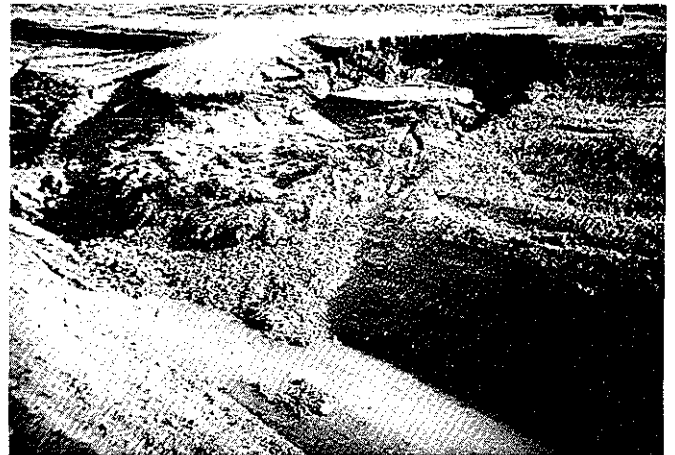
Figure 3 L.H.S. Slip at 37.50 km.

were observed at number of places. Failure patterns for the slopes in this reach of the canal as observed on 21st July 1972 are shown in Figures 3-5. Canal section details before and after the formation of the slip are shown in Figure 6.

Detailed investigations carried for the problematic stretch of the canal revealed that severe fissurisation and loss of shear strength under hydrostatic pressures or on partial drying due to time lag in construction programme seem to have contributed for the formation of slips. Failure arising out of strain incompatibility between the different horizons of the soil profile with

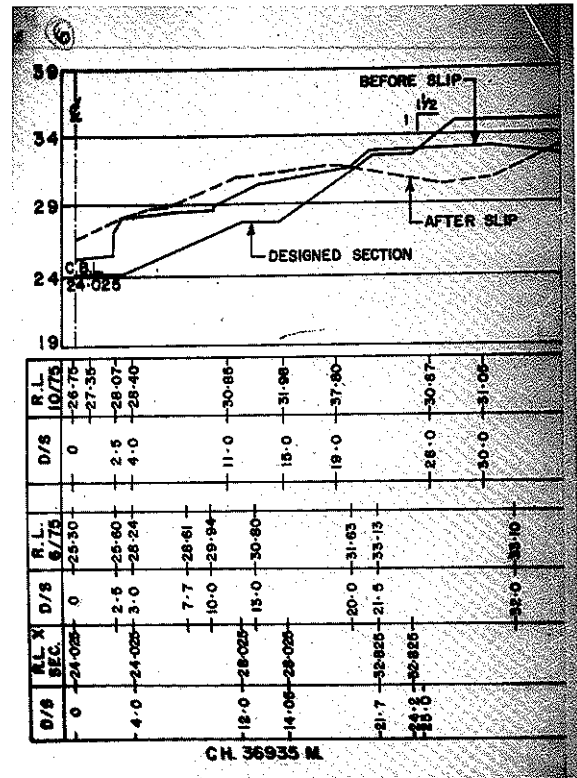
Figure 6 Canal Section Modification

Additional points which deserve attention in analysing the formation of the slips will now be presented. The initial slopes adopted for the construction work of the canal can be considered as steep as the final slopes observed after the formation of slip were of the order of 4:1 to 5:1.

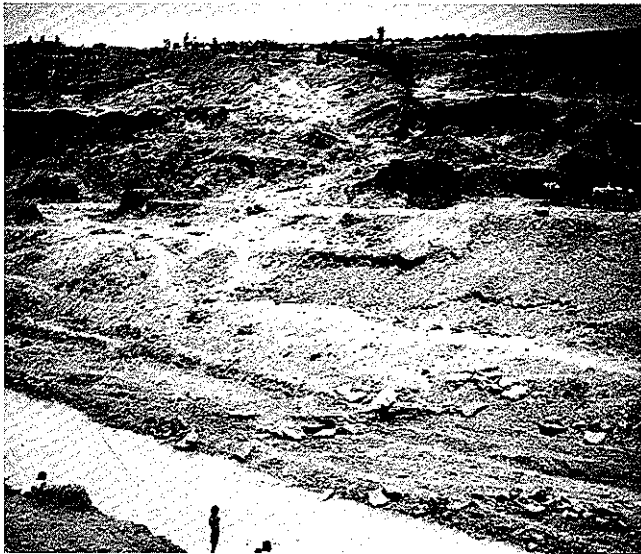
Figure 7 Major Slip L.H.S. Front View at 37.20 km.

Public Works Department engineers jointly with the consultants to the Department carried out detailed investigations in this problematic reach of the canal for the stability of slopes. While undertaking the remedial measures on trial basis with performance checks, a major slip occurred on 12th May 1976 between 36.61 km and 37.00 km reach

of the canal wherein the edge of slip was observed at a distance of about 71m from the centre line of the canal and extending right upto the spoil bank as shown in Figure 7-8.
