Use of soil nailing in stabilisation of a freeway embankment

Roads and Traffic Authority, New South Wales, Australia

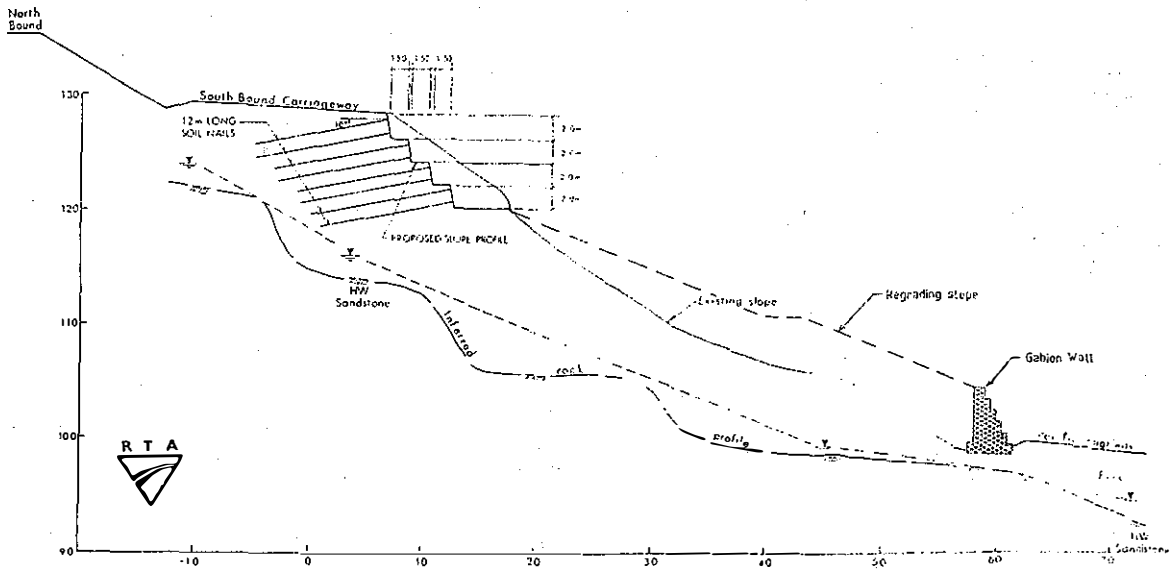
Figure 1 Typical cross-section of the site

The Roads and Traffic Authority of New South Wales has successfully completed a major soil nailing project on the F3-Sydney to Newcastle Freeway at Mt. White, 55.6 km north of Sydney. At this location the road embankment is about 30 m high and 140 m long. The embankment was constructed about 25 years ago at a slope of 1.5 (H) to 1 (V) using compacted clayey silty sands and ripped sandstone, with armour rocks for surface protection. Both northbound and southbound carriageways are supported by the embankment and have a split gradeline level as shown in Figure 1. A two lane highway (Pacific Highway) runs close to the base of the freeway embankment.

The fill slope became unstable after prolonged heavy rainfall in early 1989 with the head of the slip threatening the integrity of the embankment and road structure. Further regression of the slip was likely and would have resulted in closure of part or all of the southbound carriageway, causing massive disruption to traffic flow.

A typical cross-section showing the proposed remedial works is given in Figure 1. Listed below is a summary of the construction details.

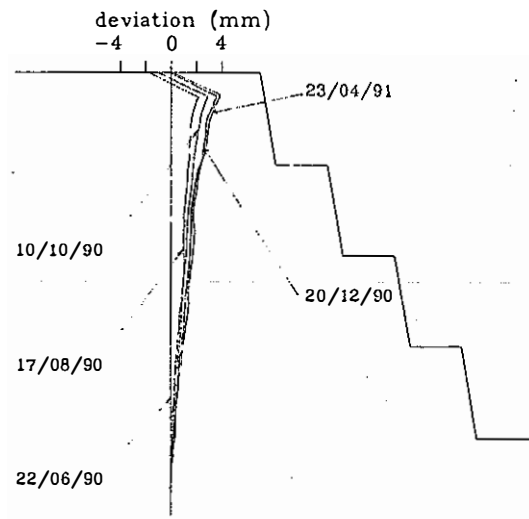
Figure 3 Inclinometer readings

Prior to the start of construction work, six vertical inclinometers were installed at road level down through the embankment into the bedrock. During the construction three of the inclinometer holes were intersected by soil nailing drilling operations and could not be used. However monitoring results from the remaining holes indicate that during the six month construction period (May to December 1990) the maximum movement near the front of the soil nailed structure was of the order of 3 mm. Since the completion of soil nailing works, no further slope movements have been detected by the inclinometers (see Figure 3).

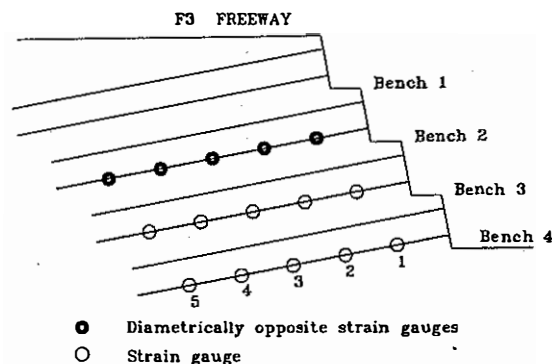
Figure 4 Instrumented soil nails

installed in the second bench. The second and third were installed on benches 3 and 4 respectively (see Figure 4).

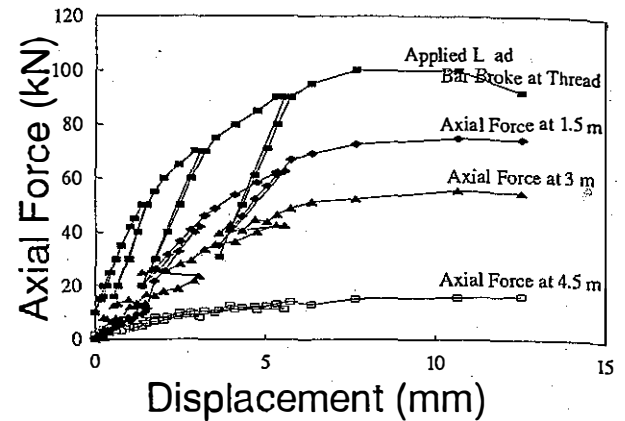
Figure 5 Pull-out test : Load - displacement

Results of a pull-out test on a fully instrumented soil nail (6 m length) is shown in Figure 5. The graph shows the development of axial force along the soil nail at 1.5, 3 and 4.5 m due to the applied load at the soil nail head. A maximum load of 105 kN was achieved when soil nail displacements reached approximately 8 mm.

However, in the elastic range (which covers about 50% of the ultimate capacity) the required displacement is less than 2 mm. It is worth noting that the test was terminated when slippage occurred between the threaded head of the bar and the jack anchorage.

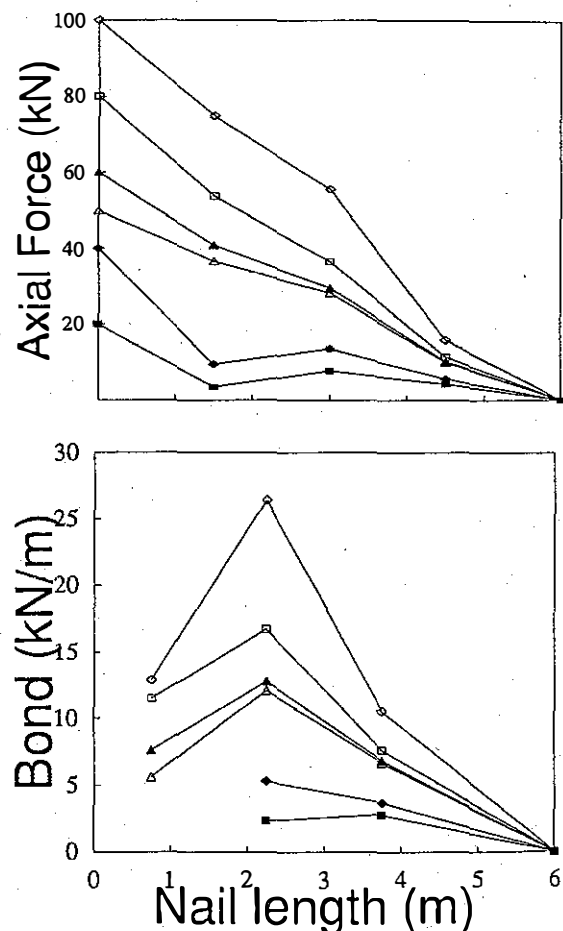
Figure 6 Pull-out Test: Load & bond distribution

The measured load distribution along the soil nail is shown in Figure 6. In general, the curves demonstrate a decrease in tensile stress along the length of steel bar at each load cycle, and an increased mobilisation of bond stress with increasing test load. However, at test loads less than 50 kN, there is a reversal of stress gradient at 1.5 m length, which may have been caused by the residual stress in the bar or the drift error of strain gauges.

From the curves of bond stress distribution, it is apparent that the maximum stress was developed between 1.5 m and 3.0 m. The bond strength for the initial 1.5 m length of soil nail is expected to be lower because of the reduction in overburden stress due to the 1.5 m wide berm above the nail. It is inferred that pull-out failure of the soil nail was not imminent at the end of the test, and the ultimate bond stress is likely to be greater than 25 kN/m where the depth of soil overburden is greater than about 7 m.

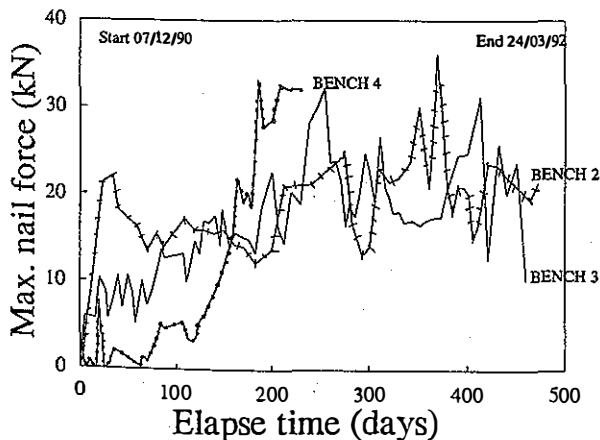
Figure 7 Development of maximum nail forces

A comprehensive strain monitoring program enabled axial tensile forces in selected soil nail to be tracked over time (1.7 years), as shown in Figure 7. Strain gauge data were calibrated to a standard temperature of $25^{\circ}\text{C} \pm 0.5^{\circ}\text{C}$. Only limited strain gauging was available from the datalogger installed on bench 4.

Results show that the instrumented soil nails gradually developed tension (range 15 - 35 kN) during the construction phase as each bench was progressively excavated. Tension forces in the soil nails have remained fairly constant after the

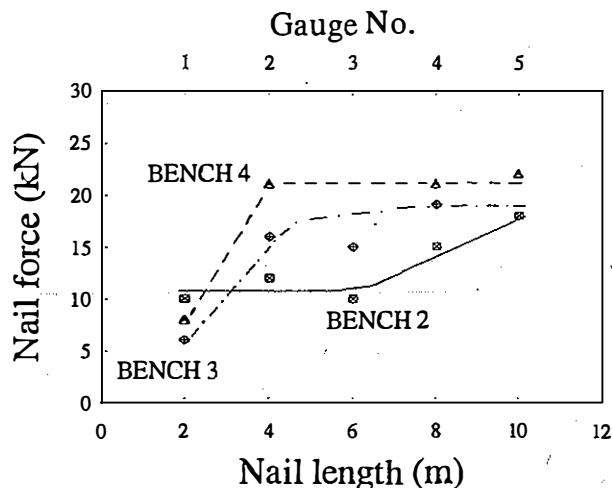
Figure 8 Observed nail force distribution

soil nail construction within this range and are well within their designed capacity. In general, nail forces in the lower benches are somewhat higher and appear to be more uniformly distributed along the nail length (see Figure 8).

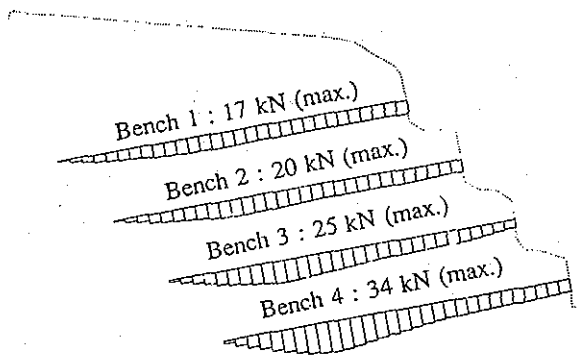
Figure 9 Predicted nail force distribution

Numerical modelling results of soil nail forces (see Figure 9) compare favourably with actual field measurements. Predicted axial forces along the soil nail are slightly higher than the measured values and they show similar trends along the soil nail length.
