# A geogrid reinforced steep slope 60.0 m high for the stabilisation of the Valpola Landslide in Northern Italy

Daniele Cazzuffi CESI SpA, Via Rubattino, Italy

Piergiorgio Recalcati TENAX SpA, Via dell'Industria, Italy

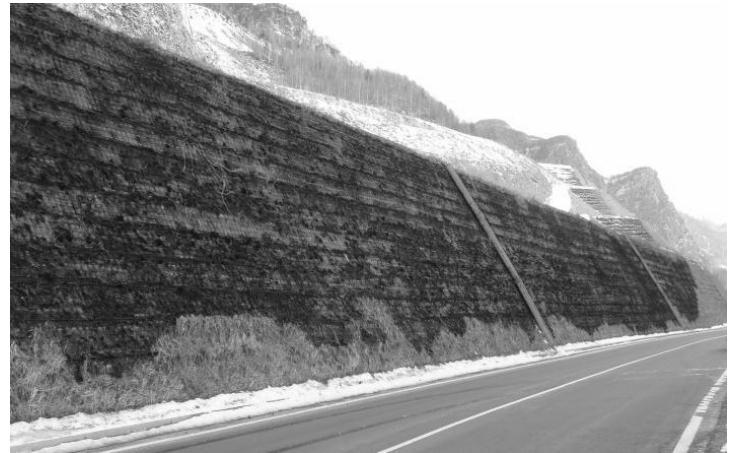
Along 2013, the reinforced structure was attacked by fire (Fig.9); a prompt inspection of the site was confirming the job was not suffering any serious damage (Cazzuffi et al., 2014).

Figure 7, The reinforced structure after the fire event

It is important to remember that the structural reinforcing elements (geogrids laid horizontally within the soil) are never affected by the flames, as oxygen is not present. A thorough inspection to assess the integrity of the works has been done, considering the banks from the top to the bottom. A survey on the top surface of the burnt berm has shown that no settlement or subsidence had occurred, and the face was found to be well aligned, with no fractures or lesions. The work therefore had not suffered any type of injury or structural damage following the fire. In the portion of reinforced slope directly affected by the fire, modest damages in the face reinforcement (extension smaller than 0.01 m<sup>2</sup>) were observed, which definitely do not undermine the stability of the work (Fig. 8).

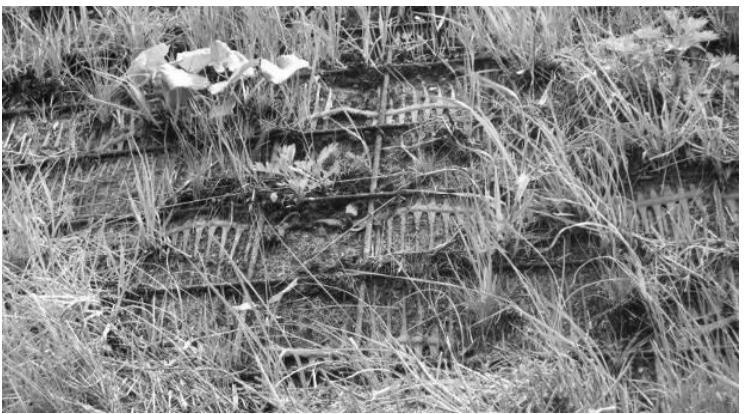
Figure 8 – Minor damages on the geogrid at the face

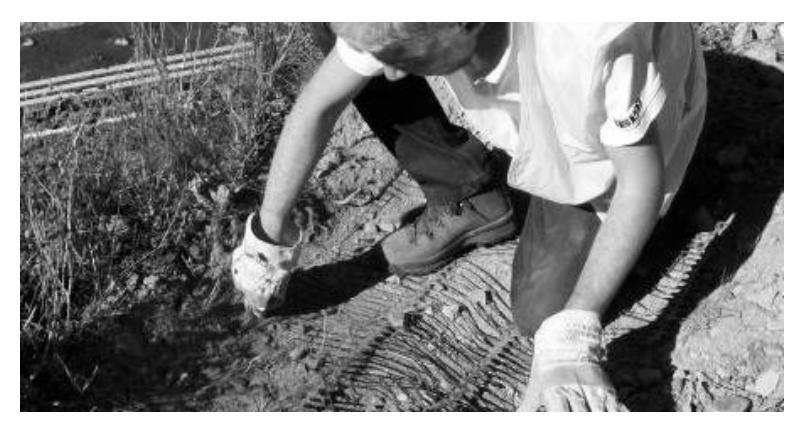
Samples of geogrid excavated from an area that was interested by the fire (Fig. 9) were subjected to mechanical tests, and the results obtained were demonstrating that the fire itself was not directly affecting the resistance of the geogrid. In conclusion, such a structure, once vegetated, has then demonstrated to be resistant even to the fire.

Figure 9 Manual exhumation of the geogrid to evaluate the residual properties

The sample of geogrid exhumed was delivered to an accredited laboratory for geosynthetics, where it was subjected to a wide width tensile test according to the UNI EN ISO 10319, as described by Cazzuffi (1996). The test results have provided values of residual strength equal to 85% of the nominal value of the geogrid. These values were due to the damage suffered during installation but especially during the exhumation, and are in no way attributable to the fire, since the geogrid in the portion removed did not show any trace of fusion, burn or change to its geometry due to heat.
