# CASE STUDY ON A LARGELY-DEFORMED GEOTEXTILE-REINFORCED SOIL RETAINING WALL INDUCED BY RECENT HEAVY RAINFALL IN JAPAN

J. Hur<sup>1</sup>, and S. Shibuya<sup>2</sup>

#### ABSTRACT

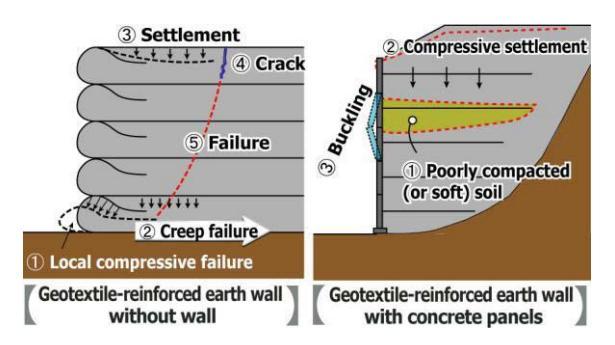
Fig. 2 Typical damages of reinforced earth walls

In Japan, reinforced earth wall with geotextile is popular for the construction of roads in mountain area. The use of reinforced earth comprising the vertical or very steep facing is advantageous in saving the construction cost compared to bridges, for example. In the case of reinforced earth wall comprising geotextile with the concrete panel facing, however, it involves a great difficulty in compacting properly the portion of the fill adjacent to the wall facing. As a result of loose compaction near the wall, the wall facing may be damaged by compressive force and/or could be completely destroyed due to the active failure of the fill (for example, refer to Tatsuoka.et al., 1997). Figure 2 shows typical damages for reinforced earth in general. In case of flexible reinforced earth without any concrete facing, a local failure involving excessive compressive deformation would take place at the bottom portion, which in turn may trigger the overall active slip failure in a progressive manner (refer to Tatsuoka et al., 2000). Conversely, when the reinforced earth with concrete panels comprises a poorly compacted (or soft soil) layer at the time of construction, a connection between the concrete panel and reinforcement material (i.e., the metal strip or geotextile) would be destroyed owing to the downward tension force at the connection, which eventually may bring about complete failure of the wall.

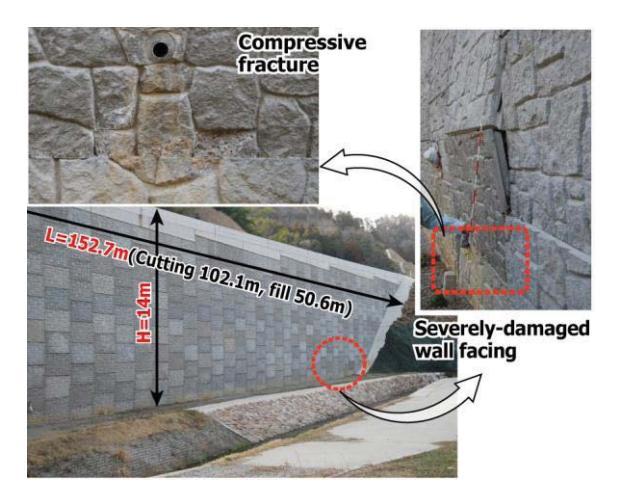
Fig. 5 Severely damaged portion

Figure 5 shows some pictures of the reinforced earth wall cited, including the severely damaged portion. The outwards deformation at the damaged portion on the wall was on-going by showing the horizontal displacement to reach the value as large as 217mm. The concrete panel wall had been constructed by using a high-density polyethylene geotextile. Based on the observation, a type of wall damage due to the existence of a poorly compacted soil layer was strongly suspected (refer to Fig. 2).

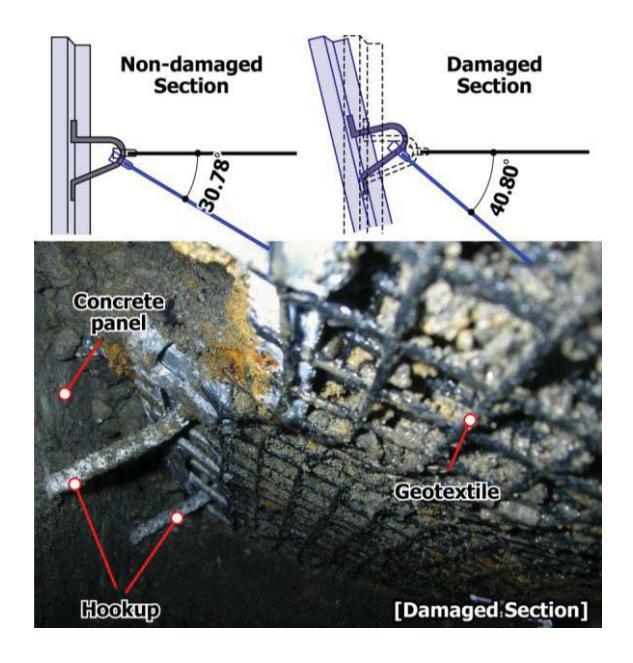
Fig. 13 Pictures inside reinforced earth wall

The results of in-situ and laboratory tests have revealed the fact that a 3m-thick weak soil layer extends behind the damaged section of the wall. The in-situ state for the weak soil layer may be characterized with unexpectedly low values of  $V_s$ ,  $\rho_d$ and the SPT N-value. In addition, the soil properties can be characterized by the occurrence of a considerable amount of settlement on soaking. Fig. 13 shows the picture inside the wall at the deformed section. A space was found underneath the geotextile, suggesting that the weight of the fill above the geotextile was partially supported by the tension force of geotextile. In this paper, the new wording of "hammock state" is conveniently used for describing it.

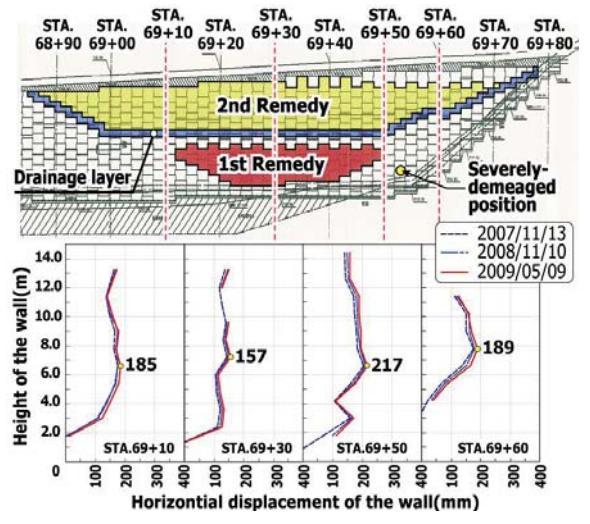
Fig. 15 Observed deformations of the wall facing

Prior to considering countermeasures to restabilize the wall, a numerical analysis was carried out in order to simulate the development of the large deformation that took place on the reinforced earth wall. As stated earlier, the wall was re-constructed twice. However, the wall deformation showed no sign to cease even at the final stage of the construction. As seen in Fig. 15, the range for the maximum value of horizontal deformation was 150 to 200mm. This corresponds to deformation rates of 1.0 to 1.5% against the height of the wall.
