Reclamation of an old landfill site using geo-synthetic materials

ABSTRACT: Some significant results coming from investigations on the possibility of reclaiming with vegetal soil a damaged lining system of an old MSW landfill are hereinafter referred. The lining system was damaged by strong and concentrated rainfall and by consequent nearby river flood. The lining system and slope reinforcement system are described as well the damages caused by the rainfall events. The properties of the vegetal soil are described as well as the works carried out to minimize slope erosion and creeping before the complete taking root of the vegetation cover.

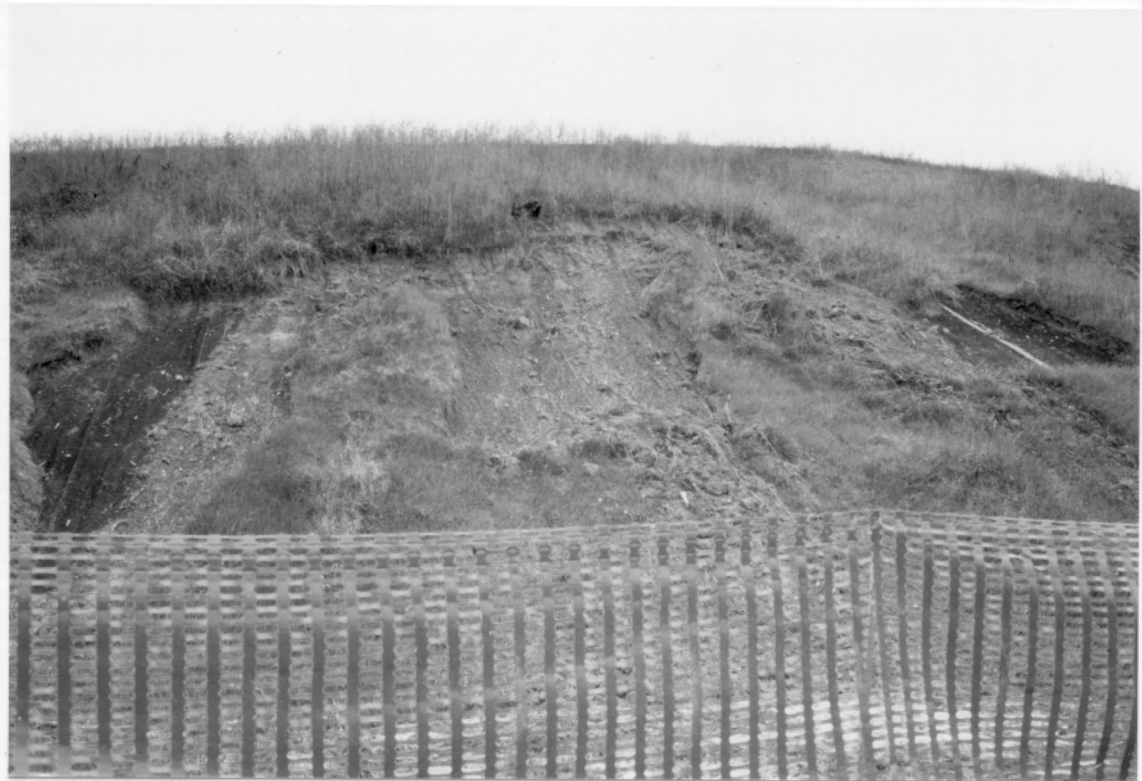
1. Sliding of plates of cover material (each plate having a surface of about 10 m²), saturated with water, either in the higher or in the lower part of the slope.
2. Erosion grooves in the scarp cover soil, particularly evident on the surfaces which were yet uncovered with grass.
3. Erosion at the foot of the landfill southern slope, with local slides, caused by quick recovery of the flood water into the river bed.

Plate sliding is visible in Figure 1. Here, the friction sheet exposure is clearly evident as well as the shallow, uncompleted development of the roots. The erosion grooves are clearly evident on the

Figure 1. Plate sliding on the landfill slope

The most urgent and efficient intervention was the planting of the grass cover, after reclaiming the original design profile with soil of better characteristics in the damaged sectors.

Precautionary measures were taken in order to prevent from strong rain damaging before the complete taking root of the grass. A drainage network for the control of surface water was realised aiming at preventing (or reducing) slope runoff and groove erosion. Independent sections of canal, 25 x 25 x 75 m, were designed. These were coated with a jute geocomposite to prevent from erosion during the first year of exercise. Prefabricated concrete descendants, aiming at linking the top canal to the ground level drainage network, were set at a distance variable from 20 to 30 m according to the slope length and inclination, and to the catchment basin.

An anti-erosion geocomposite, made up of cocoa fiber, was laid in the sectors of slope that were affected by severe failure, where rain water is expected to concentrate. This biodegradable material will disappear after 12-24 months but, in the meanwhile, it will favor the complete taking root of the green species.

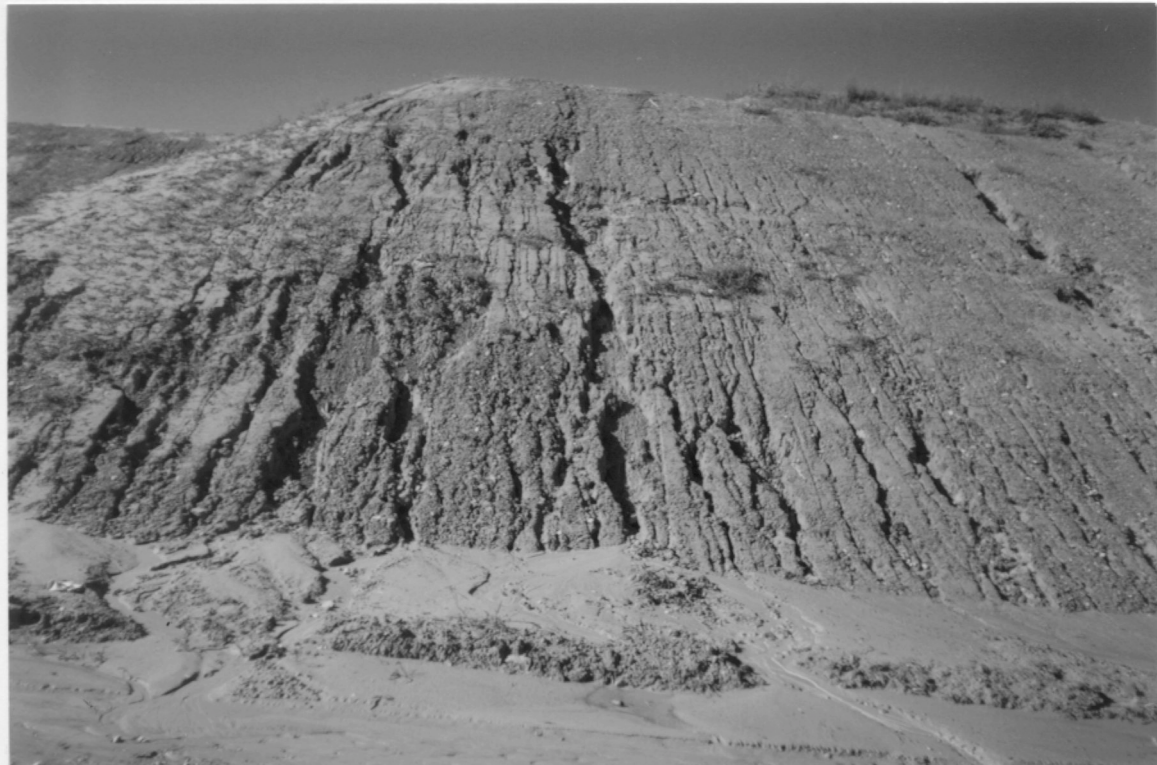
surfaces still devoid of grass (Figure 2). The different behavior of the slope not yet greened (erosion grooves) and that of the slope already greened but with scarce taking of the roots (plate sliding) are shown in Figure 3.

Figure 2. Erosion grooves

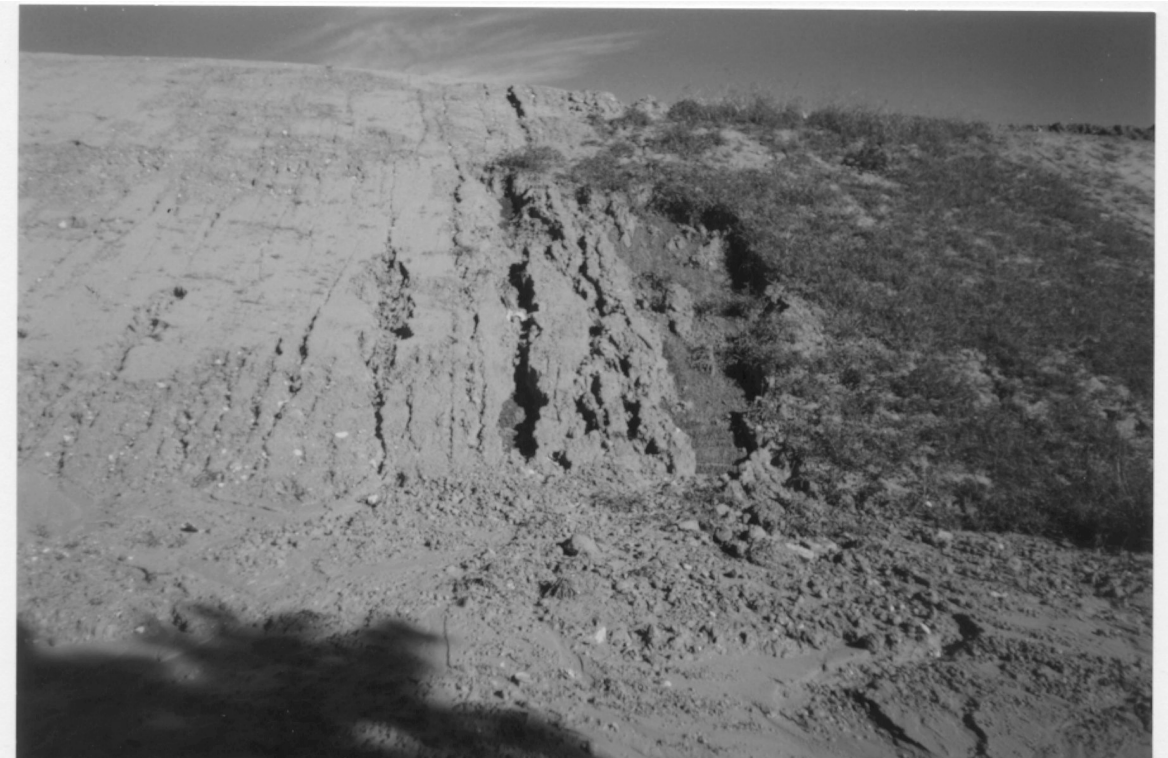
Figure 3. Different behavior on the slope

Stoloniferous species were utilized. These normally show better anti-erosion properties than tap-root species, due to the formation of a shallow net-shaped root-apparatus that confer a high stability to the soil layer. So, the mix was selected among the following pioneer and frugal species:
