A case history of geosynthetics used for the Biffa Landfill site, south of Brussels, Belgium

Keywords: Failure, Geotextiles, Installation damage, Landfills, Reinforcement

ABSTRACT: The authors describe the construction of a waste disposal facility for non-toxic waste with a high content of organic material, South of Brussels. The disposal was excavated 35 m deep in sandy soil. They describe the use of many different geosynthetics and illustrate the long-term performance of similar installations over many years under similar site conditions. The authors show how the study of past geosynthetic installations may be used to guide improvements in the design of modern systems and illustrate how these are incorporated into the latest, large-scale installation in Belgium. Previous cells of the waste disposal facility, built following the same principles of design, have been monitored over 10 years by the analysis of water from the underlying drainage system and by piezometers. These tests show that there has been no loss of leachate, thus proving the quality of the system. Appropriate design, together with a high quality of work execution, make it acceptable to build new waste disposal s

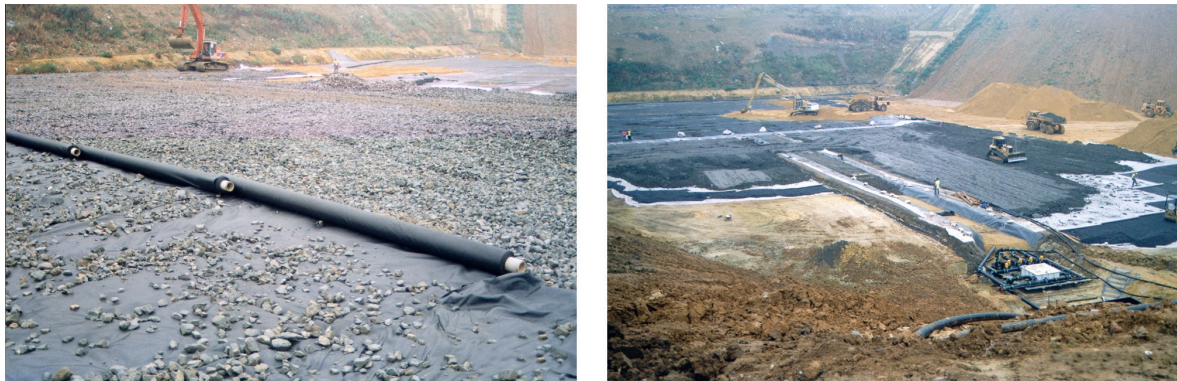
The construction cross section of the basal layers can be seen in Fig. 1 and 2. The bottom of the waste disposal is 1 m above the ground water table. A layer of gravel 20-32 mm diameter, was placed on a geotextile (a) which prevents the loss of gravel into the subsoil. On top of the gravel a separation geotextile (b) was installed and a 600 mm thick layer of clay.

This gravel layer, surrounded by two geotextiles (a and b), provides a firm base facilitating the compaction of the clay whilst also acting as a capillary barrier against the migration of water and subsoil particles. Geotextile (b) with an O_{90} smaller than 50 microns, placed beneath the clay layer,

prevents the downward migration of particles from the clay and the clogging up of the drainage layer.

Above the clay was installed a 2 mm HDPE geomembrane (c), with two smooth surfaces. Hot wedge double welding was used and each seam was checked for integrity by means of either an air pressure test, an electric wire test or a vacuum chamber test, depending upon its situation. The geomembrane is protected by a layer of sieved sand 150 mm thick and two geotextiles: a nonwoven geotextile of 300 g.s.m. weight (d), together with a 60 kN/m strong woven (e). Before approving the geotextiles used, a cylinder test was executed, simulating an overburden load of 50 m of waste on the geotextiles, the sand and the geomembrane (following Test Standard prEN 00189055 'Protection Efficiency'). The combination of a woven and a nonwoven geotextile together with 150 mm of sieved sand, proved to be an effective protection layer for the geomembrane.

Fig. 1 and 2. General view of the basal layers with Terralys geotextiles being installed.

For future projects, this combination of sand and geotextiles could be replaced by one single heavy duty geotextile. One of the advantages of replacing the 150 mm of sand by a relatively thin but strong geotextile would be that, apart from the gain in volume for waste, the hydraulic gradient on the geomembrane and the drainage system is reduced by 150 mm.

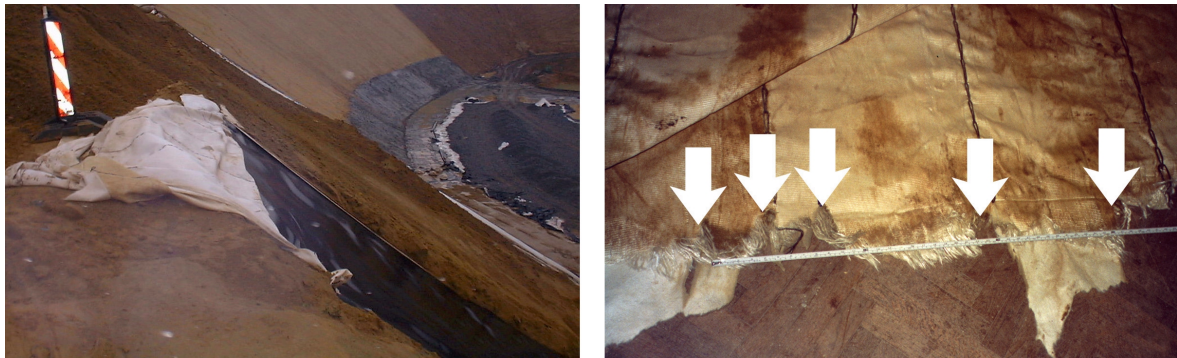
Why did the reinforcing textile fail at the slope crest? Why did only one section fail? The textiles had been placed for three weeks when the accident took place. The textile itself was a strong multifilament polyester – polypropylene had been used on slopes with flatter gradients. It had been designed to cope with the construction stresses and yet one section failed.

Examination and tests on the geotextile, including the place of rupture, confirmed that they conformed to their specification and initial tensile strength. There was not any measurable reduction from the initial specification: no damage was caused during installation and, interestingly (in view of some commonly held views on alkaline attack of polyester), after 3 weeks no reduction in strength was found caused by the alkaline environment of pH 12.5 which was measured in the overlying cement-stabilised sand.

Detailed analysis of the geotextile sample at the University of Liege (Belgium) provided the answer. It was demonstrated that mechanical damage had been caused to the textile at the crest of the slope by the cable of a winch situated at the top of the slope. This winch and cable were used to support bulldozers working on the steep slope. The cable had rubbed over the geotextile at the edge of the slope and worn it and made holes in the geotextile, which initiated rupture. The influence of such limited damage on the residual tensile strength of a reinforcement geotextile will be the subject of a separate research project. There will also be follow-up research on the residual strength of these polyester geotextiles in an alkaline environment.

Fig. 11. The failure of the reinforcement geotextile at the top of the slope.

Fig. 12. Details of the reinforcement geotextile where at least 5 holes initiated rupture.

The broken geotextile was replaced and care was taken to avoid any mechanical damage on new geotextiles installed. No further problems occurred.
