Construction of a geogrid-reinforced earth-wall inside a warehouse

Keywords: High-bay warehouse, Geogrids, Concrete facing wall, Formwork, Retaining wall

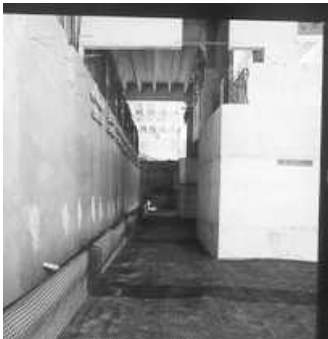
Fig. 6: Geogrid installation between the piles

The wall was built 50 cm behind a concrete facing wall, the wrap around was built with the help of a special movable formwork made of steel profiles. A steel plate was first installed horizontally every 2.0 meters on the previously constructed layer, secondly the movable part of the formwork was fixed vertically directly on the steel plate near the edge of the slope, thirdly wooden planks were installed against the formwork, next the geogrid was laid down with a sufficient length over the formwork for the layer thickness and the tie back length. After laying down and compacting the fill soil, the geogrid was wrapped around the face and fixed in the soil layer with special steel pins.

Between the piles, the geogrid was cut and fixed all around the perimeter of the piles with steel pins.

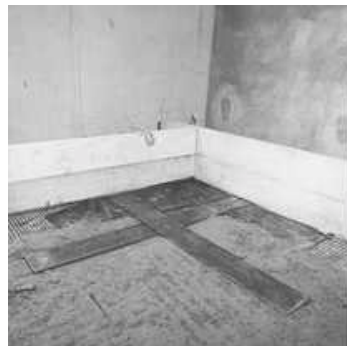
Fig 7: Edge corner of the geosynthetic wall

By the 90° edge corner, the geogrid was installed overlapped one upon another.

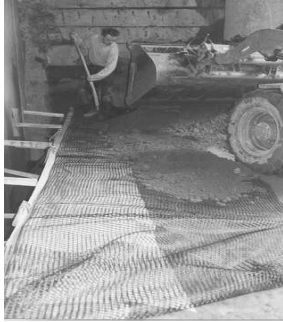
Fig. 8: Installation by hand

Due to the cramped conditions of installation and the situation between existing concrete piles, it was very important to choose the right machines for soil installation and compaction. Two wheel loaders and 3 BOMAG compaction machines were used. The installation of approximately 200 to 300 m³ of soil per day was possible. By the last three layers, the soil installation in front of the con-

struction was only possible by hand while no machine could drive under the concrete beam of the second level of the warehouse.

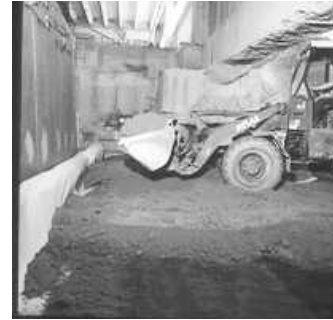
Fig.9: Situation at the upper layers

A gravel layer was well set direct by the last geogrid layer to allow a 100% contact of the concrete plate base with the geosynthetic wall.

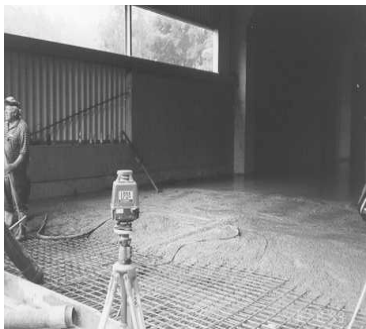
Fig.11: Concrete plate on the second level above the geogrid reinforced wall

A 7.20 meter high geosynthetic retaining structure sloping at 85° including a 90° edge corner was constructed 50 cm behind a facing concrete wall inside the warehouse to prevent earth pressure against the face saving the construction of a consequent concrete retaining structure. The concrete plate on top of the geosynthetic structure at the second level, where truck and fork-lift are circulated, was reduced in thickness.
