WALSH, I. D., Kent County Council, United Kingdom

## GEOTEXTILES IN HIGHWAY SURFACE DRESSING

The paper will describe the road trials carried out in Kent, England, in 1984 and 1985, using a polypropylene Geotextile membrane as part of the Surface Dressing System. The purpose was to seal cracks in the surface, and reduce the variations in the hardness of the surface which would affect the effectiveness of the surface dressing.

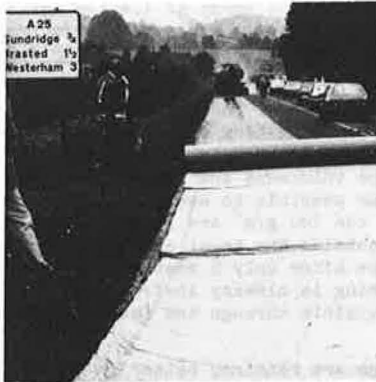
Trial Site 84/1  
Rolling out the Fabric

5.1.4 In order to accommodate the 4 m width of the roll with the standard spray bar, two passes of the spray tanker were required. The roll of geotextile was then manhandled into position across the end of the sprayed

area and rolled forward. It proved to be rather difficult to keep it in line with the road edge because of the weight of the roll and the instant bonding with the binder; it was also impossible to apply any tension to the fabric. As a result a number of creases and folds developed every time the roll was readjusted for line. Several of the large folds were later cut with a knife and overlapped. It was noted that whilst walking on the fabric some binder did appear through the membrane under the footmarks.

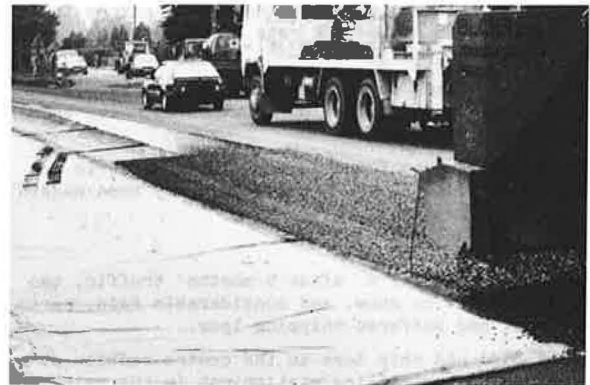
Trial Site 84/1  
Overspray and Chipping

5.1.5 The tanker reversed over the laid fabric without difficulty and sprayed the second application, followed immediately by the Phoenix chipping machine laying the chippings. Compaction was by a Dynapac vibrating roller with rubber coated drum. Slow moving traffic was then allowed on the area.

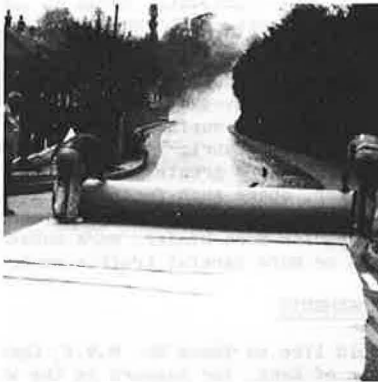
Trial Site 84/2  
Rolling out the Fabric

5.2.4 The roll of fabric 4 m wide was rolled out on the sprayed surface 3.66 m wide by hand with about 150 mm overlap on to the unsprayed road. It, again, proved to be difficult to roll out the fabric along the designated line without creases occurring at obligatory adjustments in direction. A small number of cars used the surface of the fabric temporarily during the operation. These did not damage the fabric nor pick up binder on their wheels as their weight did not seem sufficient to cause binder to penetrate the membrane.

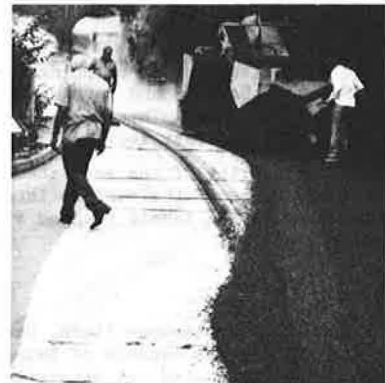
Trial Site 84/2  
Applying Chippings

5.2.5 The tanker reversed over the laid mat, marking it slightly, and sprayed the second application, followed immediately by the Phoenix chipping machine laying the chippings. Compaction was by a Dynapac vibrating roller with rubber coated drum. Slow moving traffic was then allowed on the area.

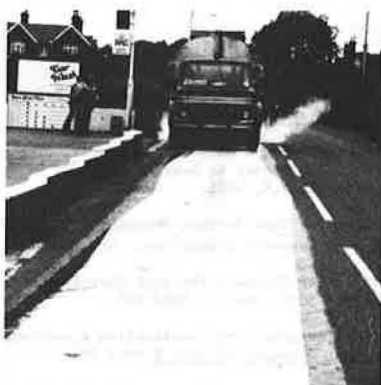
Trial Site 85/1  
Fabric before Spraying

9.1.4 The road was sprayed with binder  $2.3\text{m}$  wide and the  $2\text{m}$  wide fabric rolled out by hand. As before several large and some small creases occurred. The nearside of the fabric was given two passes of the Dynapac vibrating roller, with rubber coated drum. Whilst this marked the fabric it did not bring the binder through sufficiently for the fabric to be significantly blackened on the surface.

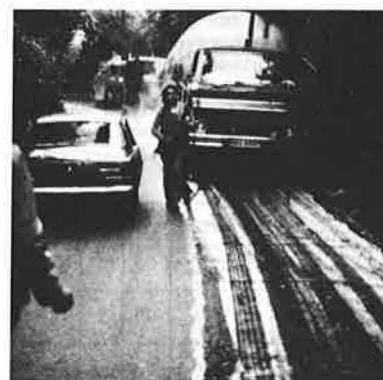
Trial Site 85/2  
Fabric before Spraying

9.2.4 The road was sprayed with binder  $2.44\text{m}$  wide with the tanker travelling up the hill, and the  $2\text{m}$  wide fabric rolled by hand. Because of the flimsiness of the fabric and the bends in the road, a number of very large creases occurred, which were left untreated. The fabric was rolled with a pneumatic tyred roller which pressed the fabric into the underlying spray, but not enough for complete saturation despite the excess binder.
