# Geotextile Reinforced Embankment of Clayey Soil with High Water Content

**ABSTRACT:** In Japan clayey soil with high water content, such as volcanic ash clayey soil and excavated waste soil, is often used as banking materials. The best strategy in such a case is to dissipate the excess pore water pressure, using geotextiles as horizontal draining materials, and reinforcing the soil through consolidation. We were able to construct test embankment to investigate the suitability of geotextile reinforced embankment of clayey soil with high water content. Test results suggested that the laying of closely-spaced spunbonded nonwoven fabrics (we used 30cm intervals) is a highly suitable technique for reinforcing high embankments of clayey soil with high water content. This technique integrates the embankment as well as assisting consolidation of the embankment.

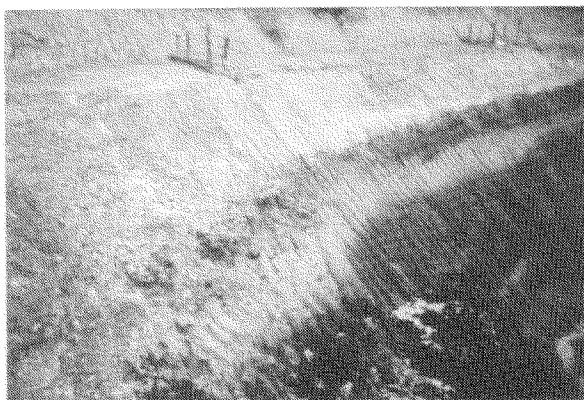
A mixture of volcanic ash clayey soil and sandy silt from construction borrow pit was used as banking material. As shown in Photograph 1, the soil layer at the borrow pit consisted of brown sandy silt of 50% natural water content at the top, followed by dark gray volcanic ash clayey soil of 130% water content and whitish-gray volcanic ash clayey

Photo. 1 Soil Layer Composition at Borrow Pit

soil of 40% water content. The soils from each of these layers were mixed after excavation (see Photograph 2), with moisture contents being dispersed between 50% and 120% according to the mixing ratio.

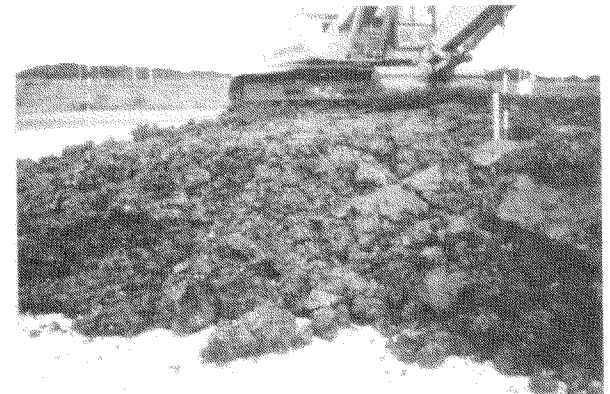
Photo. 2 Banking Material after Excavation and Removal

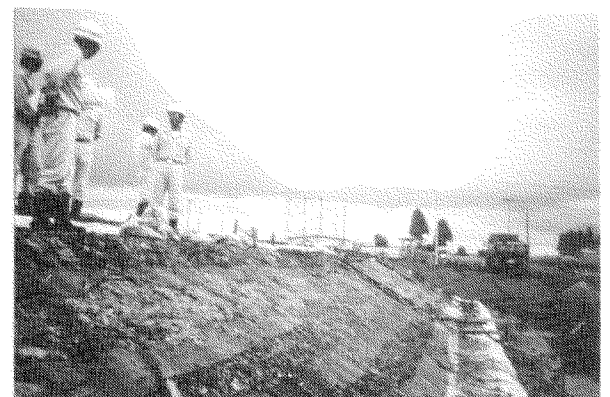
Photo. 3 Nonwoven Fabric Side of Slope

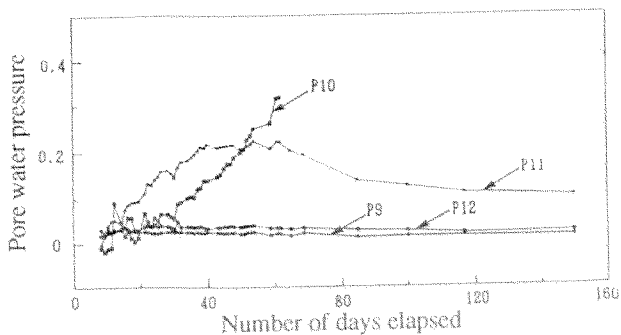
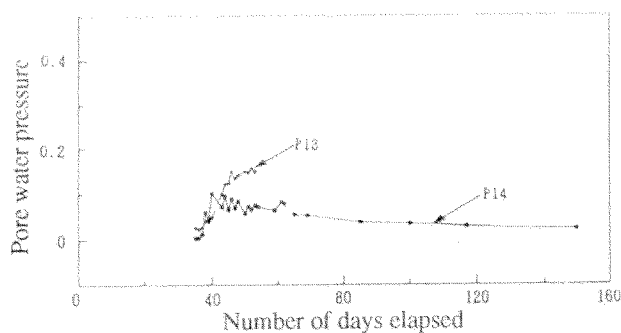
(a) 2nd Layer

(b) 9th Layer

Fig. 3 Generation of Pore Water Pressure

Figure 3 shows data recorded by the pore water pressure gauges installed in the 2nd and 9th layers of the embankment. The excess pore water pressure rises in the inside of the embankment before being dissipated rapidly on the side with the spunbonded nonwoven geotextiles. It can also be seen that the rise in excess pore water pressure during construction is quite large on the polymer grid side, where the geotextiles are spaced widely. It can be concluded therefore that excess pore water pressure will be dissipated quickly if spunbonded nonwoven geotextiles are laid at close 30cm intervals.
