# Geotextile Reinforced Retaining Wall in a Spillway Approach Channel

**ABSTRACT:** For the construction of a spillway approach channel of the Sandillal Hydropower Dam Project in Costa Rica, a rock slope in volcanic tuff had to be cut back. Due to unfavourable geological conditions, sliding of the excavated slope occurred. Because the sliding mass in the approach channel had been removed, the slope remained in unstable condition. A retaining berm at the toe of the slope was constructed to stabilize the 40 m high slope. Due to the limited width of the approach channel and hydraulic conditions, the required slope inclination of the berm of 1v:1.25h could not be achieved by means of a normal embankment out of the available random fill material. Therefore, a reinforced soil embankment was designed and constructed out of non-woven geotextile. Special shuttering was designed to allow the placing and compaction of the fill in 1 m layers between the geotextile reinforcement. The geotextile in the slope surface was protected by shotcrete against UV-radiation, atmospheric influences and water action in the spillway approach channel.

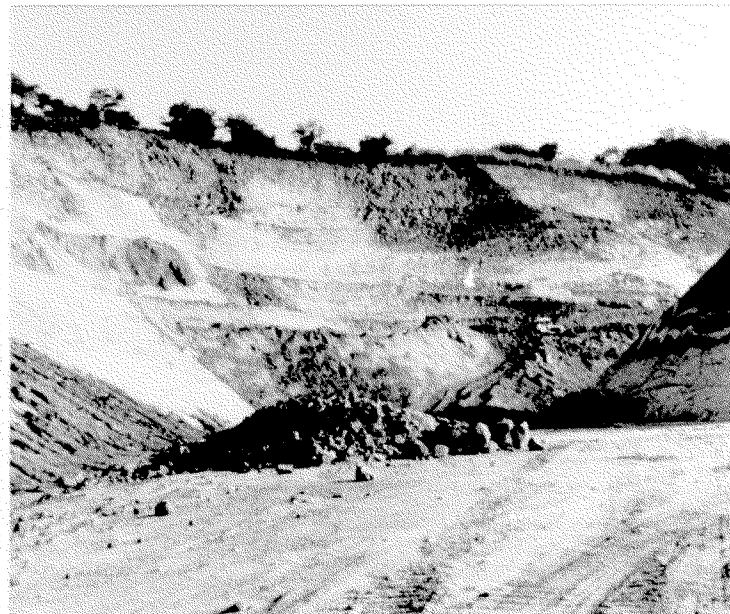
Figure 1 Sliding area of left slope of the spillway approach channel.

rainfall the relatively steep left slope became unstable. Appr. 50,000 m<sup>3</sup> of tuff and basalt slid down on a curved sliding plane through the tuffs and on top of the clay zone. The approach channel was filled with sliding mass material for a length of about 100 m, and this had to be removed to allow unrestricted flow of flood water towards the spillway.

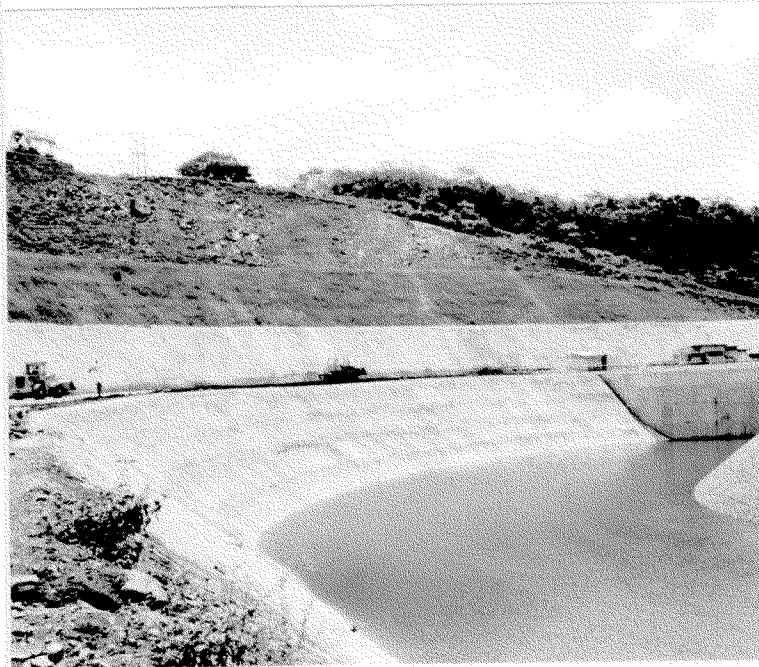
Figure 6 Completed retaining berm in the upper part of the left slope of the spillway approach channel.

Geodetic displacement measurements did not indicate movement of the reinforced retaining berm during first reservoir impoundage and initial project operation.
