Geotextile and Granular Filter Performance after Four Years of Real Scale Test

Highway Department of State of Parana, Brazil

ABSTRACT: Long term behavior of geotextiles as filters in drainage structures is often a concern of many users. In order to analyse this and other drainage issues, Highway Department of State of Parana has carried out a comprising practical research program, in which they included the construction and monitoring of six test sections of drains with different filters (granular materials and geotextiles). After four years, the sections were opened, and lab analysis were made in the collected materials.

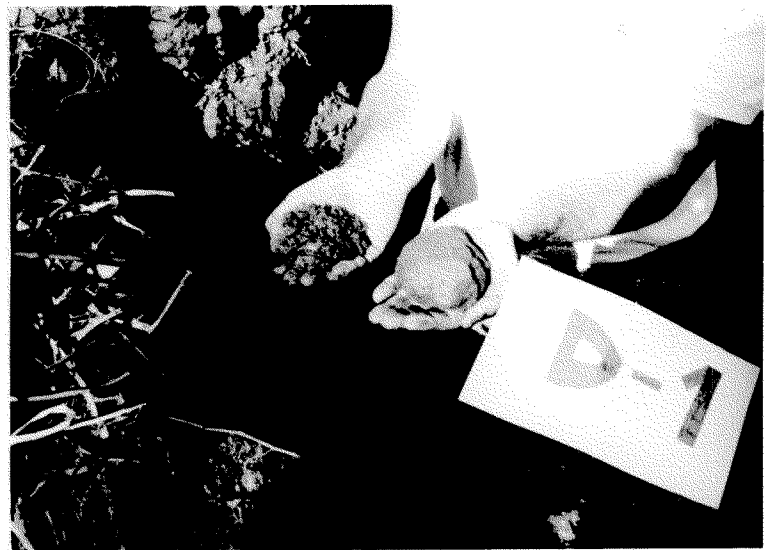
Fig. 5 Materials of Section I (well graded stone + pipe):

- . Right hand: aspect of granular material contaminated with soil;
- . Left Hand: material found inside the pipe
- All geotextiles survived installation, although less resistant geotextiles (mainly OP-15) presented some scratches and marks, caused by crushed stone which did not affect their performance.
- In section VI drain (sand+stone), clayey material was found, contaminating crushed stone, sand and pipe. The outflow box presented also some clayey material deposit.

- In "filter-draining" granular drain (Section I), there was a big contamination of crushed stone and a large clayey material deposit inside the porous pipe (about 7cm). The outflow box presented a great amount of clayey material deposit.
- Bad performance of "filter-draining" granular drain (section I) was already expected, since the material did not meet the retention requirements of Terzaghi's filter criteria. The non ideal performance of section VI may be imputed to the same reason (between sand and crushed stone) or to some construction deficiency (it was very difficult and time-consuming to construct this test section).
