# Deschutes Canal Lining Demonstration - Construction Report

J. J. Swihart

Bureau of Reclamation, Denver, CO, USA

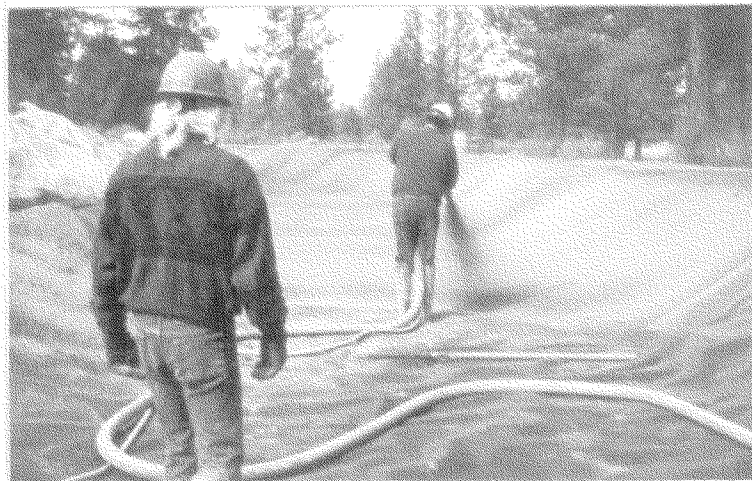
Figure 2 - Arnold Canal test sections 1 and 2. Application of shotcrete cover over geomembrane.

No	Lining Material	Cost (\$/m <sup>2</sup> )
1	0.1-mm Petromat geocomposite with 75-mm shotcrete cover	\$22.20
2	0.75-mm VLDPE* with 75-mm Shotcrete cover and 540 g/m <sup>2</sup> geotextile cushion	\$23.00
3	Exposed 2.0-mm HDPE*	\$14.85
4	Exposed PVC*/geotextile geocomposite with 200 g/m <sup>2</sup> geotextile cushion	\$11.30
5	Exposed 1.1-mm Hypalon with 540 g/m <sup>2</sup> geotextile cushion	\$11.90
6	Exposed 0.9-mm Hypalon/ Geotextile geocomposite	\$11.10
7	1.0-mm PVC with 75-mm grout-filled mattress	\$25.40
8	75-mm grout-filled mattress	\$20.00
9-10	Exposed 1.5-mm VLDPE or HDPE with 400-g/m <sup>2</sup> geotextile cushion and 75-mm grout-filled mattress on side slopes only	\$19.30

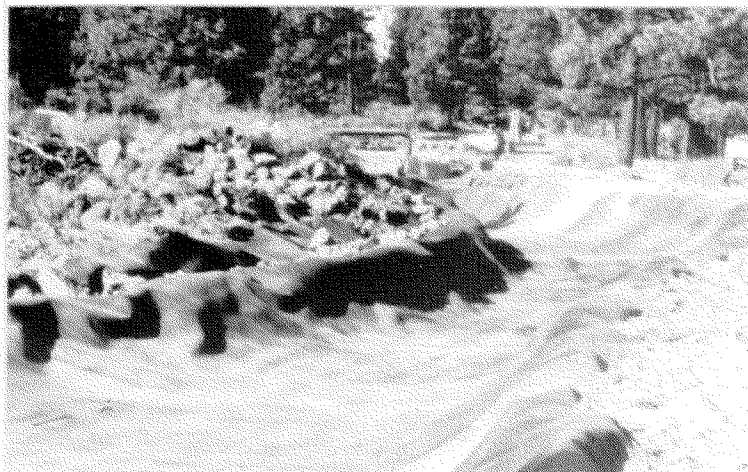
Figure 3 - Arnold Canal test sections 3 through 6. Installation of exposed geomembrane liner.

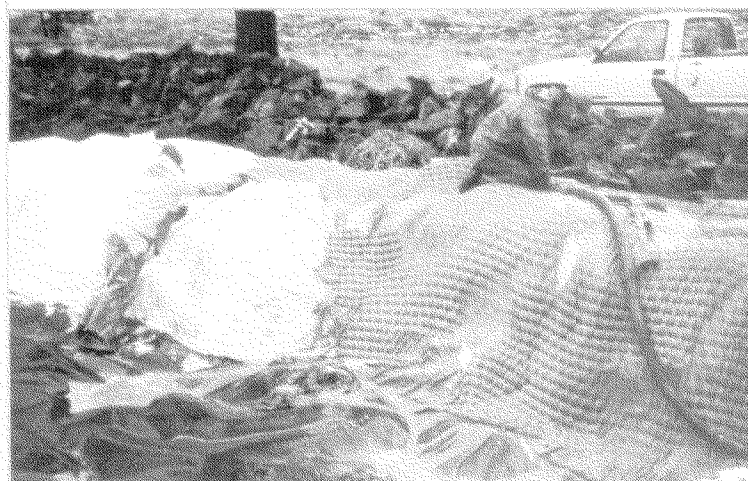
Figure 4 - Arnold Canal test sections 7 through 10. Installation of grout-filled mattress.

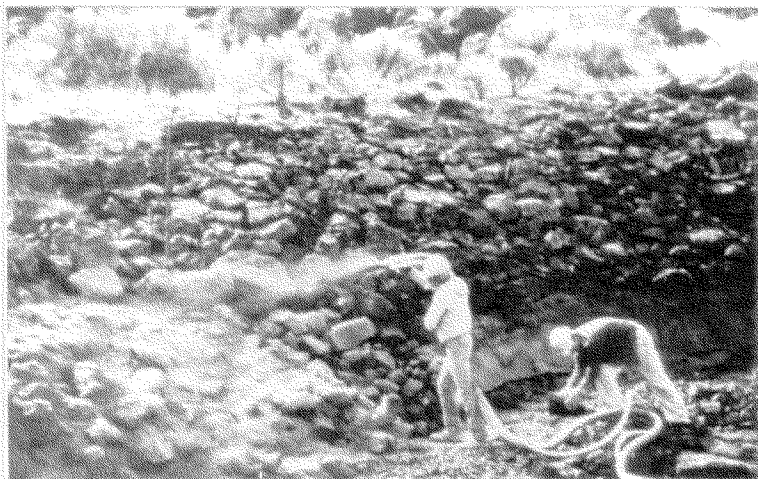
Figure 7 - North Unit Canal test sections 6 through 9. Application of 75-mm shotcrete lining.

No	Lining Material	Cost (\$/m <sup>2</sup> )
1	Polyurethane foam with Futura 500/550 protective coatings	\$46.60
2	Polyurethane foam with Geothane 5020 protective coating	\$42.20
3	Exposed 200-g woven geotextile with Geothane 5020 protective coating	\$28.40
4	Exposed 200-g/m <sup>2</sup> nonwoven geotextile with Geothane 5020 protective coating	\$28.40
6	75-mm-thick, steel-fiber reinforced shotcrete	\$17.10
7-8	75-mm-thick, polyfiber reinforced shotcrete	\$15.80
9	75-mm-thick, unreinforced shotcrete	\$14.30

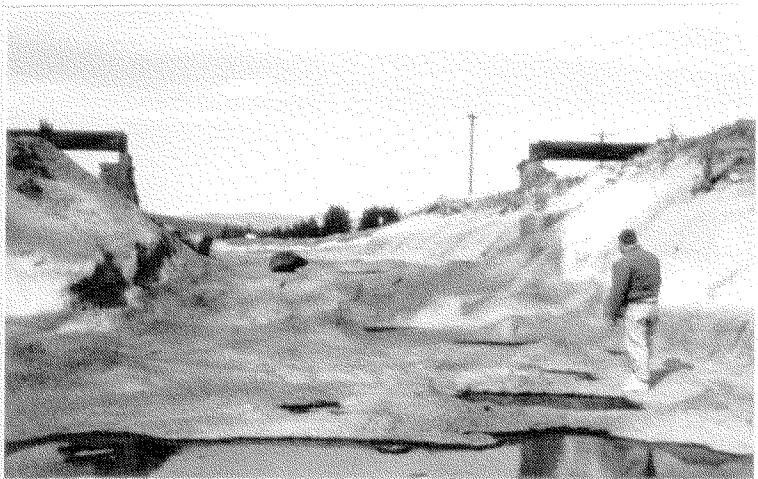
Figure 8 - North Unit Canal test sections 6 through 9. Completed canal section with 75-mm shotcrete lining.

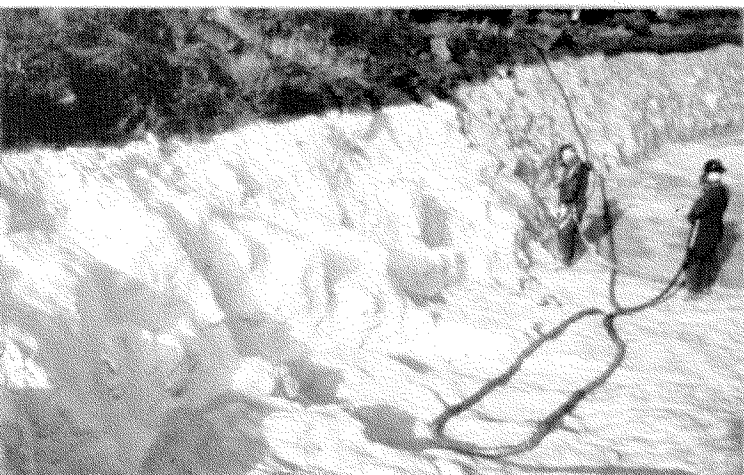
Figure 5 - North Unit Canal test sections 1 and 2. Spray application of polyurethane foam and coatings.

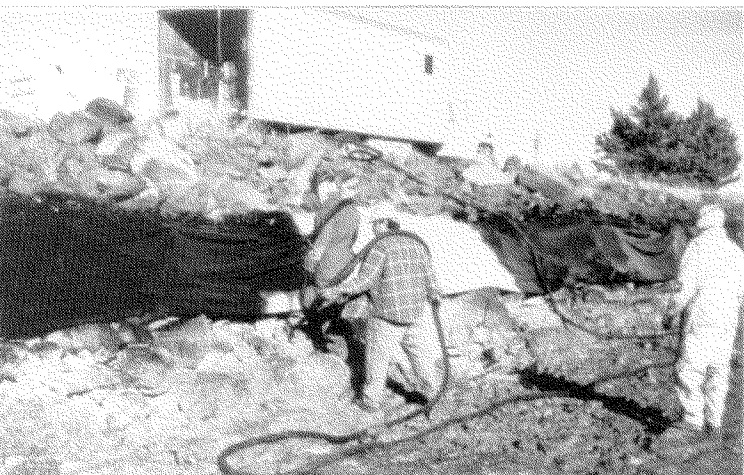
Figure 6 - North Unit Canal test sections 3 and 4. Application of protective coating to geotextile.
