Jute Geotextiles as Revetment Filter for River Bank Protection

R. Sivaramakrishnan

PSG College of Technology, Coimbatore, India

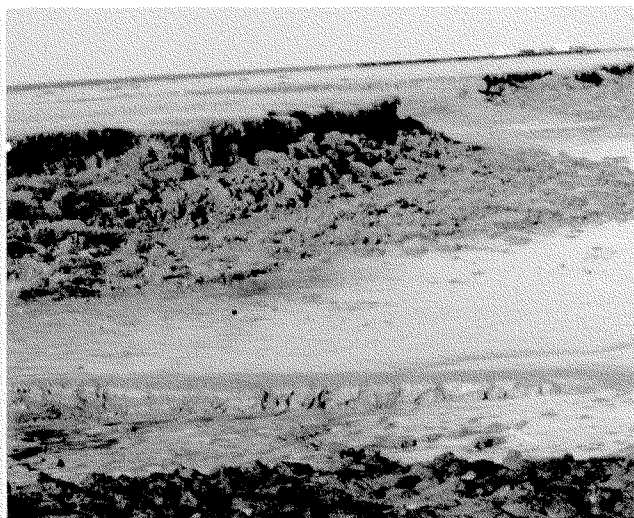
1. Erosion of river bank in Nayachor Island under Calcutta Port Trust, Haldia.

The river at Haldia is divided into two arms by a low lying island called Nayachor and because of siltation problems in the shipping channels a training arm has been installed on the northern end of the island. The objective being to divert an increased flow through the western shipping channel and reduce siltation. This training arm has been constructed using Dutch expertise. As a result of this work the western shore of the island was subjected to increased erosion forces causing severe erosion in the embankments. Photograph-1 shows typical erosion at Nayachor Island, Haldia.

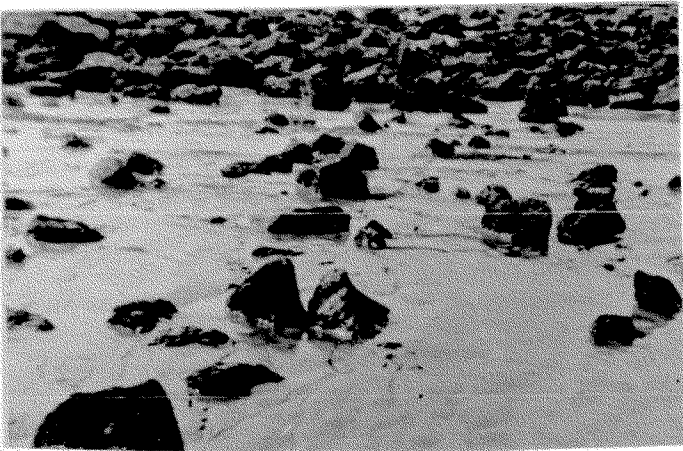
3. 600mm Siltation over the laid Jute Geotextile after a period of 8 months.

The efficiency of such application is primarily measured by silt formation over the laid site. A good amount of siltation up to a height of 600 mm was observed after a period of 8 months. A revetment filter is quite a sophisticated application involving dynamic flow and is a relatively
