ENVIRONMENTAL AND AGRICULTURAL PROTECTION BY CREATING TEN IRRIGATION RESERVOIRS IN THE AUTIZES

ABSTRACT

TEN IRRIGATION RESERVOIRS

STEP BY STEP CONSTRUCTION

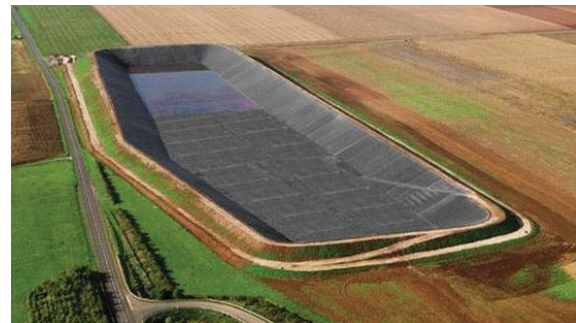
The construction of the irrigation reservoirs took place between 2006 and 2010. The capacity of the reservoirs varies from 140.000 m³ to 650.000 m³. One reservoir was constructed in natural clay. The other nine have been artificially made watertight with an EPDM geomembrane 1,1 mm as the natural ground was permeable (Fig. 8 and 9).

Fig. 8 Saint Pierre le Vieux – 485.000 m³ - 2006

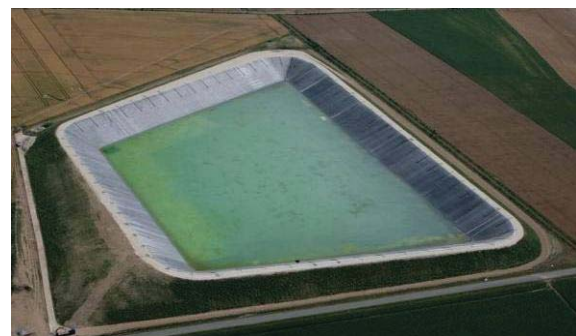
Fig. 9 Oulmes Sud – 200.000 m³ - 2010

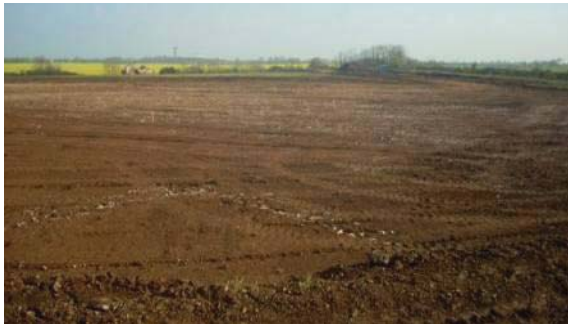
Fig. 10 Site before starting the excavations

The 9 irrigation reservoirs where an EPDM geomembrane was used are located on a limestone plain. They are built using the excavation and backfilling technique.

The limestone rocks are broken and crushed at the bed of the reservoir and the excavated ground is loaded onto trucks (Fig. 10 to Fig. 14).

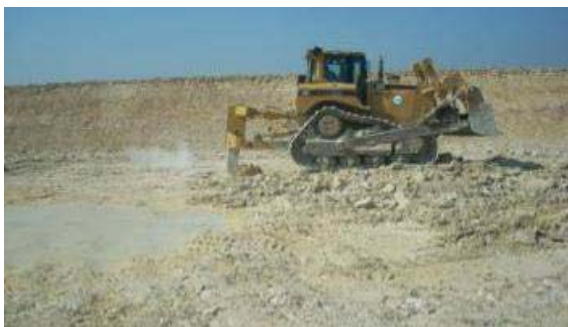
Fig. 11 Rock breaking at the base of the pond

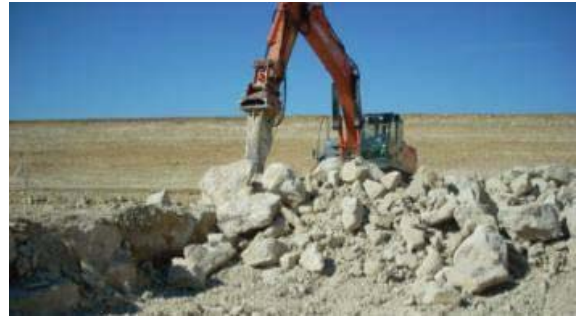
Fig. 12 Hydraulic rock breaker

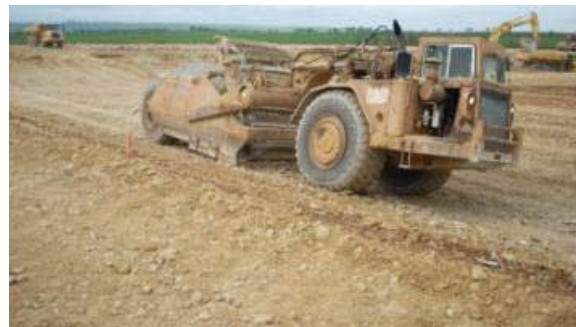
Fig. 13 Rock crusher

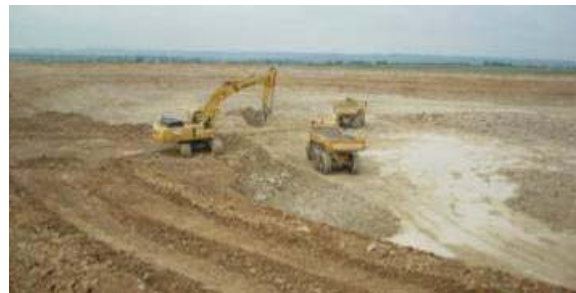
Fig. 14 Excavation of the base of the pond and truck loading

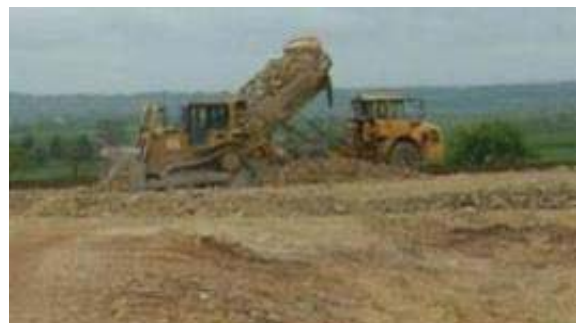
Trucks unload the excavated ground at the top of the embankment where it is leveled and compacted layer by layer. Compaction is done in order to reach the 95% of the Proctor Optimum value (Fig. 15 to Fig. 18).

Fig. 15 Unloading of excavated ground on the embankments

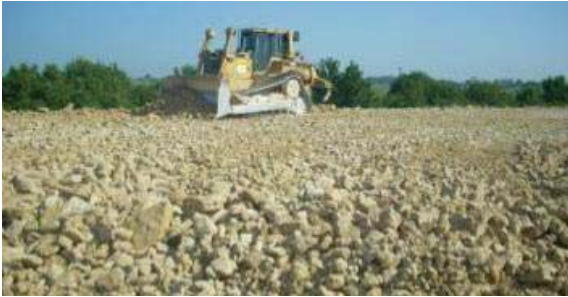
Fig. 16 Leveling with bulldozer on the embankments

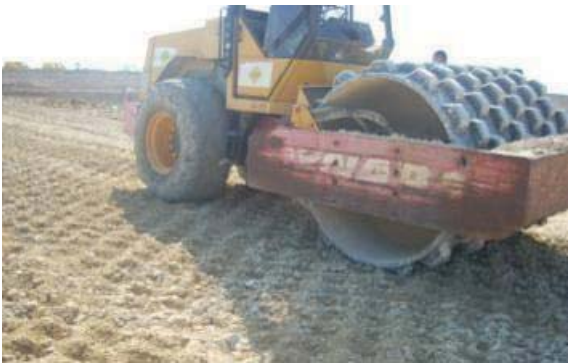
Fig. 16 Compaction of the embankments with chevron tamping wheels compactor

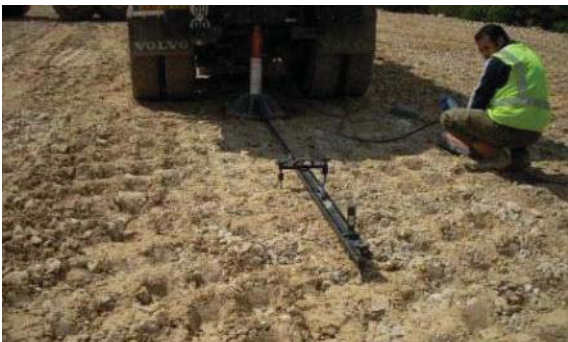
Fig. 17 Measurement of the degree of compaction

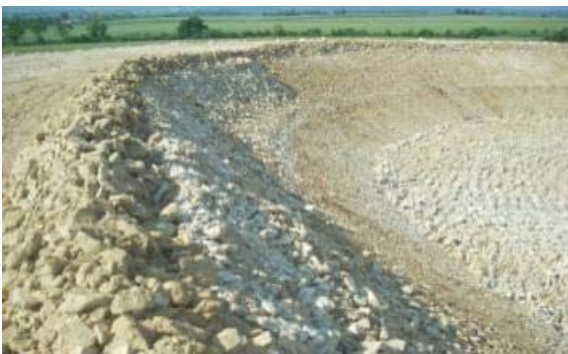
Fig. 18 Embankment before final finishing

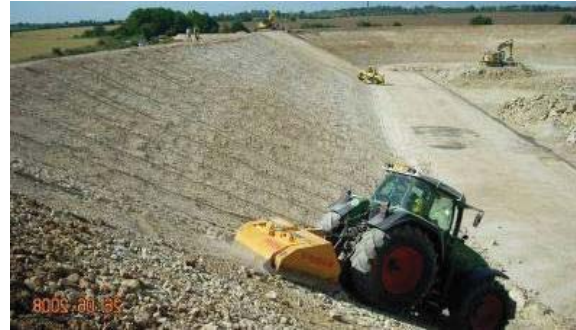
The support structure of the geosynthetic is made smooth and free from aggressive stones with a stone crusher and smooth drum roller compactor (Fig. 19 to Fig. 21).

Fig. 19 Stone crusher

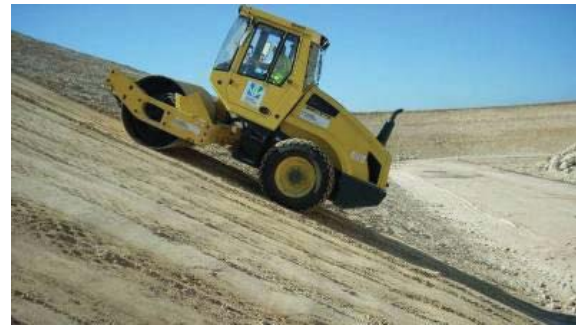
Fig. 20 Final compaction

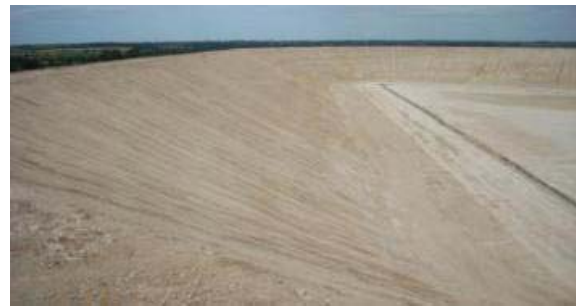
Fig. 21 Support layer overview

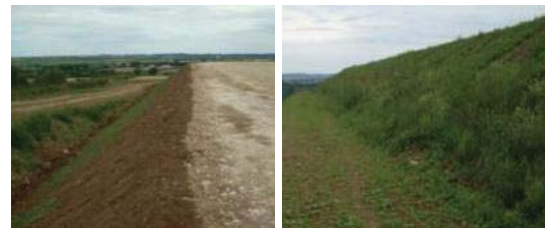
The external embankment is protected from erosion by means of a layer of topsoil seeded with grass (Fig. 22).

Fig. 22 External embankment (before and after seeding)

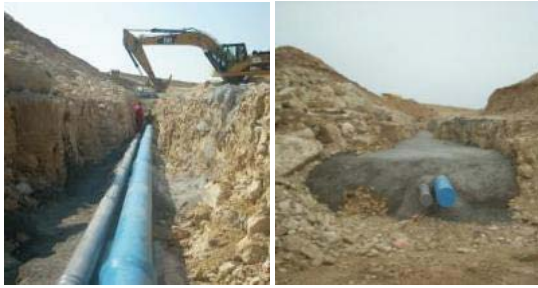
The outlet and water drainage pipes going through the embankment are covered with concrete for protection and to avoid piping phenomena (Fig. 23).

Fig. 23 Outlet and water drainage pipes through the embankment

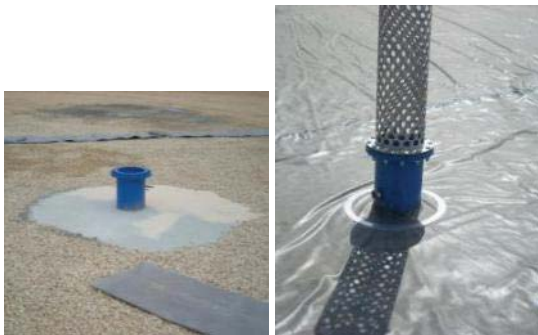
The outlet pipe is embedded in a concrete block constructed in such a way so as to limit differential settlements and present a smooth surface for mechanical anchoring of the geomembrane (Fig. 24).

Fig. 24 Water outlet pipe at the bottom

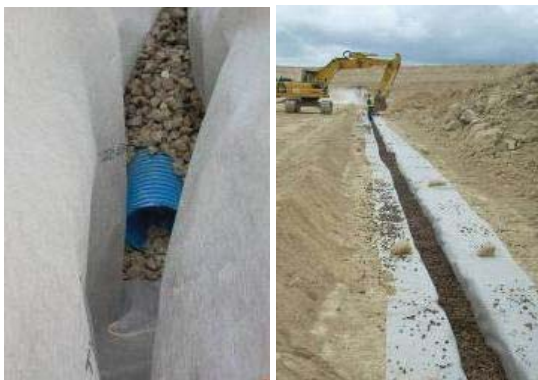
The water drainage system installed below the geomembrane will collect underground water and the water coming from an eventual leakage in the lining system. A drainage pipe is installed inside a trench with gravel and a filtration geotextile (Fig. 25 and 26).

Fig. 25 Water drainage ditch

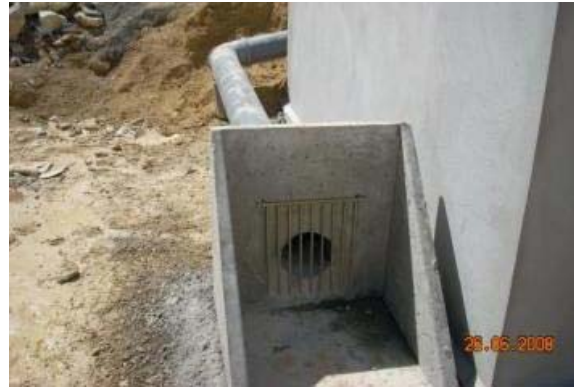
Fig. 26 Water drainage outlet

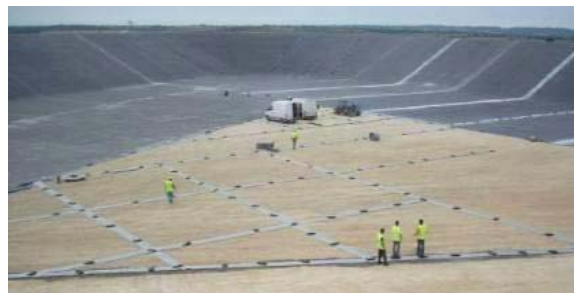
A gas drainage system is installed under the geomembrane to avoid any uplift pressure caused by the raising of the underground water table. The drainage geocomposites are made of 2 layers of filtration geotextile with a high density polyethylene geonet in the middle (55 cm large and 6 mm thick). The drainage geocomposite is connected to vents positioned on the crest of the embankment (Fig. 27 and 28).

Fig. 27 Gas drainage with geocomposite

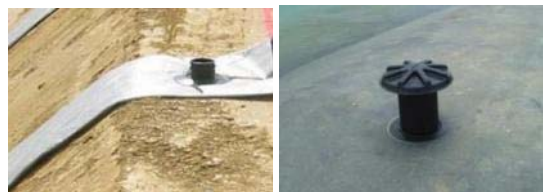
Fig. 28 Gas vent at the top of the embankment

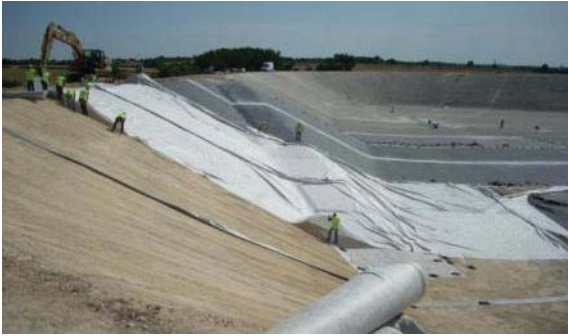
A puncture resistant geotextile is installed between the substrate and the geomembrane. The 400 g/m² Asqual (French quality certificate) certified geotextile is made of 100 % polypropylene non woven, needle punched, short fibers. The different geotextile panels are hot welded together in order to avoid any movement while installing the geomembrane (Fig. 29).

Fig. 29 Geotextile installation

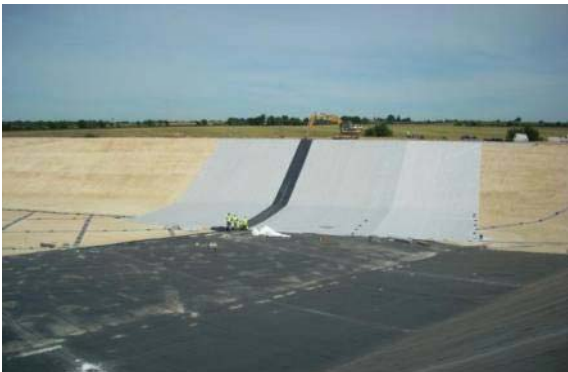
The Asqual-certified EPDM geomembrane 1,1 mm panels are positioned at the top of the embankments according to a pre-defined layout plan. The geomembrane is then unrolled and unfolded. The different panels are seamed together by Asqual-certified contractors using a self-adhesive EPDM/butyl tape and primer (Fig. 30 to 33).

Fig. 30 Unrolling of EPDM geomembrane

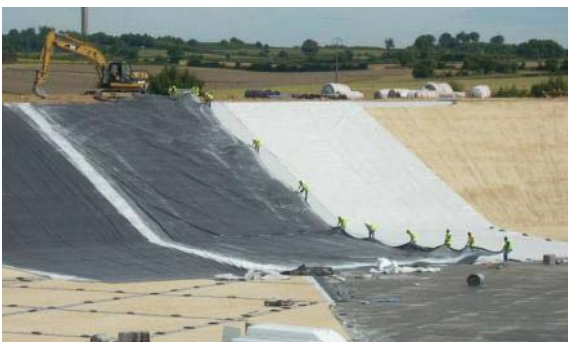
Fig. 31 Unfolding of EPDM geomembrane

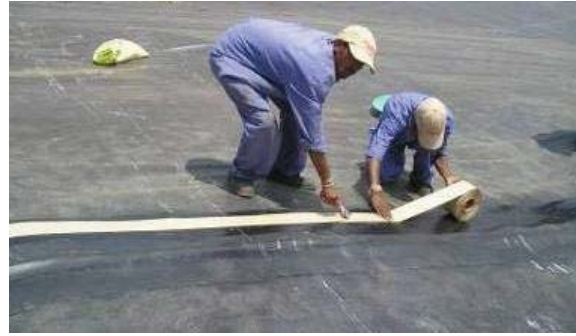
Fig. 32 Seaming of EPDM geomembrane

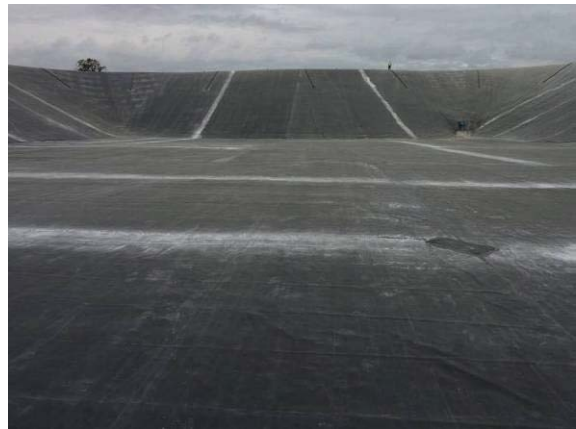
Fig. 33 Installed EPDM geomembrane

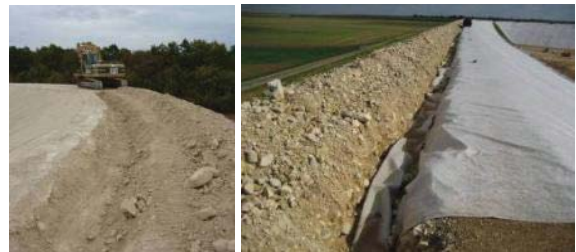
The geotextile and the geomembrane are anchored at the top of the embankment in an anchor trench. After installing the geosynthetics, the anchor trench is backfilled and compacted without subjecting the geomembrane to stress.

Fig. 34 Anchor trench with geotextile

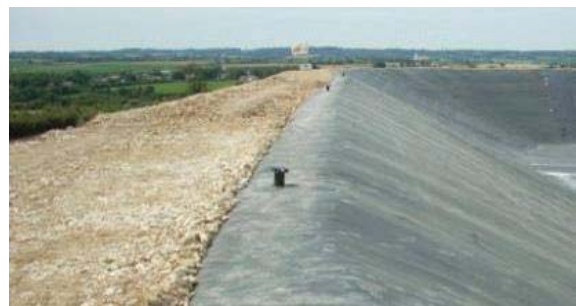
Fig. 35 Anchor trench after back filling

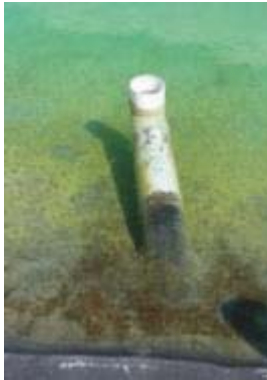
In order to prevent an overflow of the reservoir a designed spillway is installed in the sidewall (Fig. 36).

Fig. 36 Pipe spillway

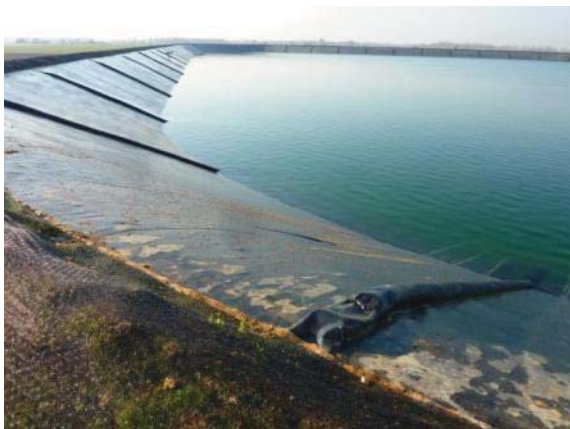
In order to avoid wind uplift, 5-6 m long PE bags, filled with gravel, are coming from the top of the embankment and anchored on the crest (Fig. 37).

Fig. 37 Wind ballast with PE bags filled with gravel and anchored on the crest

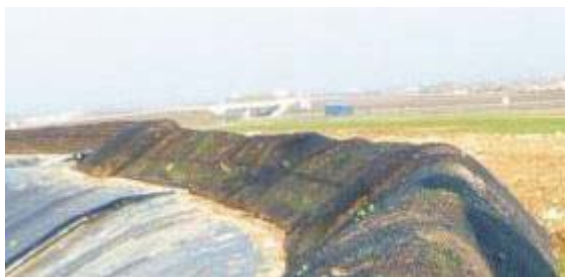
Some reservoirs that can be exposed to strong winds require an extra protection of the crest against waves overflow. It is a small seeded mound of ground protected with an anti-erosion geotextile (Fig. 38).

Fig. 38 Waves protection

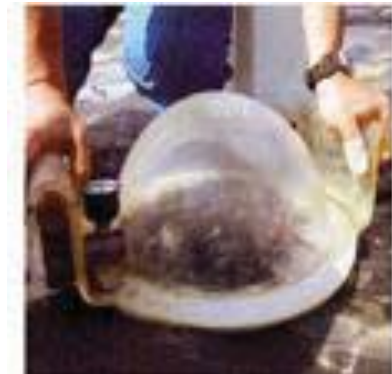
During the entire installation a strict internal and external control process is implemented on delivered materials and installation quality (Fig. 39).

Fig. 39 Quality control with vacuum chamber

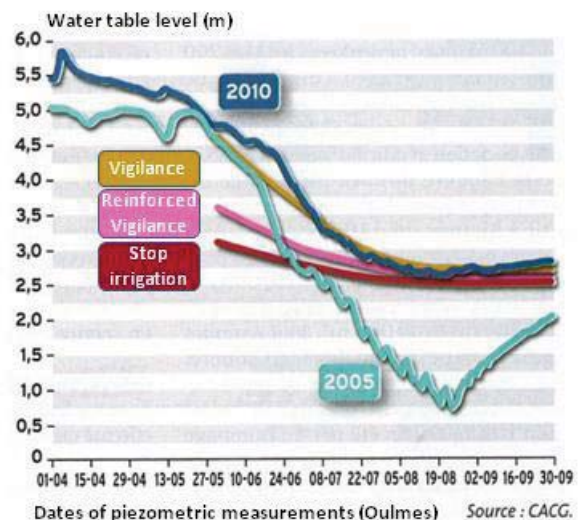
As the last irrigation reservoir was only finished in 2010, there is little feedback to evaluate the real impact of the project. Nevertheless, some preliminary results have been observed. In 2009 (with 7 reservoirs), the critical piezometric level was not reached. In 2010 (7 reservoirs), rainfall has been as poor as in 2005 (0 reservoirs). In 2010, with 7 reservoirs, the minimum water table level was 1,9 m higher than in 2005 (Fig. 40) and the minimum water level in the main marsh canal (situated downstream) was 0,2 m higher with a delayed drop of one month.

Fig. 40 Water table levels in 2005 and 2010
