PAVING FABRICS FOR ROAD REHABILITATION, ASIA EXPERIENCE

C. J. J. Marcus¹, S. N. Pang², W. C. Loh³

Keywords: Paving fabric, bitumen, road rehabilitation

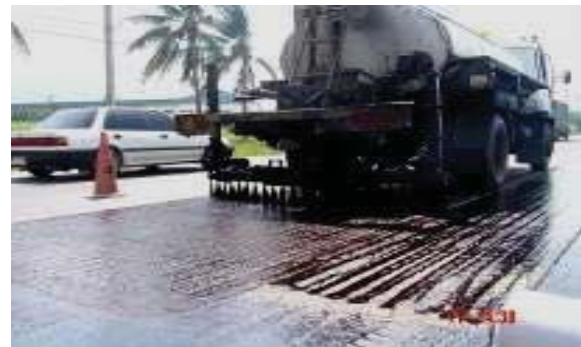
Fig. 1 Spraying of bitumen.

The paving fabric system comprises three components; the paving fabric, a bitumen binder, and the installation process. The usual process is for a bitumen binder to be sprayed over the old cracked road surface. The paving fabric is then laid over and adheres to the bitumen binder. Asphalt is then laid

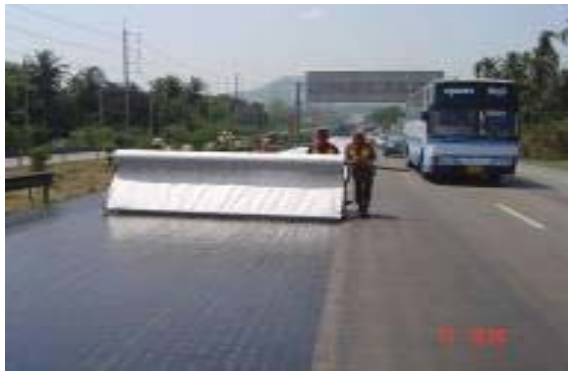
Fig. 2 Laying paving fabrics.

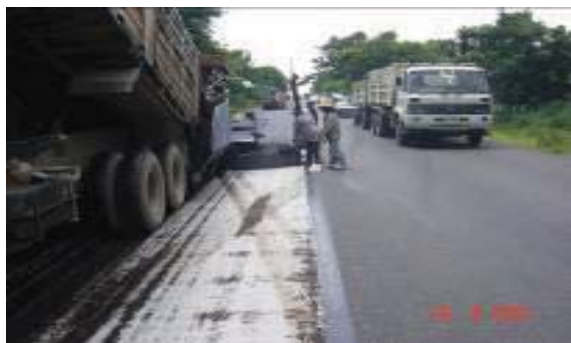
Fig. 3 Overlaying with asphalt.

over the paving fabric and rolled in the normal way. The asphaltting process draws the bitumen binder up into, and saturates the paving fabric creating bitumen rich stress absorption and waterproofing layer between the old pavement and new overlay. Traffic stress and temperature differentials in the pavement are uniformly absorbed and transmitted down through the pavement and base, delaying the onset of reflective cracking and extending the life of the asphalt pavement.

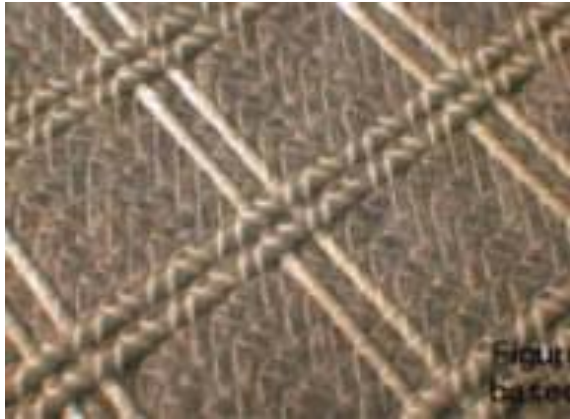
Fig. 4 Polyfelt PGM-G50/50 – nonwoven polypropylene geotextile reinforced with glass fibre.

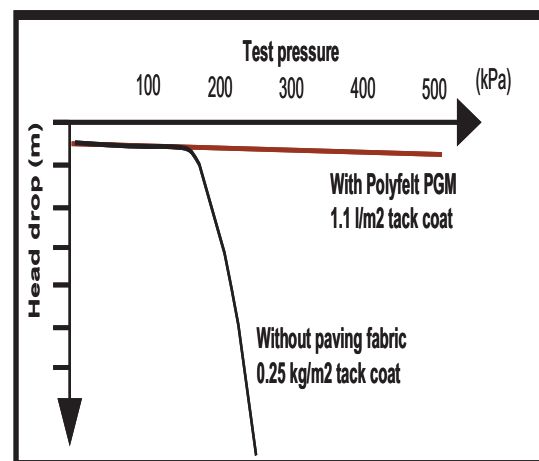
Fig. 6 Sealing benefits of paving fabric.

Comprehensive laboratory tests carried out by Resource International Laboratories, Ohio USA, have quantified the sealing properties of bitumen impregnated paving fabrics. In the tests, the highest possible maximum hydrostatic pressure corresponding to that of both passenger cars and trucks over cracked road filled with water was applied. In the test the effects of moisture penetration corresponding to a pressure of 276 kPa, equivalent to a car and 517 kPa equivalent to a truck was measured. The results showed a significant reduction in forced moisture and oxygen penetration of the asphalt is achieved when bitumen impregnated paving fabric are used (Fig. 6).

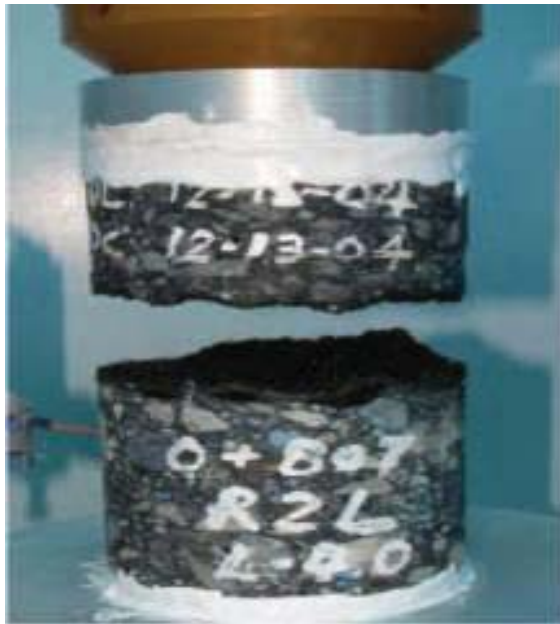
Fig. 7 Adhesion tests show paving fabrics improve bonding between layers.

layers into the base course the shear resistance at the interface between the old and new overlay must be high enough to prevent shear yielding through stress caused by braking or turning manoeuvres. To measure this adhesion tests cored samples were carried out on a Polyfelt paving fabric extracted from an airport runway project in the Philippines (Fig. 7). The results showed that paving fabrics induced high and more uniform bond strength than is achieved with conventional (no fabric interfaced) overlays (Table 2). Correspondingly it is this superior, uniform bonding of layers which improves the effective transfer of traffic stress down through the whole road structure, contributing to extended pavement life.

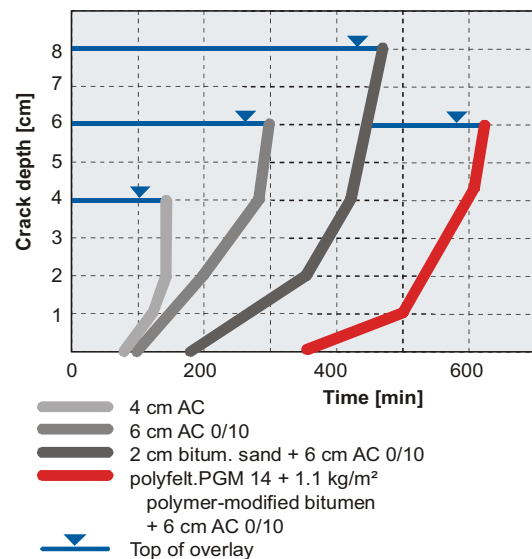
Fig. 9 Crack propagation in asphalt concrete.

Published results of tests conducted at Alun Regional Road Laboratory, France to evaluate the stress absorbing effect of paving fabric showed that bitumen impregnated paving fabric has an essential effect on the crack propagation and retard reflective cracking to a substantial extend. The series of tests evaluated and compared the results of various systems. From the test results, not only is the start of the crack delayed in the system using paving fabric, the life span is increased by 100% with a bitumen

impregnated paving fabric compared with 60 mm asphalt concrete without any paving fabric (Fig. 9).

The effects of Polyfelt paving fabrics saturated by different types of bitumen on crack reflection time were researched by the Alun Regional Road Laboratory, France. The results shown in Figure (8) show that the crack propagated time of paving fabrics saturated by polymer modified bitumen is approximately double that of overlays without paving fabrics.

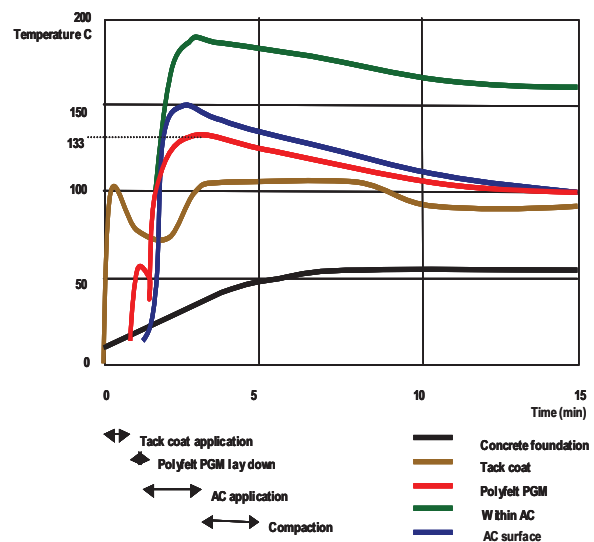
Fig. 10 Temperature gradient at different interface layers.

Suppliers of paving fabrics using polyester fibres commonly misleadingly claim that polypropylene paving fabrics are damaged by heat. The fact is that the vast majority of paving fabrics installed worldwide are polypropylene based and quite easily withstand the heat effects of hot asphalt laid directly over the fabric. The reality is that the temperature of asphalt in contact with the paving fabric as delivered to site has a temperature substantially less than the melting point of polypropylene. To clarify this issue the University of Liege, France which is world renowned for asphalt research and testing conducted extensive tests and trials. Their finding was that the temperature at the asphalt/paving fabric interface consistently never exceeds 100 °C even when the asphalt concrete overlay was laid at 160°C. This range of temperature is not critical for paving fabric made of polypropylene polymer as the melting of polypropylene is about 165°C (Fig. 10).

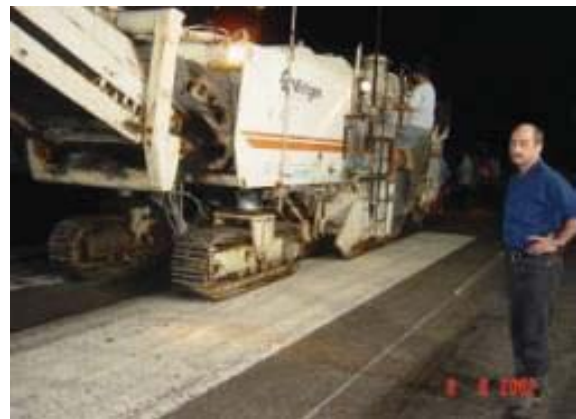
Fig. A1 Milling of the center line 100mm into the existing old asphalt concrete

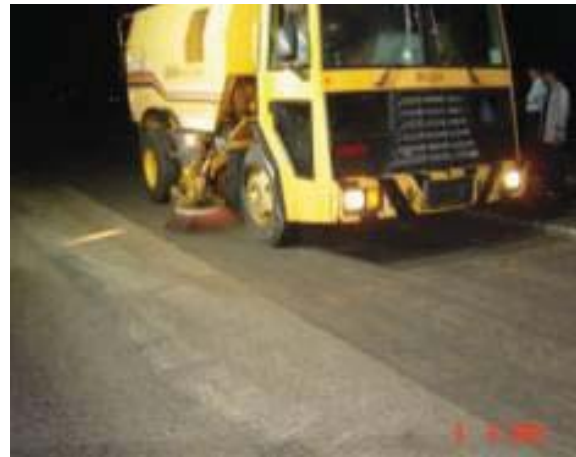
Fig. A2 Cleaning of dust from milled area.

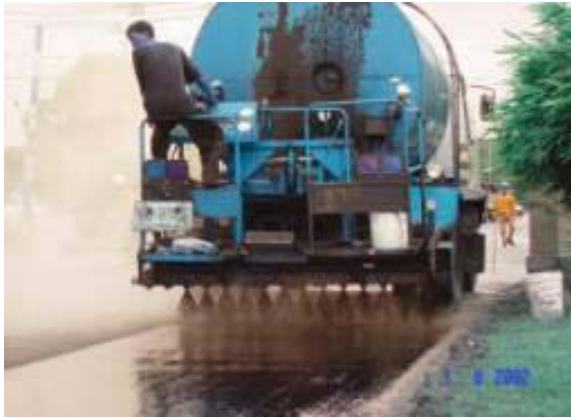
Fig. A3 Spreading of pure bitumen tack coat using metered dozing system.

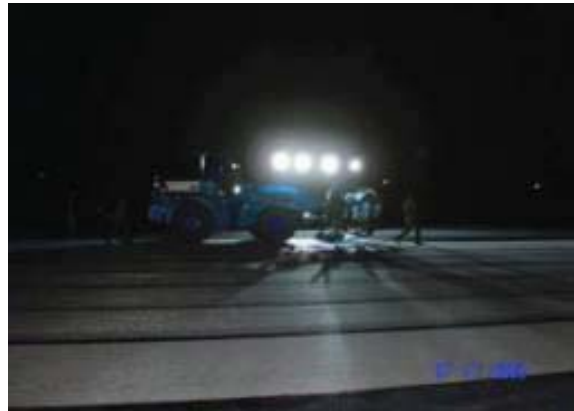
Fig. A5 Overview of installed paving fabrics.

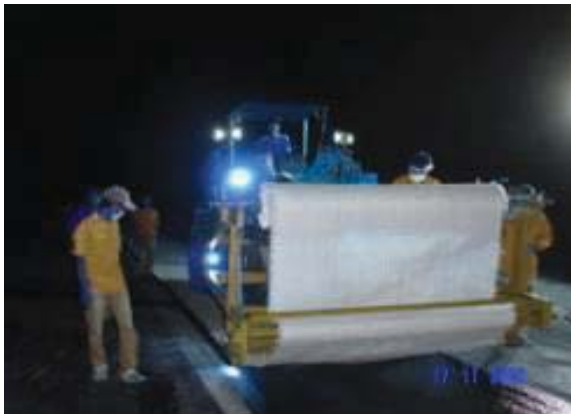
Fig. A4 Installation of PGM-G50/50 paving fabric onto tack coat.

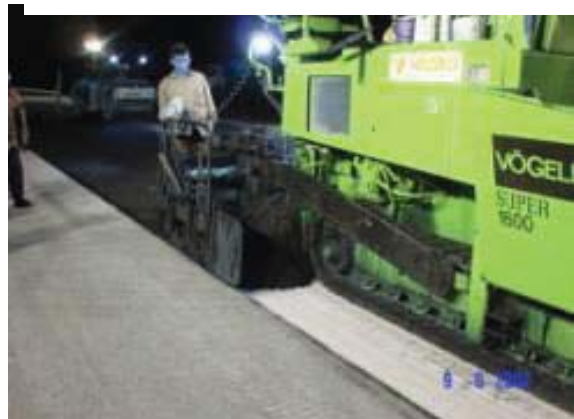
Fig. A6 Overview of asphalt concrete being discharge from track loader.

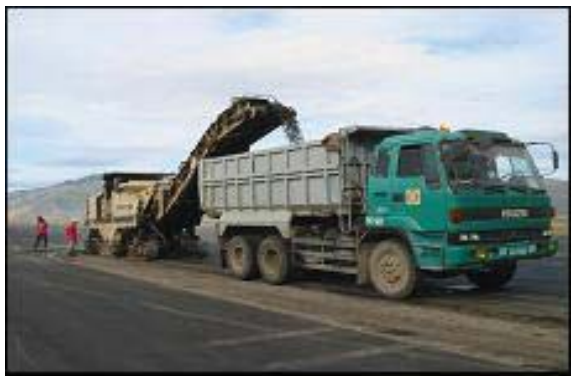
Fig. B1 Runway centerline milling and cleaning of existing pavement 50mm thick.

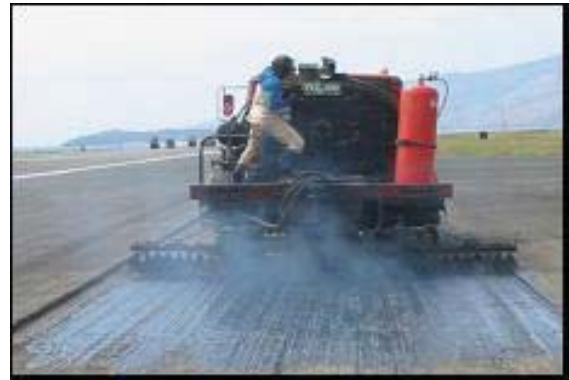
Fig. B2 Initial run of tanker controlled spray bar with 1.1kg/m² rate of application.

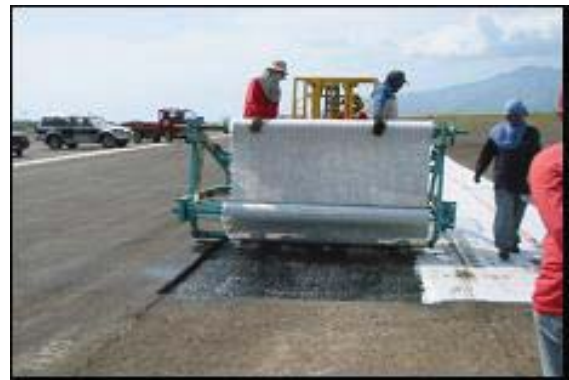
Fig. B3 Installation of PGM-G paving fabric utilizing Polyfelt custom rig.

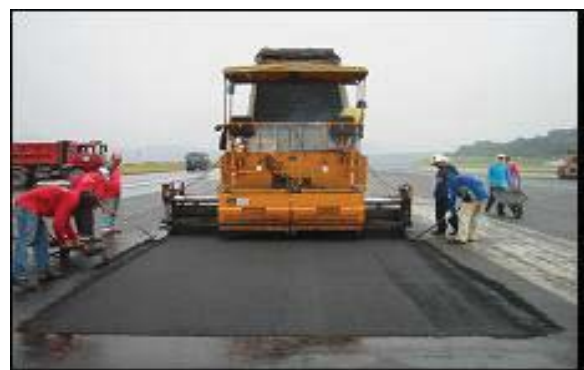
Fig. B4 Tipping of asphalt concrete and its uniform spreading.

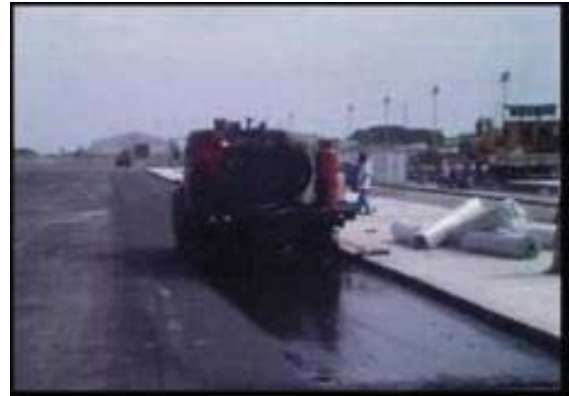
Fig. C1 Tanker with controlled spray bar for initial pure bitumen application.

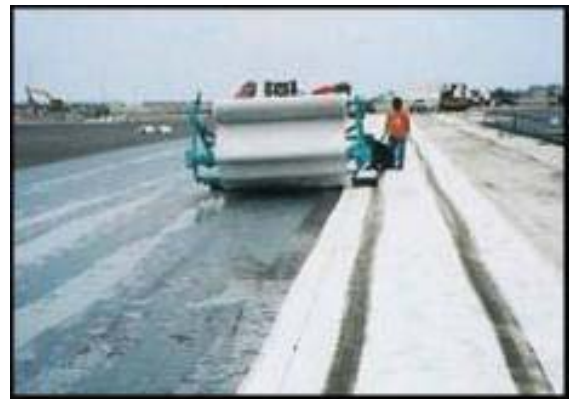
Fig. C2 Installation of PGM-G 100/100 paving fabric using a customize Polyfelt paving rig.

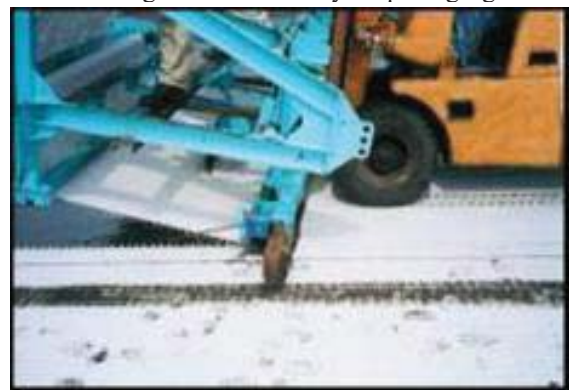
Fig. C3 Specially fabricated brushes prevent wrinkles on the fabric.

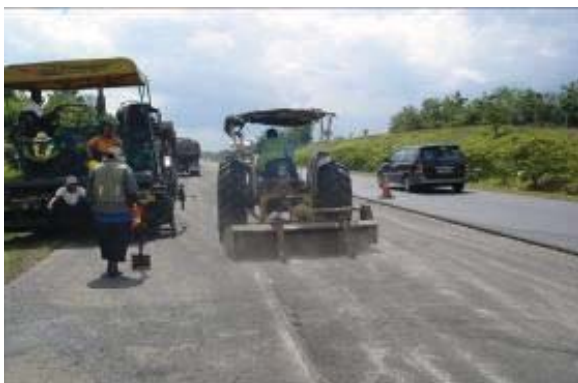
Fig. D1 Milling of old pavement.

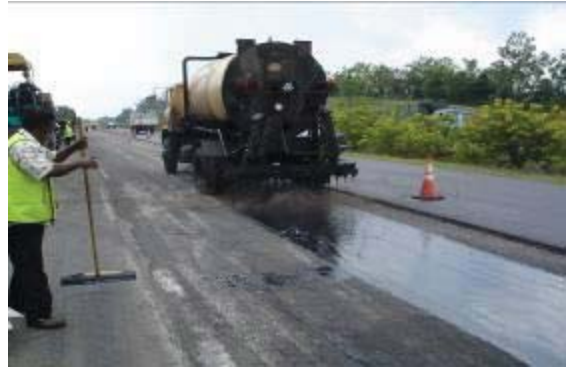
Fig. D2 Polymer modified bitumen tack coat was applied to the old pavement.paving rig.

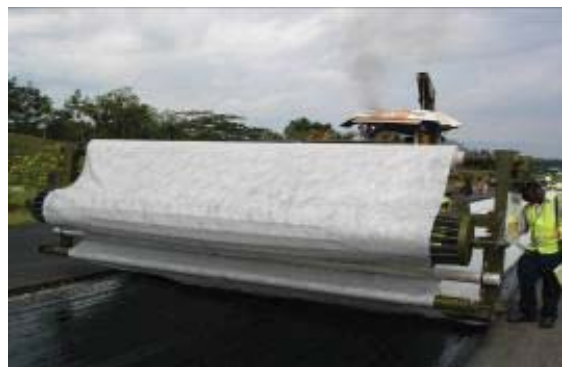
Fig. D3 Installation of PGM 14 paving fabric.

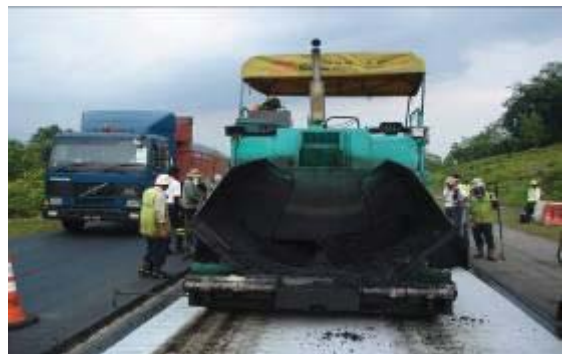
Fig. D4 Tipping of asphalt concrete

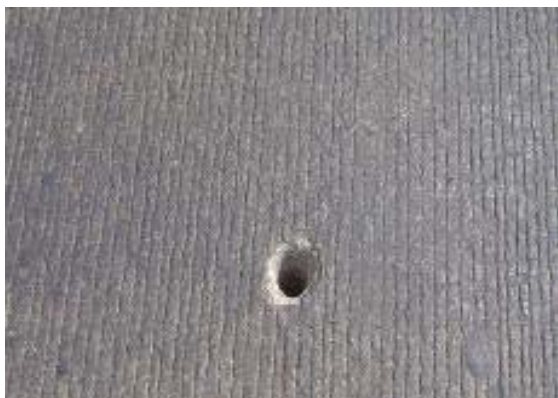
Fig. E1 Sealing of base course with cement grout.

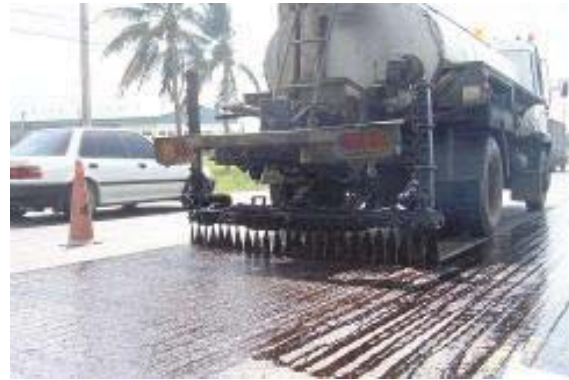
Fig. E2 Spraying of Cationic Rapid Setting (CRS-2) bitumen emulsion tack coat.

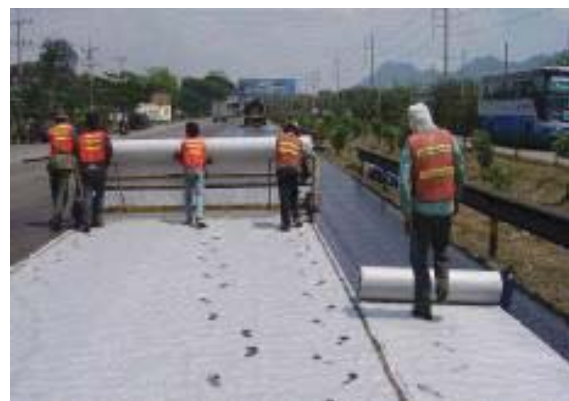
Fig. E3 Installation of paving fabric.

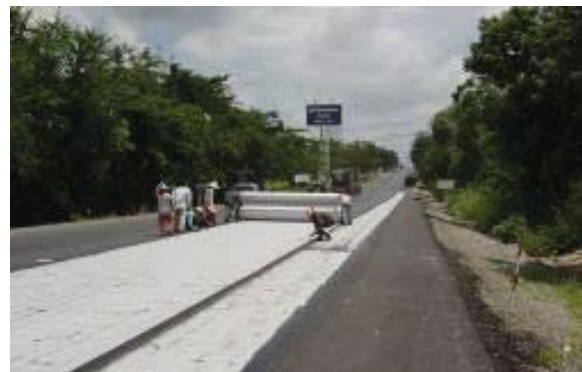
Fig. E4 Butt joint along the length of the paving fabric.
