THE USE OF GEOTEXTILE CONTAINER FOR SHORE PROTECTION WORK AT EAST COAST PARK AND PASIR RIS PARK IN SINGAPORE

ABSTRACT

Keywords: Headland, beach and geotextile containers

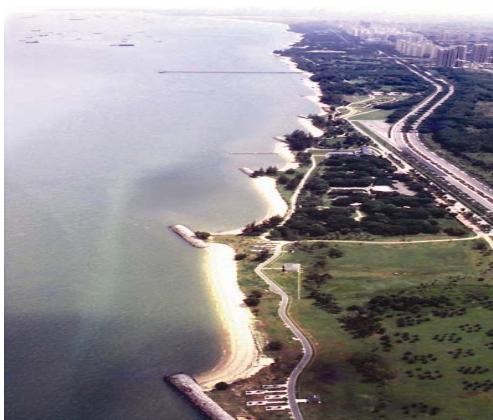
Fig. 2 Aerial view of bay beaches

An aerial view of bay beaches at East Coast Park is shown in Fig. 2. In the past, all headland breakwaters have been designed using rock materials and occasionally with pre-cast concrete blocks.

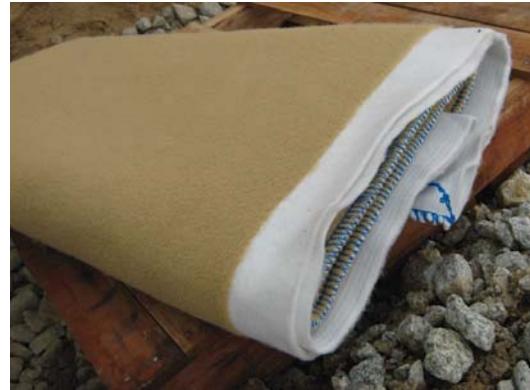
As the external geotextile containers are exposed to the environment, the materials must be durable to protect the in-filled materials from breaking out, thereby compromising the overall stability of the revetment system. With this in mind, the geotextile containers are designed to consist of 2 layers of geotextiles. The outer layer geotextile with higher ultra-violet (UV) resistance will function as a protection and sacrificial layer. In addition, the color of the outer layer geotextile is chosen to blend well with the surrounding beach environment. As for the internal geotextile containers, since they are fully covered without exposing to the sunlight, their material has been design with non-woven geotextile. A close up view of the geotextile is shown in Fig. 6.

Fig. 6 Close up view of geotextile

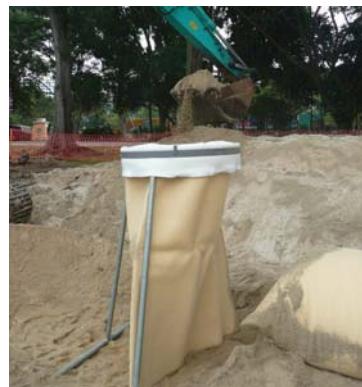
In the geotextile container revetment work, the most critical activity is the filling up of the geotextile containers. To facilitate the efficient way of the filling operation, An A-frame as shown in Fig. 7 was fabricated to hold the geotextile container in an upright / opening position.

Fig. 7 A-Frame holding geotextile container

This equipment was found to be effective and efficient in expediting the filling operation with minimum workforce.

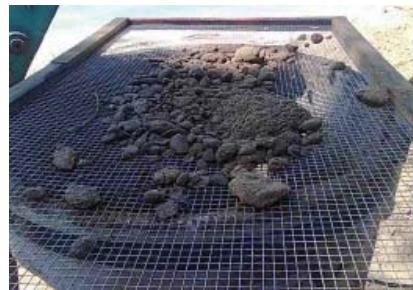
It was also discovered that some foreign materials, i.e. stone and soft lumpy clay were unintentionally enter into the container. To prevent this, an improvised metal grating as shown in Fig. 8 was place on top of the A-frame to sieve out the unwanted materials.

Fig. 8 Metal grating sieving out unwanted materials

This gadget has shown to be effective in removing foreign materials and hence ensure the quality of the in-filled geotextile container. Otherwise, the presence of foreign materials would hamper the overall long term performance of the container system.

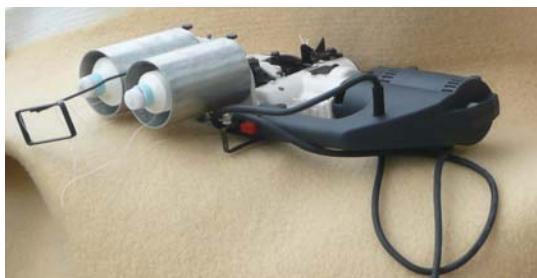
Once the container has been filled up to the required height, the container must be sealed to prevent the in-filled materials from leaching out. A mechanical device as shown in Figure 9 is used to stitch together the open edges of container.

Fig. 9 Hand-held stitching machine

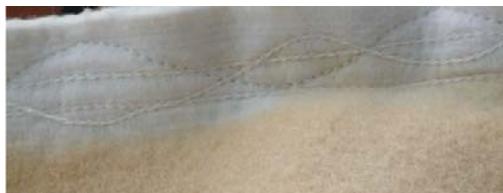
To ensure the stitched seam is robust to prevent leaching and vandalism, the project team together with the contractor and his supplier had deliberated and agreed on the method of closing the seam. The pattern would be to provide two parallel stitches 80mm apart running along the open edge followed by 1 ‘sine-wave’ stitch line intersecting the 2 parallel stitch lines with a distance between 2 peak points about 200mm, and a final diagonal locking stitch at the two corners resulted in a properly sealed container. Stitching is a critical step in the quality control of the final product, to ensure consistency; the stitching work was carried out by a designated staff that has been trained for the assigned task. All completed in-filled geotextile containers were inspected by the site supervisors before installation. Special instruction was given to the contractor to place the newly stitched end of the containers to face inward. This arrangement as shown in Figure 10 would help to prevent exposing the seam unnecessary.

Fig. 10 Stitch pattern

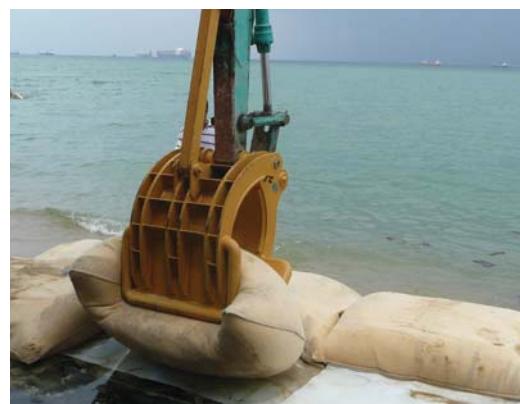
Having completed the design and taken all the necessary precautions during construction, it is important to ensure the geotextile containers are being handled in the most delicate manner to prevent damaging the materials or causing the seams to overstress and burst up during installation. The contractor has employed a specially manufactured equipment as shown in Figure 11 to handle the geotextile containers. The purposed built grab is fitted to the excavator and is designed to spread the stress evenly across the contact surface of geotextile container during handling thereby facilitate accurate placement. The quality finished work on site provided full evident of the effectiveness of the equipment to be employed.

Fig. 11 Grab of container

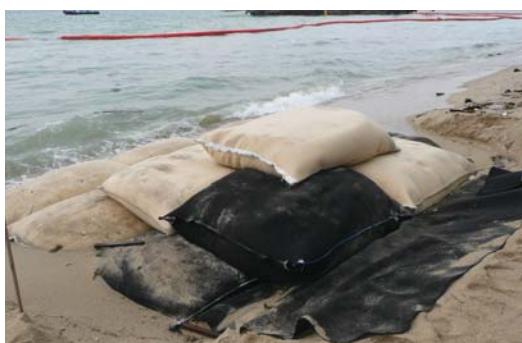
the completed structure and enhance the system's stability through interlocking of the geotextile containers. The completed section of the geotextile containers is shown in Fig. 12. The off-white geotextile containers are double layer and are placed externally to protect the black containers as mentioned in the previous section on Design Considerations.

Fig. 12 Typical laying pattern of geotextile containers

The geotextile containers are placed against each other in a regular pre-determined configuration. The upper geotextile containers is straddled across two geotextile containers beneath. The recommended pattern would help to minimize uneven settlement of

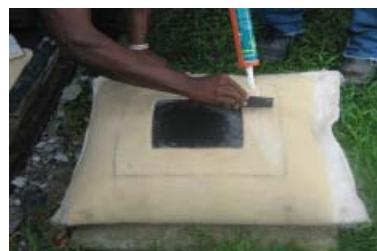
After which, the sealant is applied along the edge of black geotextile and on top of geotextile container within the marked area (see Fig. 13c).

Fig. 13c Applying sealant

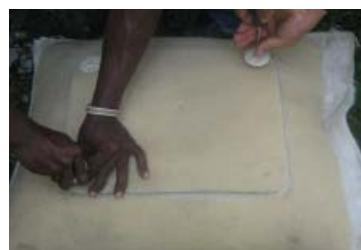
Lastly, the second piece of geotextile is placed on top and secured by the 4 plastic screws (see Fig. 13d).

Fig. 13d Geotextile secured by screws

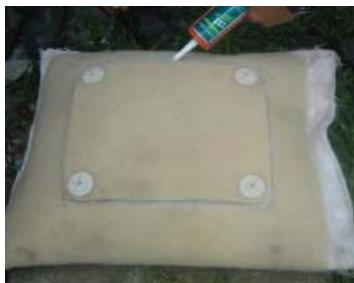
Sealant is applied along the edge of the geotextile to seal the void (see Fig. 13e).

Fig. 13e Apply sealant

The above repair procedures are effective and easy to follow. These have been accepted by Client and Surbana and are documented in the Maintenance Agreement when the situation calls for it to be carried out.

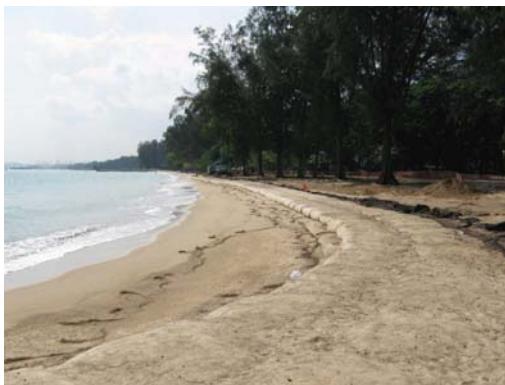
Shore of Singapore ECP and PRP are found to be an acceptable option of shore protection structure. It is able to blend pleasantly with the sandy beach as shown in Fig. 14. The completed structure is soft and flexible that poses a lesser risk against injury from falling and unintentional contact as compared to hard stone revetment. It also does not absorb heat so readily. With the step like stacking arrangement, the completed structure provided the public an attractive resting and recreation point between the beach and Parkland. The performance of the geotextile containers will continue to be monitored closely. If these are found to be durable, it provides the engineering consultants with alternative method for shore protection in Singapore.

Fig. 14 Geotextile revetments at ECP of Singapore
