# Reuse of ribbon archs as reinforcement element in retaining walls with face made by concrete blocks

**ABSTRACT:** This paper shows a retaining wall construction with face made of concrete blocks without grouting utilization, and stability analysis. It reused polyester ribbon as reinforcement element in soil for minimize building cost of this kind of building and decrease environmental impact, the reuse of polyester ribbon reduces waste production of difficult decomposition. A prototype was built in order to prove that is possible and practicable the building of this type of structure and the execution was based in parameters applied in soil reinforcement program. The prototype was built with a factor of safety of 2, for agree to the stability for execution of permanent buildings, and was applied overload on the structure made of soil, verified the expected good behavior of the retaining wall, supporting an overload of 24 kN. Besides, tensile strength tests on the ribbon used in the building allowed compare the value adopted as real resistance value reached by the ribbon tested and them these data comproved the experiment efficiency.

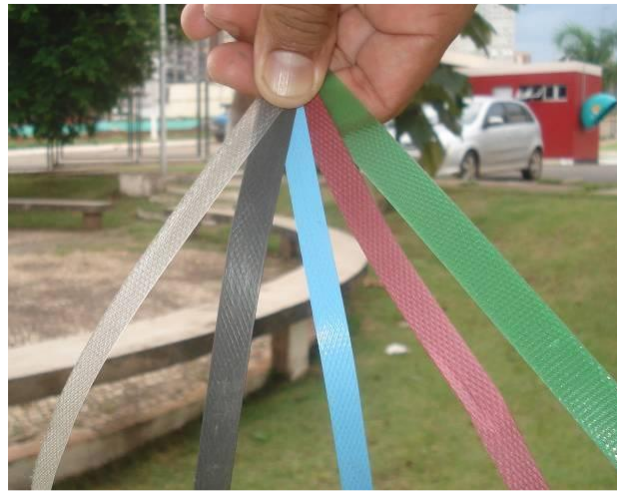
Figure 1. Tapes in various colors and widths.

The idea for the development of this work originated from the observation of a considerable number of arching tapes that are dumped into the environment. These tapes have high strength and can be found easily in construction sites, transportation company areas or even in industrial areas, as they are used to "tie" or wrap boxes, concrete blocks, among other uses. They can be found in several colors (Figure 1), widths and strengths, which provides in relation to the latter, several possibilities of applications of this material as a reinforcing element in the soil. In addition, they can be of the smooth or rough type (Figure 2), providing greater interaction with the soil.

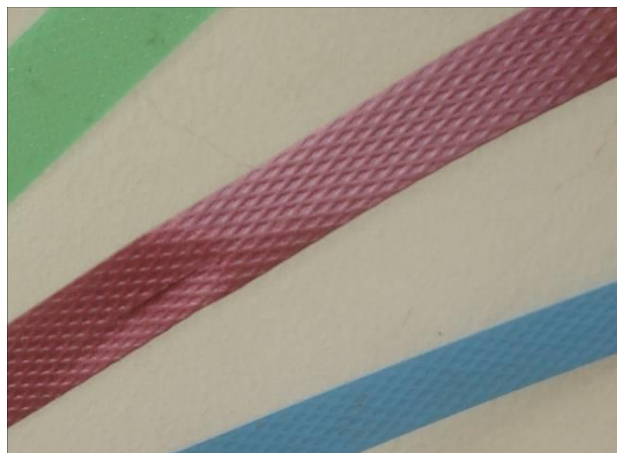
Figure 2. Detail of the arching tape rugged.

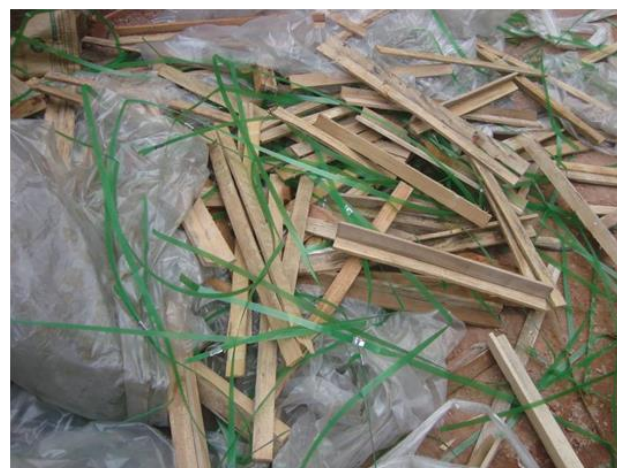
Figure 3. Discarded tapes in the works of Águas Claras, Federal District (DF).

Figures 3 and 4 show arch discs discarded on construction sites and road margins.

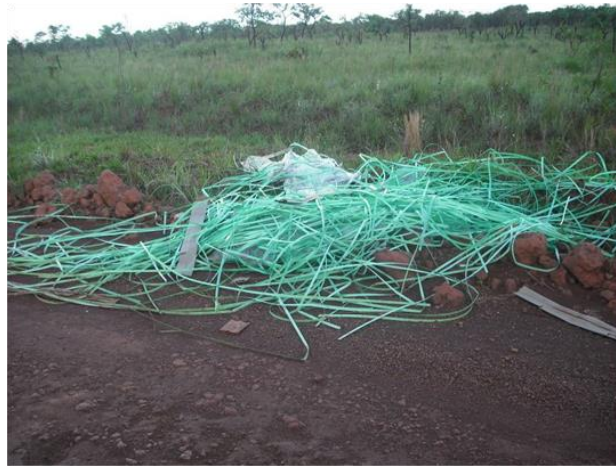
Figure 4. Discarded tapes on the banks of the National Park of Brasília / DF.

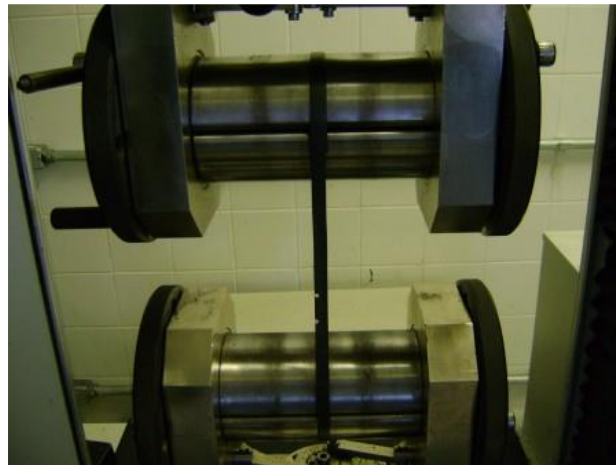
Figure 5. Execution of the tensile test on the arching ribbons.

A sample of the arching tape used in the execution of the experiment was sent to Maccaferri do Brasil, a unit in Camaçari, Bahia, to perform tensile strength (kN) and strain (%) tests. Figures 5 and 6 show some moments of performing this test.

The tensile tests were carried out on 6 samples of the arching ribbons. After the test, the data obtained according to Tables 1 and 2 were presented.

For the data entry in the equipment, the original values of the width and thickness of the samples were used. Thus, at the end of the test, the equipment provides the values of the maximum strength, tensile strength, strain obtained, tensile strength at 2; 5; 10 and 12%.

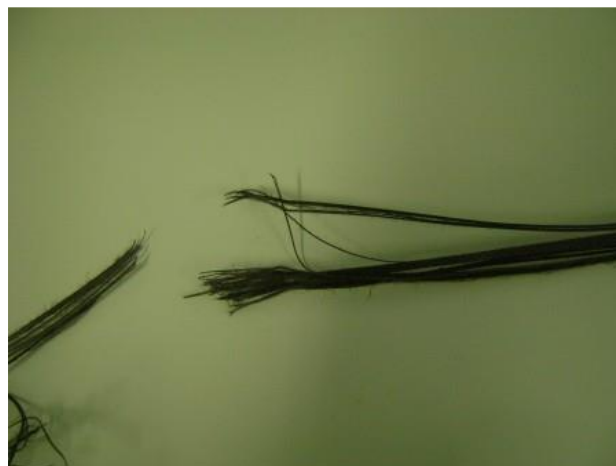
Figure 6. View of the broken tape in the tensile test.

The tapes used in the test were considered to be high strength and were only 13 mm wide.

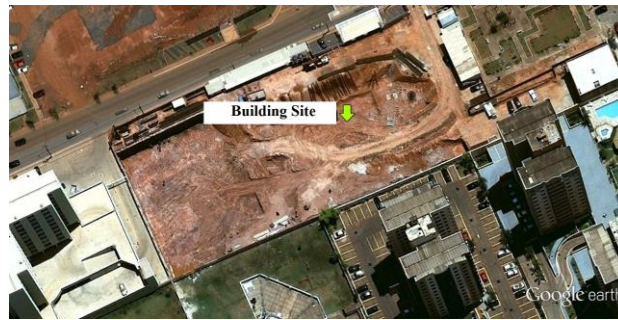
Figure 8. View of the execution site of the wall.

The site used for the construction of the reinforced wall was in a work in Águas Claras / DF, located near Avenida Araucárias (Figures 7 and 8).

The wall was built next to the drilling hole SP9 indicated in figure 9, and the soil found from the fourth meter of the drilling hole (Table 3) was a moist purple silt and, from that point was the execution of the wall containment.

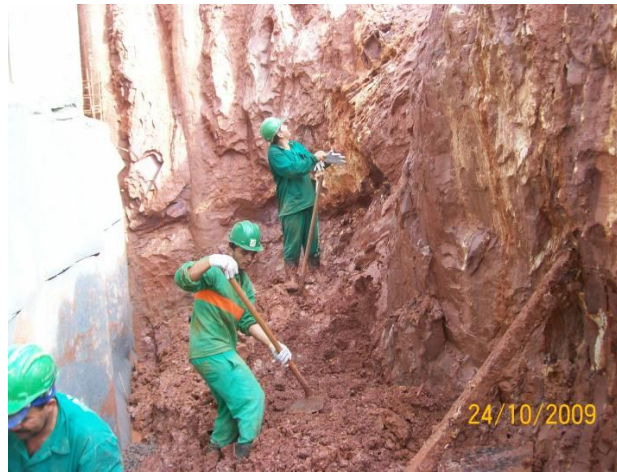
Figura 12. Remoção de terra e regularização da área utilizada para a construção do protótipo.

The execution of the reinforced wall, started with remotion of the surplus soil, then the slope was lateralized that laterally side the wall on the inner side, right side (Figure 12), using manual equipment, type pick.

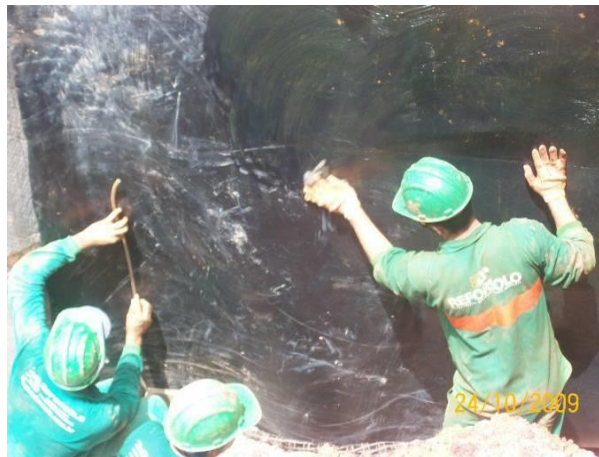
Figura 13. Aplicação de graxa na geomembrana de PEAD disposta verticalmente.

The area of 2.5 x 2.9 m, which served as the basis for the landfill and construction of the wall was compacted with mechanical equipment, type compactor frog. Then, a greased HDPE geomembrane was fixed in the contacts with the sides of the wall to be executed, in order to avoid lateral interactions with the adjacent soils (Figure 13).

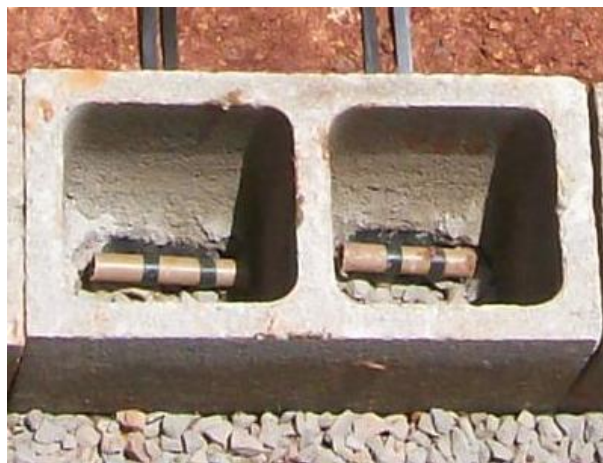
Figure 15. Fixing detail of PVC pipes, arcing tape and concrete block.

After leveling the ground, the first row of concrete blocks was set, with the bottoms (bottom) broken, for proper fittings with PVC pipes, as fasteners of the arching tape. (Figures 5 to 16).

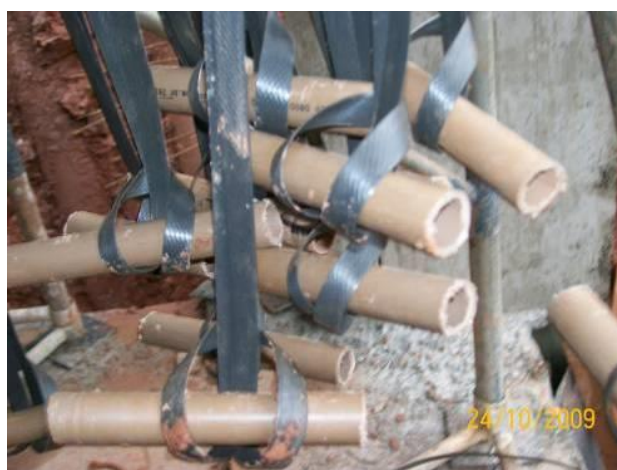
Figure 16. Views of the mooring of PVC pipes.

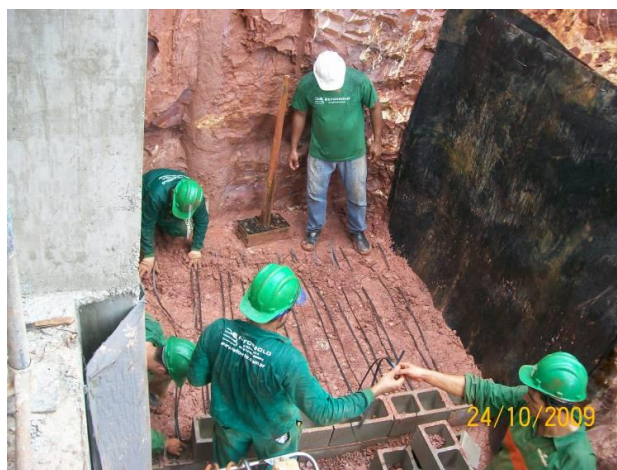
Figure 17. Application of the arching tapes in the second layer.

After the completion of this step, the landfill of the posterior layers was performed (Figures 17 to 19).

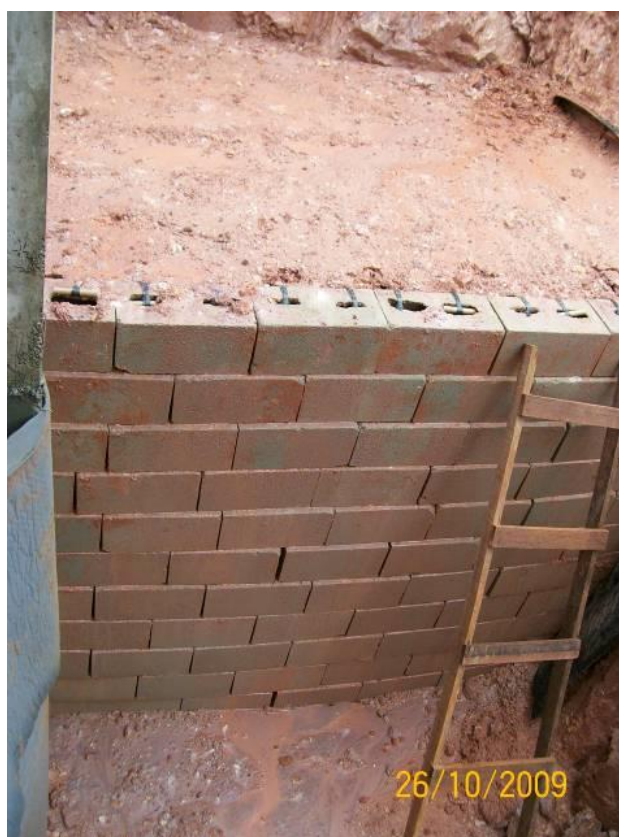
Figure 19. Finalization of the prototype.

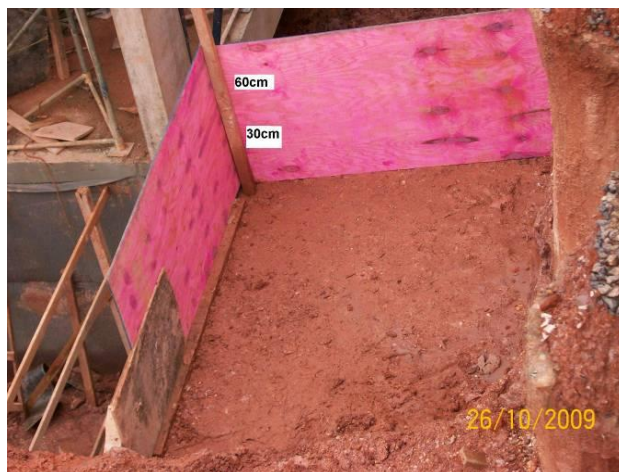
Figure 20. A wooden structure, mounted on a retaining wall, to contain a soil load (overload).

After the finalization of the retaining wall, and without major visual deformations in the interval of 1 (one) day, an overload of 1.50 meters of compacted soil is carried out on the finished containment structure (Figure 20).

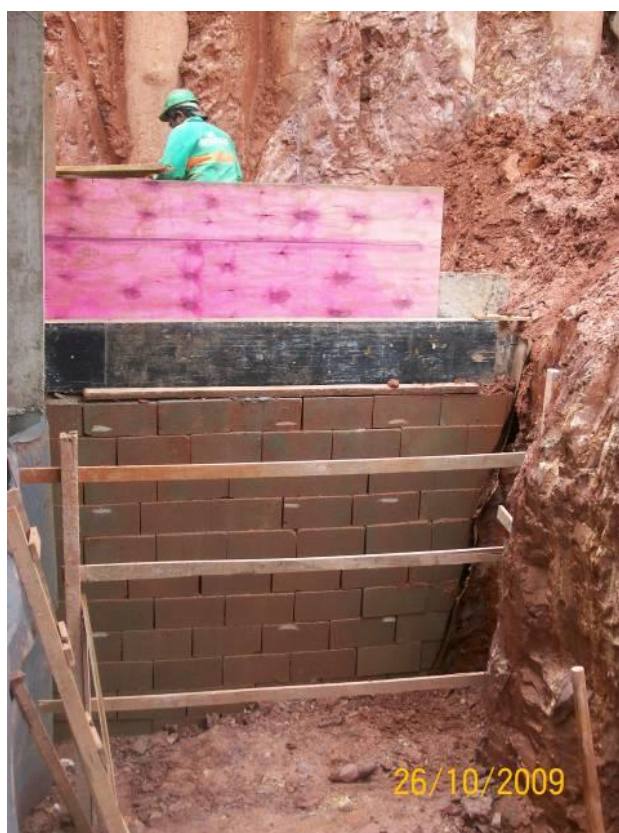
Figure 21. View of the wooden jig mounted in front of the wall.

To measure the deformations, a wooden jig was mounted in front of the retaining wall (Figure 21), to enable measurements of the deformations in the wall.

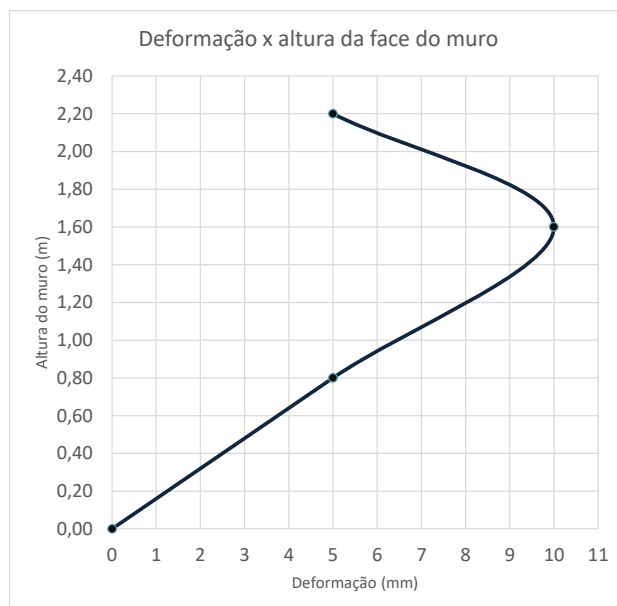
Figure 22. Measured deformation on the face of the wall.

The measurements showed little variation during the execution of the wall, so that the vertical alignment underwent minor adjustments during the laying of the blocks. However, when the overload was applied, considerable deformations were observed. This is due to the fact that in the sizing this increase of load was not predicted.

Figure 22 shows the maximum deformations, measured on the face of the wall, at 0.0 m (at the foot of the wall), 0.80 m high, 1.60 m high and at the crest; after the execution of the overhead of 1,50 m of height of ground placed on the wall constructed with arching ribbons.
