# Innovative Geosynthetic Technology Saves 100-Year-Old Panama Canal Locks

T. C. Stephens, TenCate Geosynthetics, Bedford, Virginia, USA

## ABSTRACT

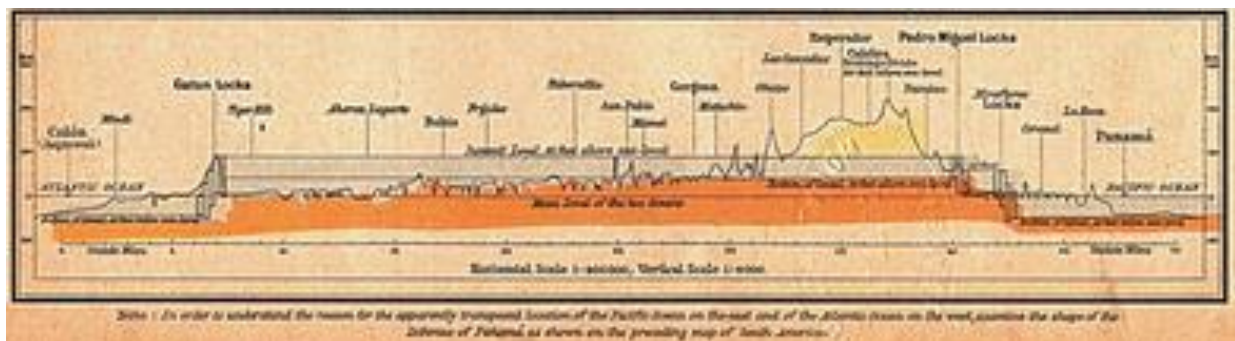
The new US design required three sets of locks. The Gatun Locks with three sets of parallel chambers would be constructed on the Atlantic side. The Pedro Miguel Locks with one step of parallel chambers and the Miraflores Locks two sets of parallel chambers would be built on the Pacific side. Each chamber would be 33.5 meters (110 ft.) wide by 305 meters (1,000 ft.) long. The Gatun Locks would raise or lower ships 26 meters (85 ft.) to and from the Atlantic Ocean allowing ships to transverse over the continental divide. The Pedro Miguel and the Miraflores Locks would raise or lower ships 26 meters (85 ft.) to and from the Pacific Ocean. The first concrete was poured at the Gatun Locks in August 1909. The final set of locks were completed four years later in May 1913. At the time of their construction, their overall mass, dimensions and innovative design surpassed any similar existing structures, and they are still considered to be an engineering wonder of the world. However, time, the environment, and shipping technology have taken a toll on these magnificently designed yet simplistic operating structures.

Figure 2 The 1907 US Design for The Panama Canal

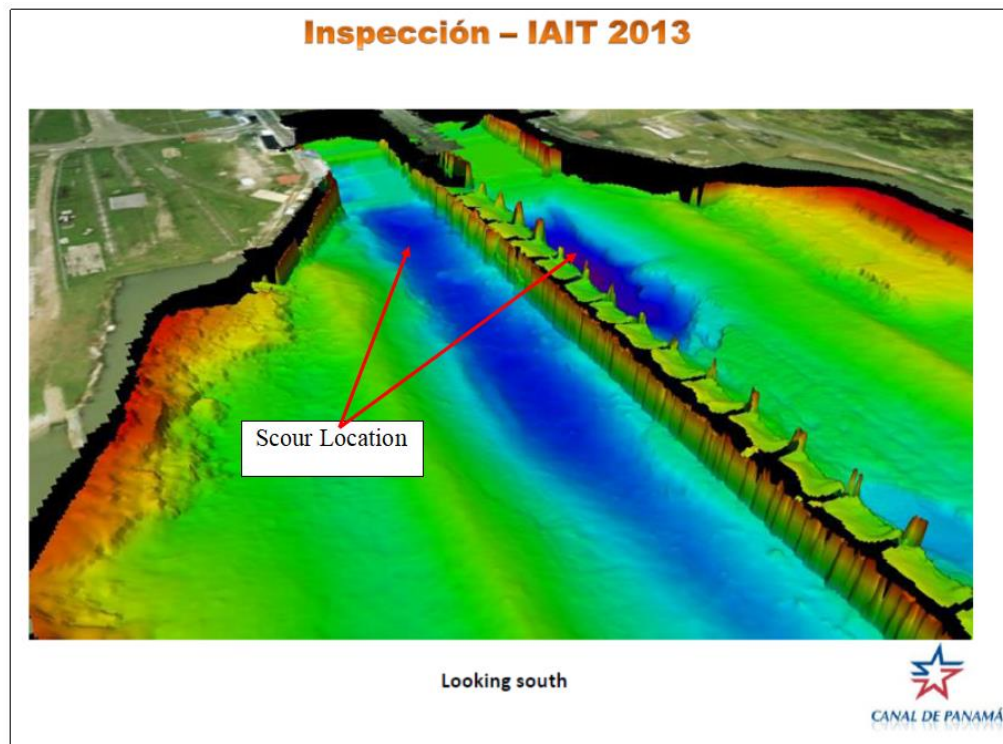
Figure 4 Erosion Scour at Gatun Locks Atlantic Entry

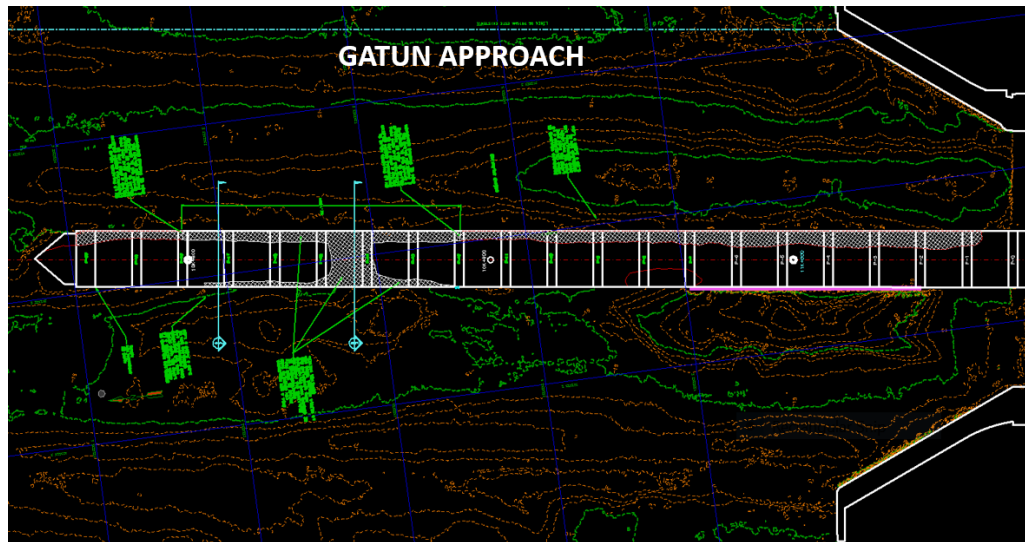
After construction, the Panama Canal was administered by the United States until 1979 when the Canal Zone was transferred to Panama and it has since been administered and operated by the Autoridad del Canal de Panamá (ACP). The ACP Engineering and Maintenance Division has insured that the canal has been continually operated under safe conditions with modern upgrades and expansions. In December 2013 the ACP Engineering and Maintenance team conducted the annual comprehensive sonar investigation of the entrance and exit of each chamber of all three sets of locks. It was discovered that there were numerous areas of erosion scour that were occurring at the leading edge and under the approach slabs, along the dividing wall foundations, and around the base of several wing walls. This erosion was significantly more advanced and extensive than had been observed in previous years as detailed in Figures 4. The worst areas of erosion scour which were occurring at the Atlantic entrance to the Gatun Locks approach slab and dividing wall. These areas were monitored every month during 2014. In early 2015 ACP determined that the scour areas were continuing to progress, and two areas were becoming critical. Figure 5 details the extent of the erosion under the Gatun Locks Atlantic dividing wall in July 2015.

Figure 5 Dividing Wall Erosion Scour Areas of Concern in 2015

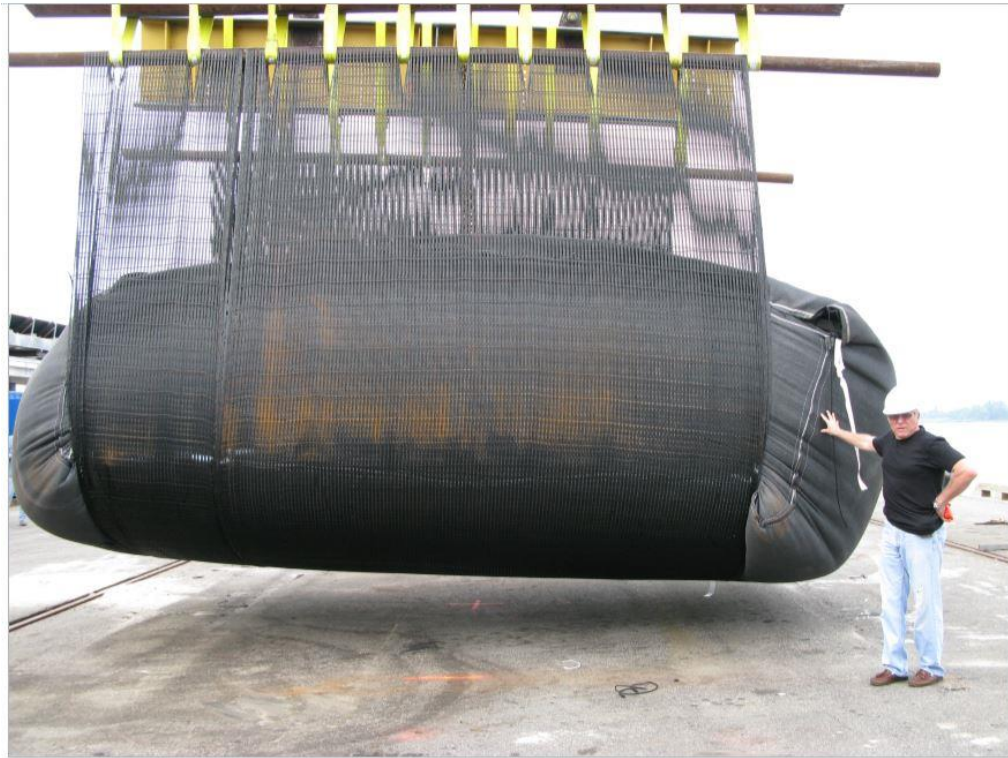
TenCate had previously developed the system of filling, lifting, and placing 50m<sup>3</sup> (65.4 yd<sup>3</sup>) sand filled Geobag® containers weighing 90 metric tons (99 Imperial tons). See Figure 6. The bags were fabricated from a 200 kN/m (1,142 lb./in.) woven polypropylene geotextile in a 5.0m wide x 5.0m long x 2.0m high (16.4 ft. long x 16.4 ft. wide x 6.56 ft. high) configuration. The bag had a top lid that was open for filling with sand and could be closed and mechanically sealed to permanently contain the sand. A unique 400 kN/m (2,284 lb./in.) friction geogrid harness was designed to provide a flexible system of lifting and placing. See Figure 7 for the calculations of the Geogrid Friction Lifting Harness Pull Out Resistance and Figure 8 for the Geobag strength and factors of safety. The keys were: 1.) to have a barge mounted crane that could lift and place these Geobag containers as required within the Panama Canal Locks, 2.) that these Geobag containers were massive enough that the propwash of 4,400 HP tugs could not move the 90 metric ton (99 tons) Geobag containers, and 3.) yet to be flexible enough to contour to the eroded bottom of the canal to protect against future erosion scour.

Figure 6 First Test Lifting of the 50 m3 Sand Filled Geobag Container weighing 90 Metric Tons

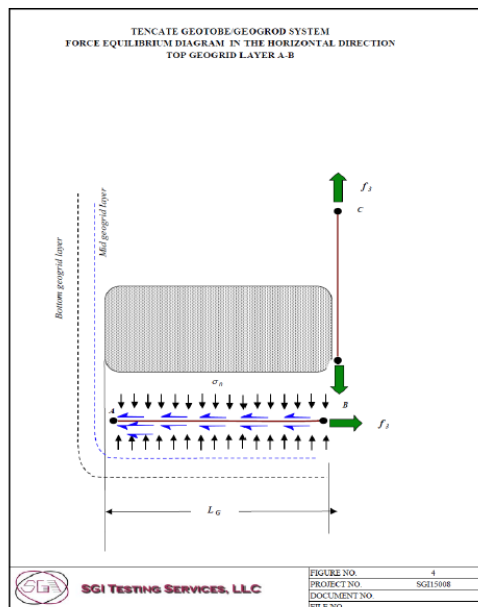
Input Data		
Project:	Ocensa - oleoducto Central	
N1 Total Gravity Force of Geobag Container	882.90	kN
N2 Total Gravity Force of Geobag Container	0.00	kN
Embedment Length, $L_{AB}$	5.00	m
Geogrid Width, $W_G$	5.00	m
Pull Out Force, $f_1$	220.73	kN
Average Geogrid/Geotextile/Geogrid Interface Normal Stress	35.32	kPa
Apparent Friction Coefficient (Top Geogrid Pullout)	0.36	
Apparent Friction Coefficient (Mid Geogrid Pullout)	0.32	
Output Data		
Pull Out Resistance $P_{AB}$	600.37	kN
Factor of Safety against Top Geogrid Pullout	1.44	FS
Factor of Safety against Mid Geogrid Pullout	1.28	FS

Figure 7 Geogrid Friction Harness Pull Out Resistance Calculation

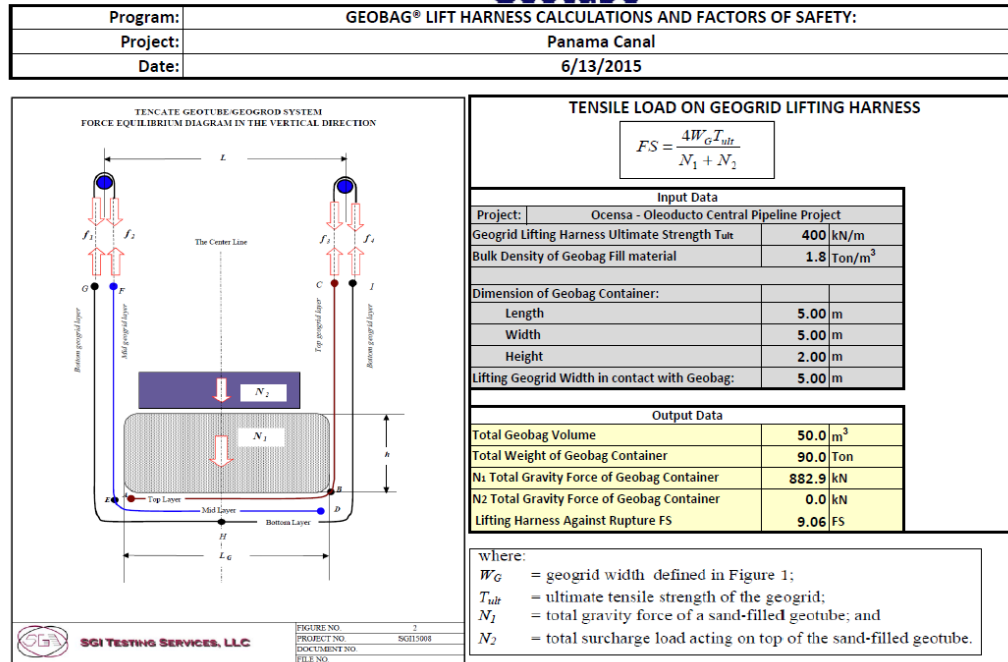
Figure 8 Geobag Calculations

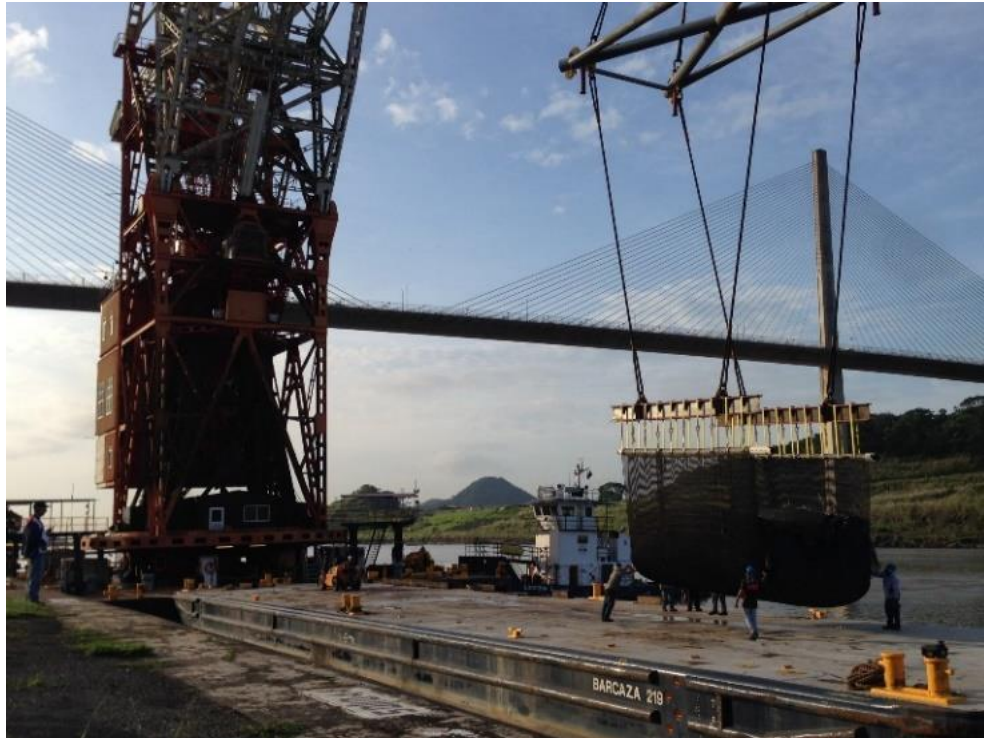
Figure 9 The 300 Ton Crane Placing the 90 Ton Geobag® Containers on Transfer Barge

The ACP determined that the Geobag® filling operation would be conducted at an ACP maintenance dock facility adjacent to the canal near the Gaillard Cut. The ACP 300 metric ton (330 Imperial ton) Titan barge mounted crane lifted the sand filled 90 metric ton (99 Imperial ton) Geobag containers on to a transfer barge that was moved to the Gatun Locks to be ready to start as soon as the 12-hour maintenance window opened. See Figure 8. The first repair was to the scour erosion underneath the approach slab to the left chamber of the Atlantic approach to the Gatun Locks. The scour was the entire 33.5m width (110 ft.) of the slab down to a depth of 4.0m (13.1 ft.) below the slab and 8.0m (26.2 ft.) underneath the slab. This repair would require constructing the coffer dam using 10 or 12 of the 90 metric ton (99 Imperial ton) sand filled 50m<sup>3</sup> (65.4 yd<sup>3</sup>) Geobag containers. See Figure 9 for the first Geobag® placement using the 300 metric ton (330 Imperial ton) Titan barge crane. Figure 11 is the engineers sketch of the first 8 Geobag® positions as they were placed and the position of the Geobag® #9 and #10 that are to be placed. It only took 10 bags to form the coffer dam and all were placed within the first scheduled 12-hour maintenance window that was a nighttime operation. During the next month's 12-hour nighttime maintenance window more 300 m<sup>3</sup> (393 yd<sup>3</sup>) of concrete was pumped behind the Geobag coffer dam and under the approach slab to fill the scour void under the slab.

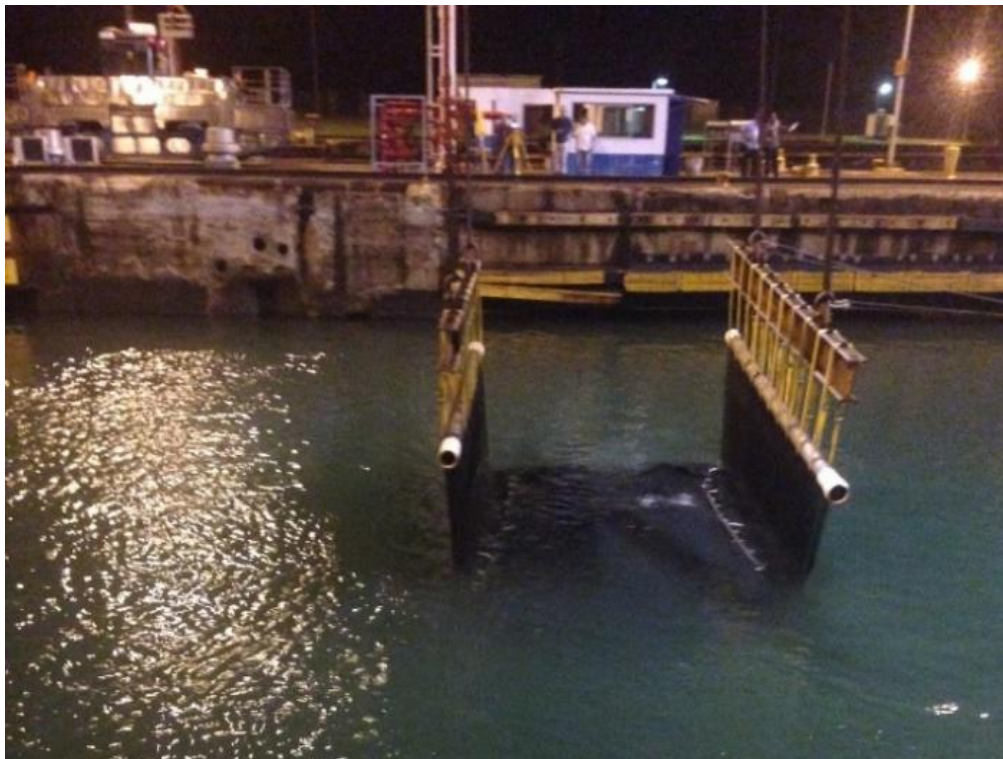
Figure 10 Placing the first 50m3 Geobag® in the Bottom of the Gatun Locks

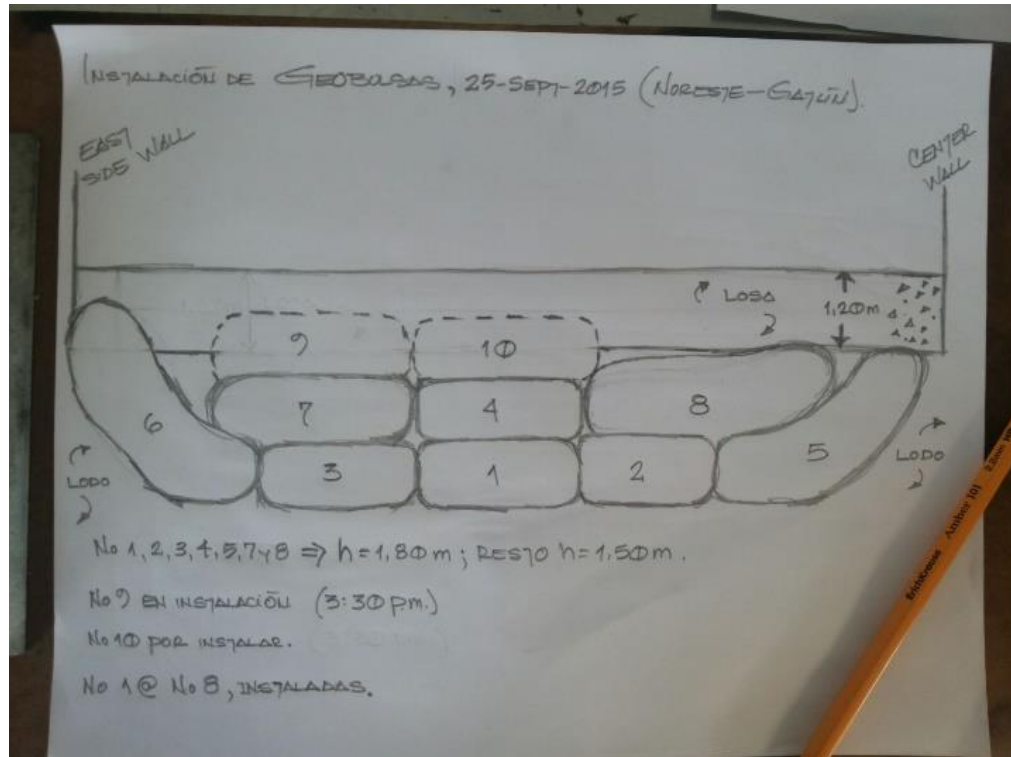
Figure 11 Engineers Drawing of Geobag® Placement

The solution called for an underwater coffer dam to be installed adjacent to the base of the concrete structures under which erosion scour was occurring. The coffer dam would be formed using large flexible geosynthetic Geobag® containers that would be filled above water and lifted and placed underwater with a crane. Once in place, concrete would be pumped behind the coffer dam filling the void caused by the erosion scour. This could be a two-step process; Step 1) construction of the underwater coffer dam, and Step 2) filling the void with concrete. Each step would be performed separately during successive scheduled 12-hour maintenance windows.

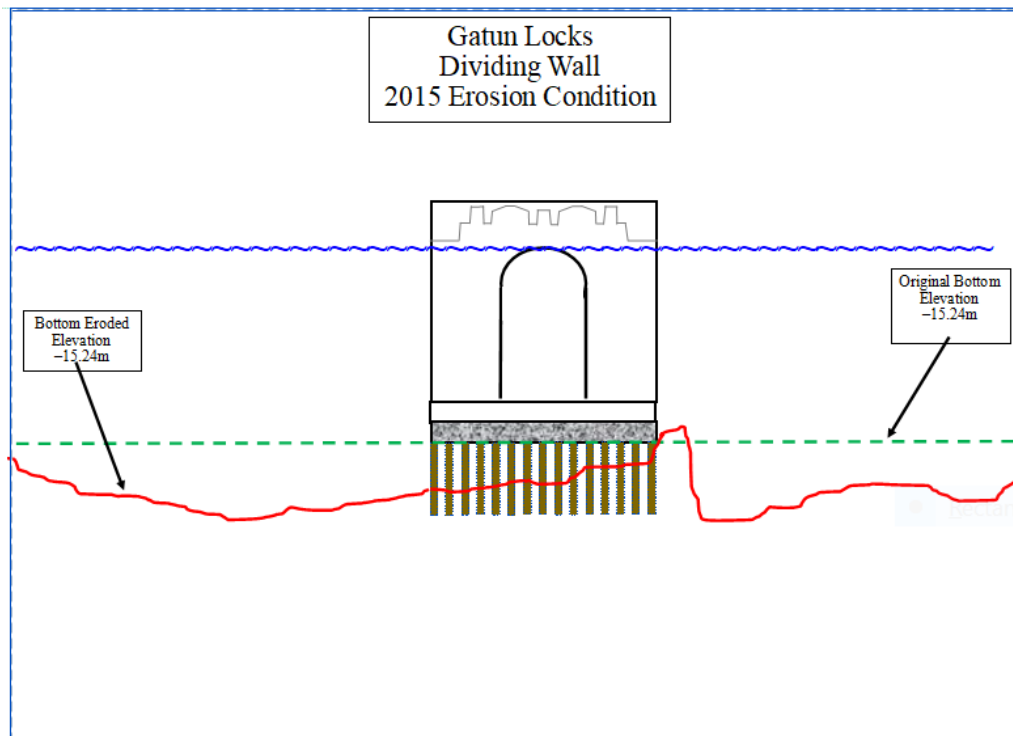
Figure 12 Cross Section of Gatun Locks Dividing Wall Before Repair

This same procedure was followed to make the scour erosion repair to both sides of the dividing wall to the approach to the Gatun Locks as detailed in Figure 12, 13, and 14. The same methodology was followed to perform similar repairs to the Miraflores and Pedro Miguel Locks. Figure 15 details how the Geobag coffer dam functioned in retaining the pumped concrete under the canal entry slabs, dividing wall and wing structures.

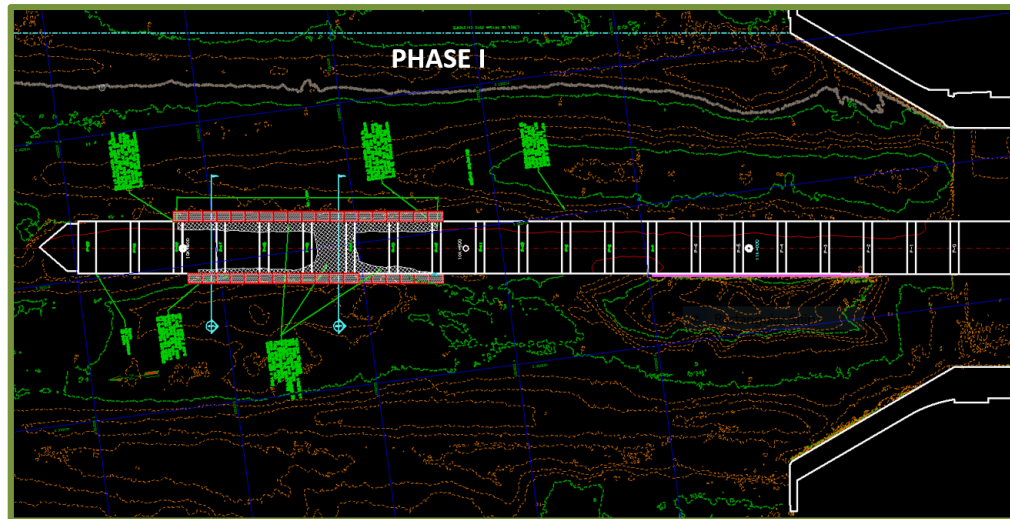
Figure 13 Phase 1 Repair to the Gatun Locks Dividing Wall

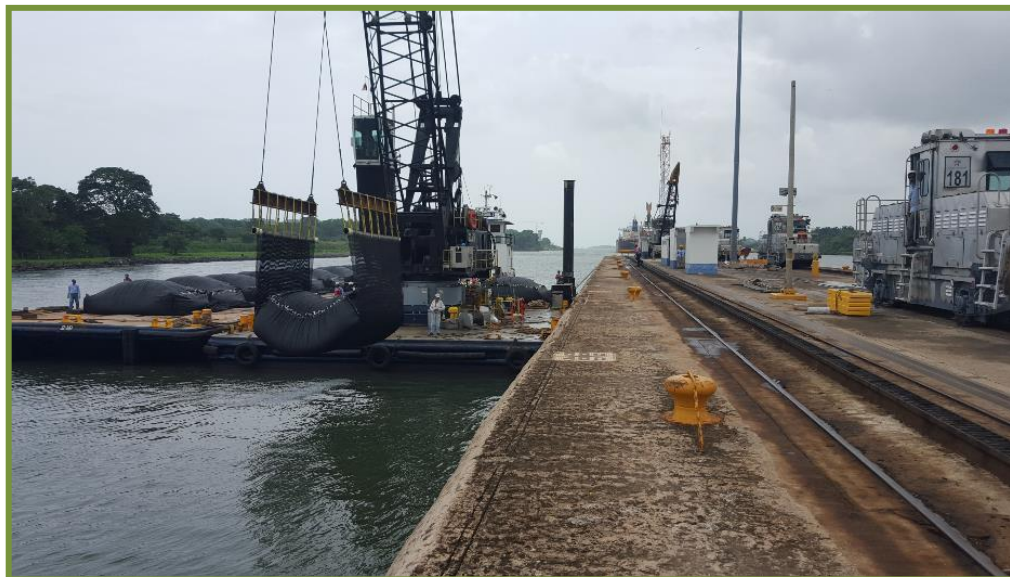
Figure 14 Installing Geobag® Units Along Gatun Locks Dividing Wall

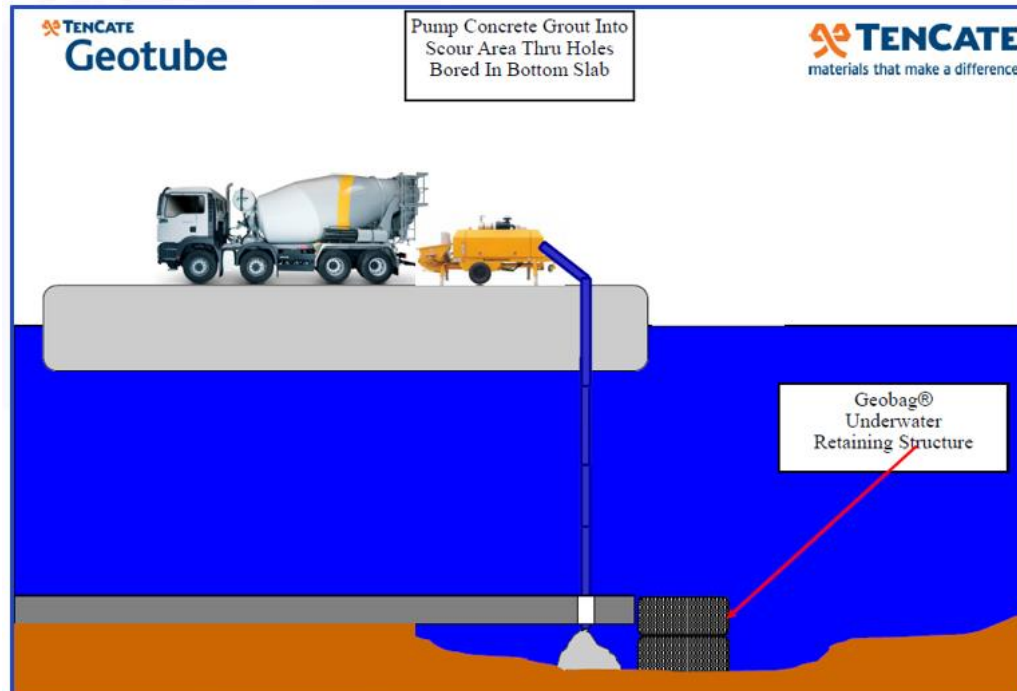
Figure 15 Method of Repair to Scour Erosion Under Slabs and Dividing Walls
