## Case Study - Reinforced Soil Wall with Geogrids at Hillside Using Volcanic Tuff as Filling Material

Guillermo Paz, Master in Soil Mechanics and Geotechnical Engineering 2019 (CEDEX - UNED), Spain.

This document presents a case study of a project in Honduras of a mechanically stabilized earth wall with geogrids, which was built on a hillside for a widening of the road in one of the most important stretches of the country's roads.

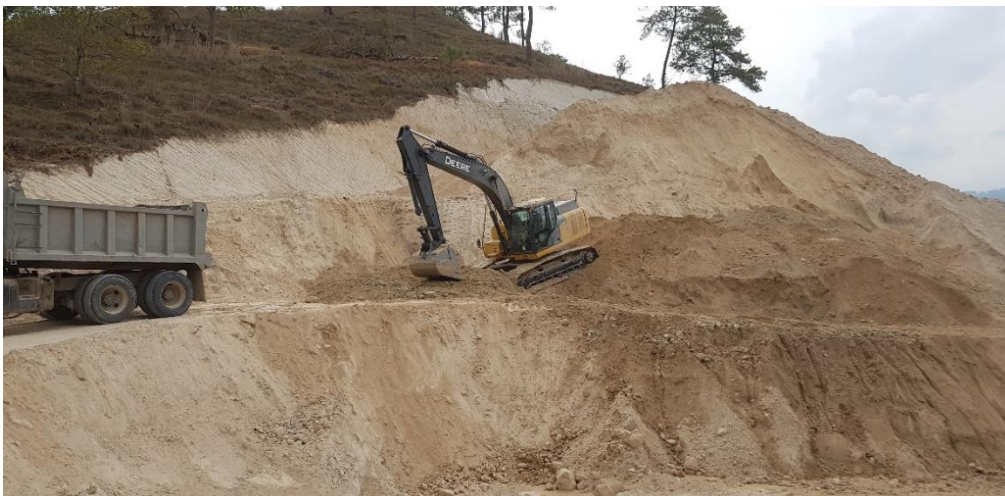
The filler material used (Figure 2) was a tuff, taken from a borrow pit located 12 km away from the construction zone. Its geotechnical parameters are shown below in Table 1:

Figure 2. Borrow pit 12+700 (volcanic tuff)

- The comparison between the filler material used from the 12 + 700 borrow pit and the SIERRA borrow pit produce a significant effect on the calculation of the value of the safety factor) due to the global stability of the mse wall in the dynamic analysis. By not including the natural guard at the foot of the mse wall, we eliminated a counterweight that could possibly reduce the destabilizing forces increased by the heavier specific weight of the SIERRA material ( $21 \text{ KN/m}^3$ ) in comparison with the volcanic tuff who has a lighter specific weight ( $14 \text{ KN/m}^3$ ). Even though the SIERRA material has a better workability for the compaction process, the volcanic tuff represented a better option in factor of safety terms.

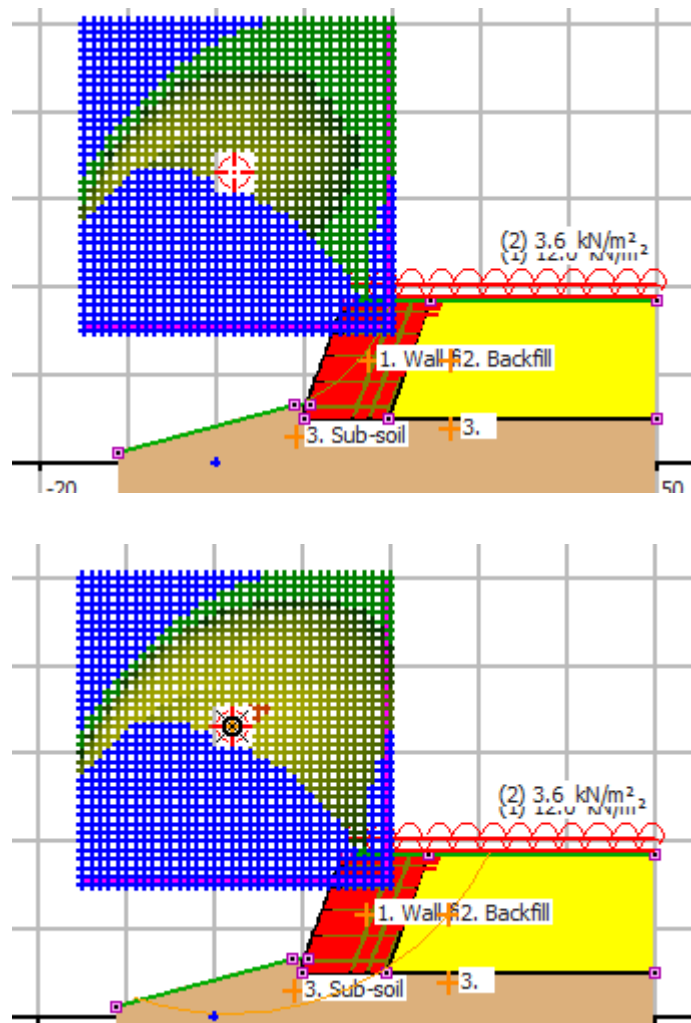
Now, using the Sierra Bank and varying the values of friction angle ( $35.3^\circ$ ) and specific weight ( $21\text{KN/m}^3$ ), the following results are obtained as follows in Figure 6:

Figure 6. Global stability analysis of static (minimum FS 1,311 > 1.3, OK) and dynamic scenarios (minimum FS of 1,051 < 1.1, failed).

With this results, it can be infer that with a heavier material as concrete (specific weight = 24 KN/m<sup>3</sup>), a failure due to global stability might happen if a concrete wall is used.

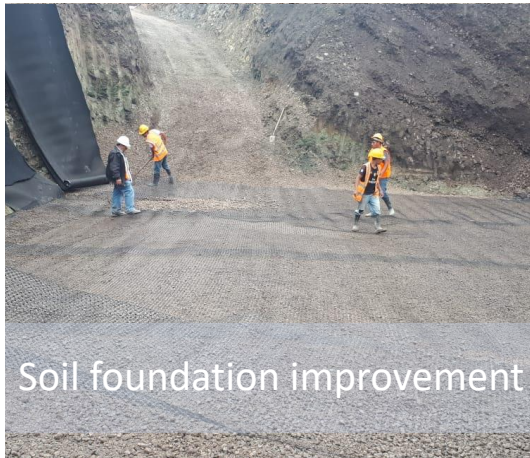
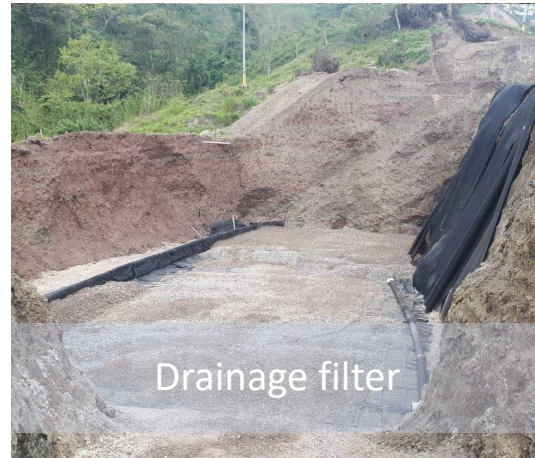
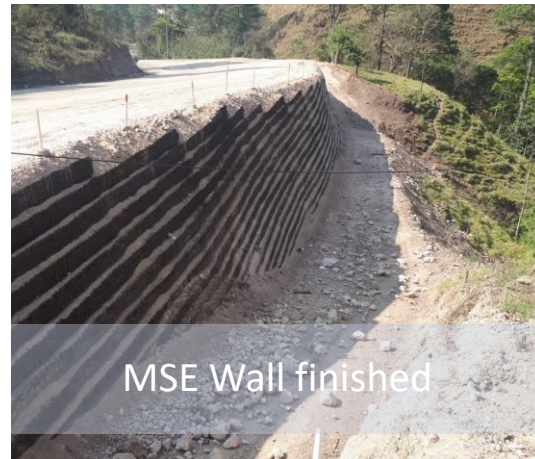
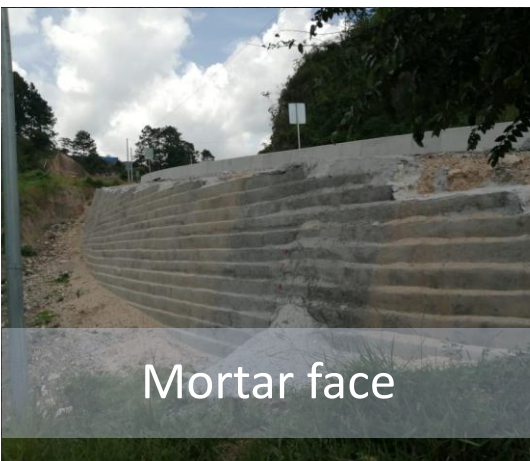
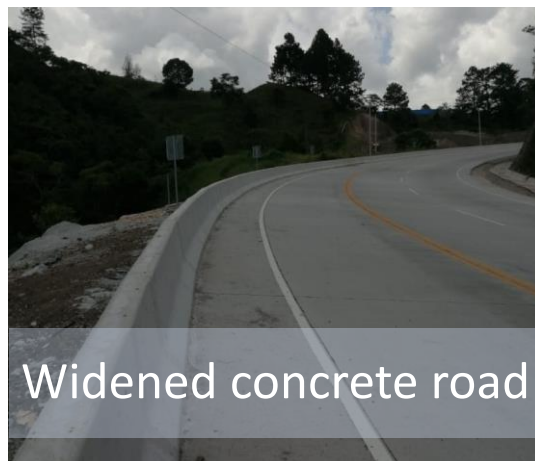
Once this stage was completed, the 50 cm thick draining filter basket was placed. On top of this layer, the crushed gravel is protected by placing a blanket of non-woven geotextile and the placement of reinforced material baskets vertically spaced every 50 cm begins. The reinforced filling is compacted with a compaction energy of 95% of the Modified Proctor with the maximum density values of 14 KN/m<sup>3</sup> and an optimum humidity of 23.4%. The construction process is shown in Figure 7 below:

Figure 7. Construction process of the MSE wall reinforced with geogrids

The construction of the wall was done in 3 months. To do this, the first step was improved the conditions of the foundation ground. In this phase, a ground improvement was made by placing 2 layers 50 cm of crushed gravel reinforced with triaxial geogrids with the aim of reducing possible differential seats and thus improving the bearing capacity of the foundation soil.
