Use of Enhanced Lateral Drainage Geotextiles in a Pavement Founded on Expansive Clays

M.M. Azevedo, Jacobs Engineering (Portland, Oregon, USA) and The University of Texas at Austin
J.G. Zornberg, Department of Civil, Architectural, and Environmental Engineering, The University of Texas at Austin, Texas, USA

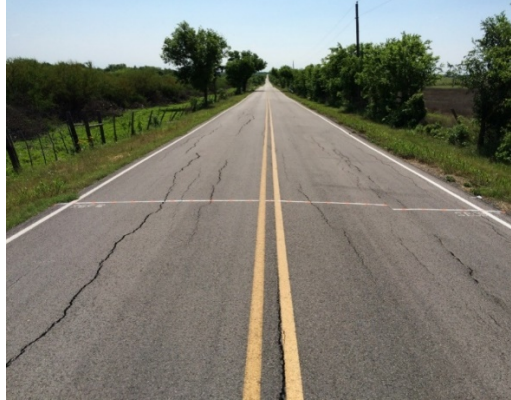
The main distress associated with pavements founded on expansive clays is environmentally induced longitudinal cracks near the shoulders of pavements. Figure 1 shows a typical pavement section founded on expansive clays. Damages induced by expansive clay are identified by multiple parallel longitudinal cracks near the pavement shoulders.

Figure 1. Typical longitudinal cracks related to expansive clays in pavements

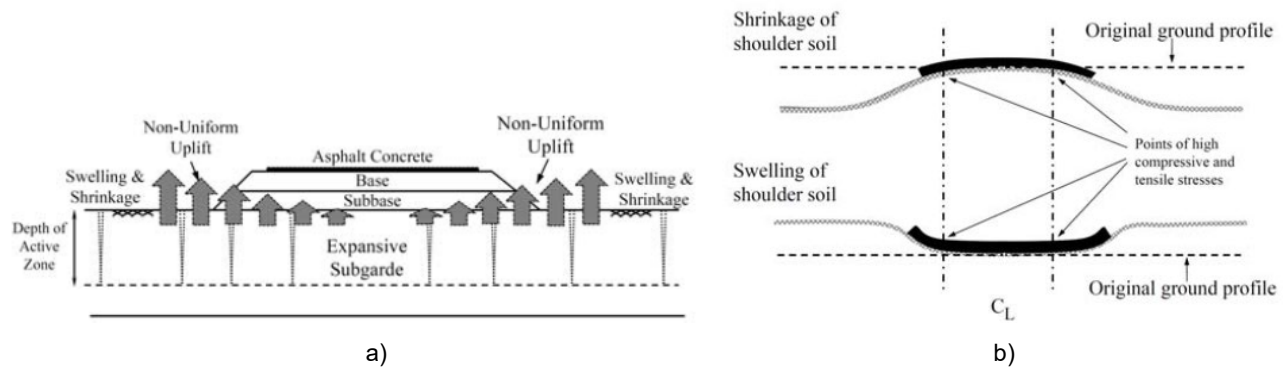
The mechanism instigating expansive clay related pavement distress is induced by seasonal wet and dry cycles. The environmental moisture variations due to these rainy or dry periods may lead to different values of moisture content in the center of a pavement than at the shoulder. As shown in Figure 2a, the shoulder of a typical pavement will have more access to moisture from the environment. On the other hand, it is unlikely that moisture will migrate to the center of the pavement. Therefore, the edges of the pavement will shrink and swell due to moisture fluctuations, while the center of the pavement will not. Cyclic wet and dry seasons cause the pavement to swell during moist conditions, and shrink during dry periods. This repetitive shrink-swell behavior creates a non-uniform uplift between the center and shoulder of the pavement. As shown in Figure 2b, this differential settlement creates zones of high stresses that manifest into longitudinal cracks (Roodi & Zornberg, 2012). During particularly long periods of drought, multiple parallel significant longitudinal cracks may occur due to the severe shrinking of the soil in the pavement shoulders (Zornberg et al., 2010).

Figure 2. Diagram of pavements founded on expansive clays, (a) non-uniform uplift caused by uneven moisture distribution, (b) zones of high stresses where longitudinal cracks appear (Roodi & Zornberg, 2012).

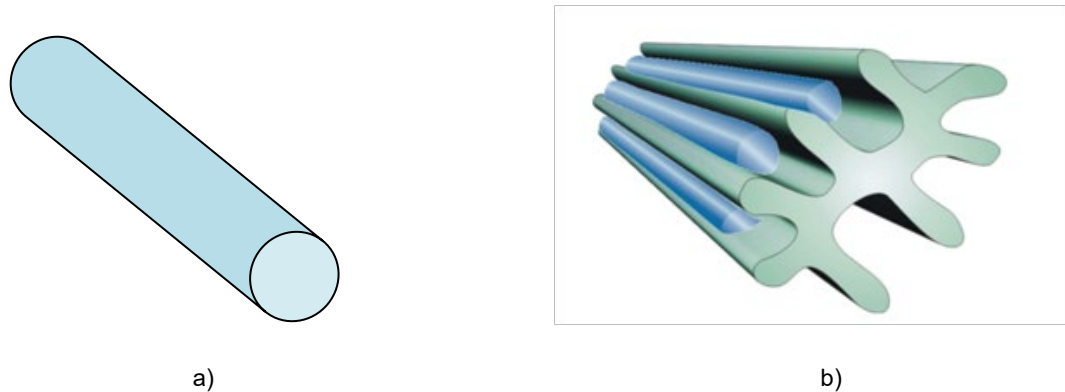
The enhanced drainage capacity of the IPED geotextile utilized in this study is provided by special grooved nylon fibers woven into the geotextile. Figures 3a and 3b display both a typical fiber present in standard geotextiles and a grooved cross-section that would be present in an IPED geotextile, respectively. The nylon fiber was developed with a unique grooved cross-section. The unique fiber cross-section shown in Figure 3b has deep grooves that allow for water to be carried by channels along the longitudinal axis of the fiber. The nylon fabric is both hydrophilic and hygroscopic. That is, the nylon will pull water from the surrounding soil as well as provide a conduit for the moisture along its channels. The channels provide some moisture storage as well, but since the channels are not large, their main function is to transport any absorbed water laterally. The channel width between the grooves is approximately 8 μm to prevent clogging from larger particles. Each grooved yarn is bundled into a strand of approximately 150 fibers.

The grooved fibers shown in Figure 3b can be substituted for the standard monofilament fibers in a conventional woven geotextile. In this case, the drainage capability of the woven geotextile is increased by allowing for transmission along its

Figure 3. Geotextile fiber cross-sections, (a) typical monofilament fiber and (b) grooved cross-section to allow moisture transmission along the fiber.

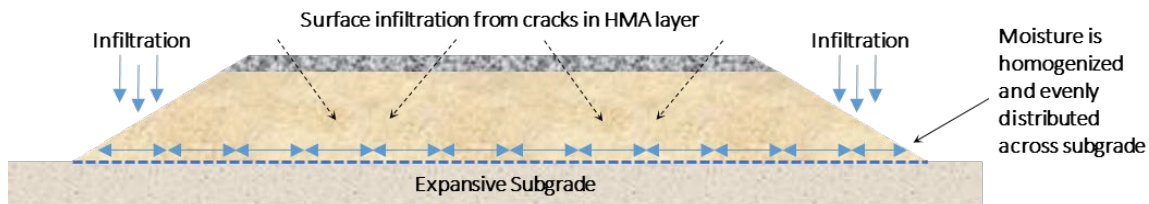
The objective of this study was to construct multiple test sections along a pavement founded on expansive clays to observe how an IPED geotextile may reduce the consequences associated with the shrink-swell behavior of the expansive clay subgrade soil in comparison to conventional geotextiles. The mechanism for mitigating shrink-swell related damage in pavements is associated with the ability for the IPED geotextile to transport water along its plane. Figure 4 illustrates the effect of placing an IPED geotextile at the interface of the base layer and an expansive clay subgrade. Theoretically, the geotextile is able to homogenize the distribution of water along its entire length. Accordingly, while moisture variations may still occur closer to the pavement edge, the IPED geotextile may facilitate migration of moisture under unsaturated conditions, resulting in a comparatively uniform moisture distribution across the width of the pavement structure. In the subgrade, this improved uniform moisture distribution will minimize differential vertical movements in the pavement and thus mitigate the development of longitudinal cracking. That is, while an IPED geotextile may not prevent a soil from shrinking or swelling, the shrink-swell behavior is expected to be uniform which will reduce the differential movements that lead to cracking.

Figure 4. Moisture homogenization in expansive clay subgrade by IPED geotextile

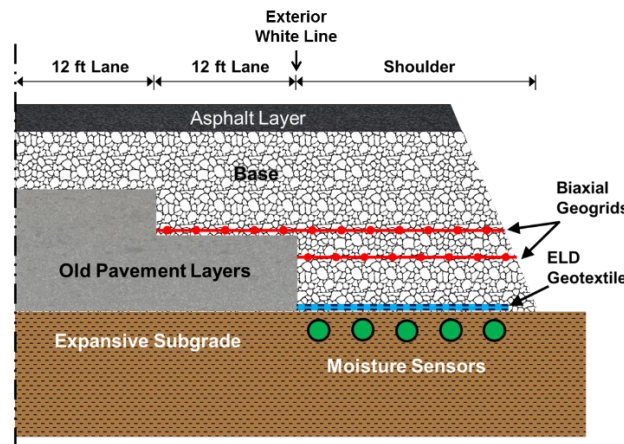
TxDOT developed a pavement design to rehabilitate this poorly performing section of SH-21. A cross-section of the reconstructed pavement in the area where the test sections would be constructed is shown in Figure 5. The rehabilitation plan called for milling the top 3 in of the existing pavement, partially excavating the outside line, and widening of the existing shoulder. Following completion of the excavation process, a 9 ft geotextile was placed on the shoulder of the pavement, and overlain by base aggregate (gravel between 3/8 in and 3 in diameter). At two locations within the base aggregate layer, biaxial geogrids were placed as shown in Figure 5. To complete the pavement, 6 in of cement treated base was added, followed by a 3 in thick layer of hot mix asphalt (HMA), and topped off with a thin overlay mixture.

Figure 5. Reconstructed SH-21 cross section showing moisture sensor locations

It should be noted that the original TxDOT design specified a separator geotextile (GT1) and geogrids as shown in Figure 5. No other changes were allowed or made to the pavement section other than simply substituting GT1 with other geotextiles in the test sections. As shown in Figure 6, each geotextile was 9 ft wide and placed only in the pavement shoulder area, in accordance with the planned rehabilitation project, where the subgrade was exposed in this portion of pavement only. A control section with no geotextile or geogrid was not permitted in any test section.

As part of the evaluation program, moisture sensors were installed in the subgrade at the center of each 500 ft (152 m) long test section to monitor the performance of the geotextiles. These moisture sensors allowed monitoring of changes in moisture content in the subgrade along the road shoulder, where moisture fluctuations were expected to be highest. A horizontal array of sensors was installed 3 cm below the top of the subgrade to evaluate the hydraulic performance of the various geotextiles. The approximate location of the sensor array is displayed in Figure 5.

installed approximately 2 ft apart. Once the sensors were installed, the trenches were backfilled and recompact to the same level as the surrounding soil. Geotextiles were installed above the subgrade by unrolling the product rolls in each test section. After placement of the geotextiles, a layer of base gravel was placed immediately above the geotextiles. Construction continued following the design shown in Figure 5 until all layers of the pavement were installed.

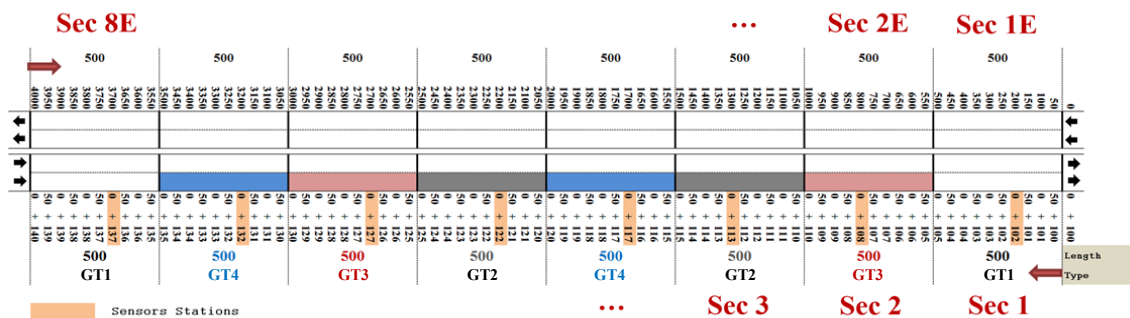
Figure 6 shows the layout of the test sections along SH-21. In total, there are eight sections, and each section is 500 ft in length. A repeat section for each geotextile was constructed along the eastbound side of the highway for reliability purposes. The eastbound section of the highway was only constructed with the control geotextile GT1.

Figure 6. SH-21 test section layout

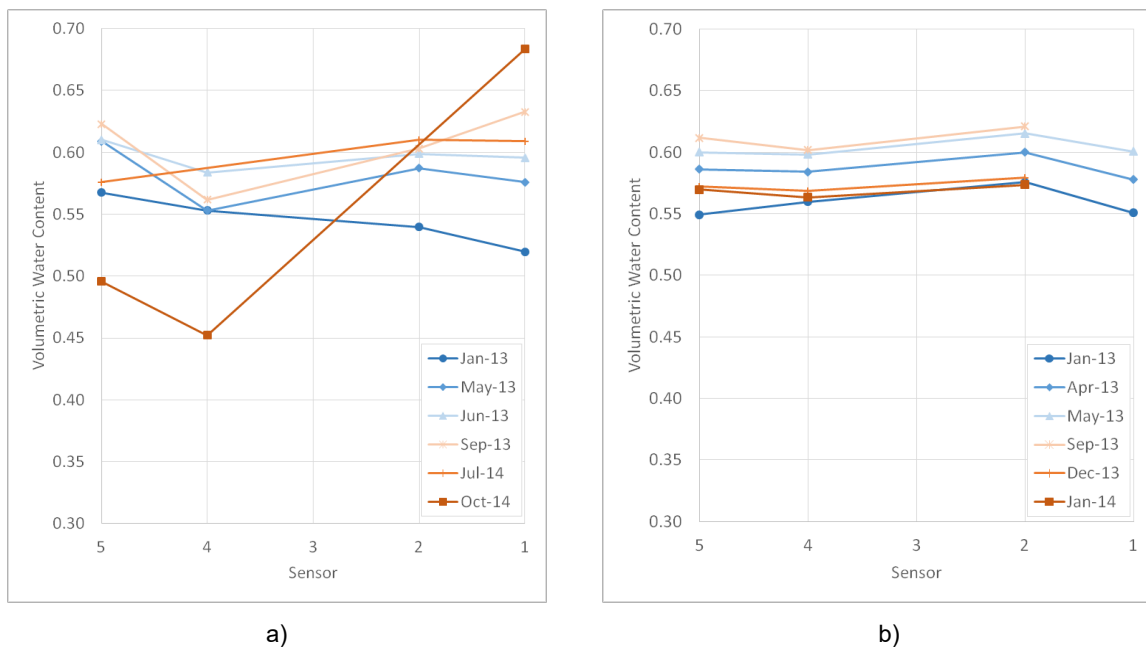
The horizontal moisture sensor array data is shown in the form of moisture profiles. This approach involves taking the average moisture content in a given month for each sensor and plotting horizontal moisture profiles over time. In this manner, the change in moisture content beneath the subgrade at a given time can be visualized. The horizontal moisture profiles for a conventional geotextile section are shown in Figure 7a. The results in this figure show that the moisture content in these sections was rather non-uniform, typically with the highest value toward the pavement edge and lowest value toward the center of the road. In fact, the difference in volumetric moisture content between the edge and the center of the pavement reached values as high as 15%.

Figure 7. Moisture content along SH-21 shoulder, (a) Conventional geotextile section and (b) IPED geotextile section.

Figure 7b displays moisture profiles for a test section in which an IPED geotextile was used. For IPED geotextile sections, moisture content remained relatively uniform over time and across the entire width of the shoulder. Even though changes in moisture content were expected over time because the monitoring period included reasonably wet and dry seasons, the changes were fairly similar across the various monitored locations. Consequently, moisture content distribution remained reasonably uniform at any given time. In this case, the difference in volumetric moisture content between the edge and the center of the pavement remained around 3%.

One of the main objectives of this project was to compare the moisture content distribution in sections with conventional geotextiles and sections with IPED geotextiles. Results from the horizontal moisture content profiles constructed with GT4 (Sections 4 and 7) showed a uniform trend in moisture distribution in the subgrade in those sections. Section 4 started out with generally uniform moisture content, and maintained a similar distribution throughout the recorded data period. When the moisture content values did change for Section 4, all of the sensors in the horizontal array generally recorded the same increase or decrease in water content. This was reflected in the moisture content profiles through a vertical shift in the data. On the other hand, the initial moisture content distribution for Section 7 was highly non-uniform, with an approximately 9% moisture difference between all sensors. However, over time, the difference steadily decreased to 5%, appearing to be on track to becoming uniform. Results from the test sections constructed with conventional geotextiles GT1, GT2, and GT3 did not show any tendencies of homogenizing the moisture content beneath the geotextiles in the subgrade. For those sections, the moisture contents varied inconsistently in the subgrade.

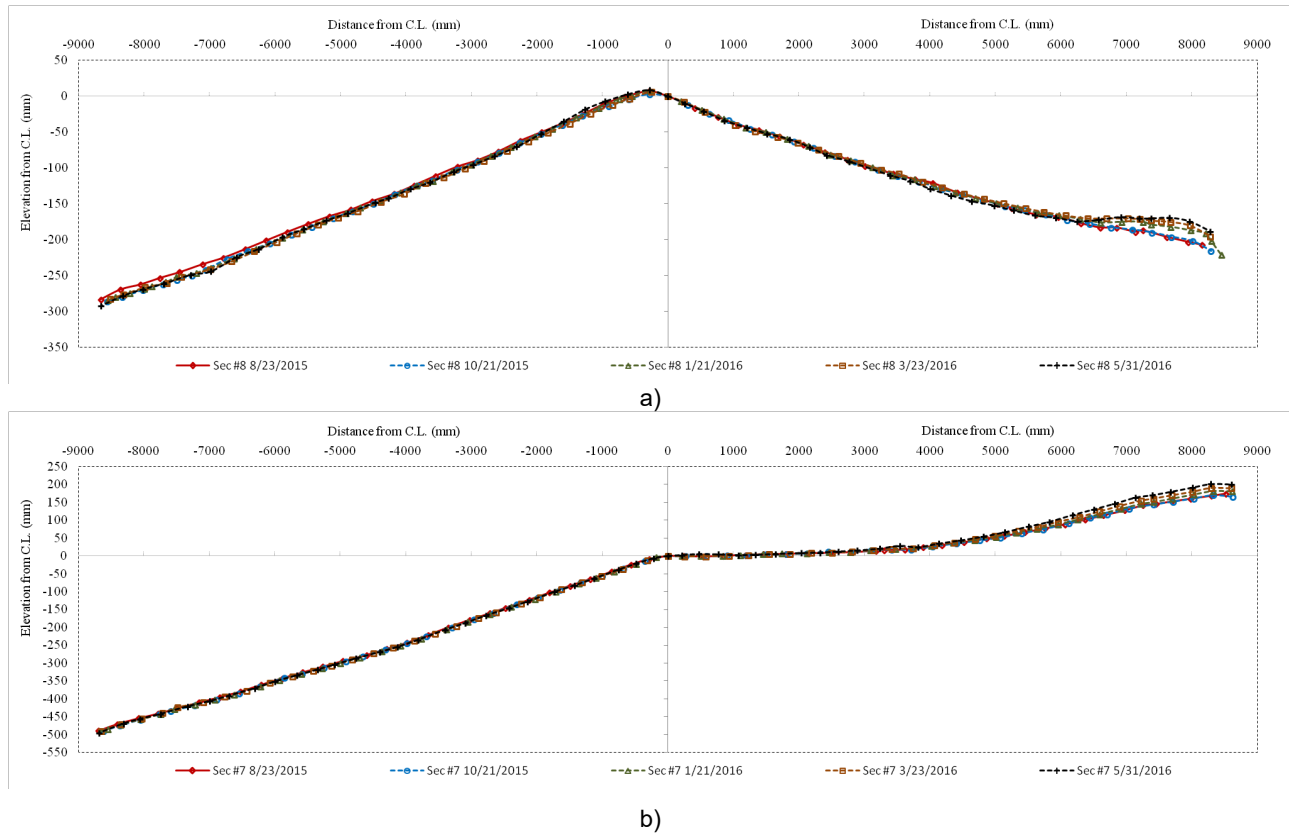
Total station surveys were initiated in August 2015 to monitor any fluctuations in the shrink-swell behavior of the soil. The surveys involved measuring the surface elevation of the pavement at each section with a total station as outlined in

Roodi et al. (2016). By repeating the survey every two months at the same location, a record of changes in the pavement surface profile could be observed. To ensure that readings were taken at the same location each time, permanent markings were painted onto the shoulder of the pavement near the location of the moisture sensor array for each test section. Due to safety concerns, permanent markings were not able to be placed along the width of the road inside the lanes. Instead, a rope with marked 1 ft intervals was placed across the width of the road at the profile measurement location. While the survey points in the inside lanes were not taken at the exact same location each time, the permanent markings on the shoulder provided a few constant survey points. Considering that most of the potential heave or shrink of the pavement was expected to occur in the shoulder, this method was deemed acceptable. Also, survey results showed that even with the slightly different survey points, consistent surface profiles were recorded. Figure 8a and 8b show typical pavement surface profiles for conventional geotextile sections and IPED geotextile sections. For each profile, the eastbound lane corresponds to a negative distance from the pavement center line, while the eastbound lane corresponds to a positive distance from the center line.

Figure 8. Typical total station survey results, (a) Conventional geotextile section and (b) IPED geotextile section.

Even without additional moisture data, the total station survey data provides further evidence of the homogenization of moisture contents beneath the pavement subgrade in the IPED geotextile sections. Profiles for both Section 4 and 7 with GT4 show that the entire pavement shoulder moves uniformly with time. Since total station surveys began in 2015, the shoulders of Sections 4 and 7 were at a consistently higher elevation upon each subsequent survey. Considering that 2015 and 2016 have been abnormally wet years in the area, it is consistent with the nature of expansive clays that the soil may swell under these wet conditions. A few sections with conventional geotextiles also exhibited signs of soil heave. In particular, Section 8 with GT1 showed significant swelling in a portion of the shoulder area. Unlike the sections with the IPED geotextile however, the swelling observed in the shoulder of Section 8 was non-uniform.

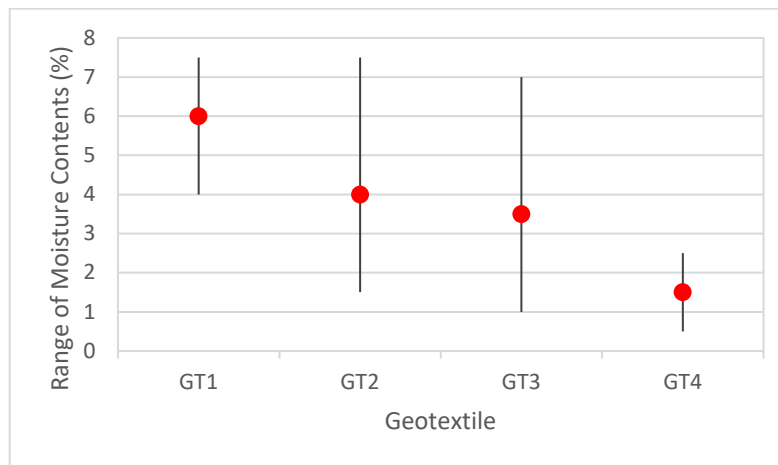
To further illustrate the moisture content differences between each geotextile, Figure 9 was prepared displaying the range of moisture contents beneath each geotextile in the subgrade. The figure shows the average difference in the

moisture contents between the five sensors in each section, along with the minimum and maximum observed difference over time. From this plot, it is clear that the IPED geotextile GT4 has the smallest range of moisture content distributions compared to the other geotextiles. This is indicative that the IPED geotextile may have been able to homogenize the moisture content in the subgrade, as hypothesized. On the other hand, the large range of moisture contents observed in the sections with conventional geotextiles leads to the conclusion that these geotextiles are unable to influence the moisture content distribution in the subgrade soils.

Figure 9. Range of moisture contents for each geotextile
