ASPHALT REINFORCEMENT WITH POLYESTER GRIDS - A PROVEN TECHNOLOGY

Keywords: Asphalt reinforcement, polyester, pavement rehabilitation

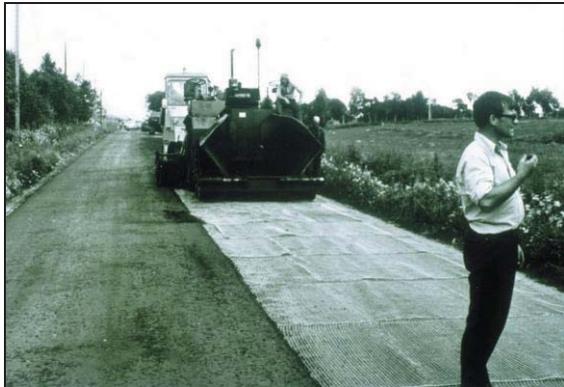
Fig. 1 First use of asphalt reinforcement grid (here HaTelit[®]) at the early 1970s.

The idea of a reinforcing fabric for asphalt road construction first emerged at the early 1970s (Fig. 1). First experiences had been made with Geogrids in Earthworks and Foundations, so the idea had come up to use them in asphalt pavements. The initial intention was that the embedded geotextile layer was able to pick up the tensile stresses in the asphalt and therefore prevent cracks from forming, however, it was soon realised that this principle did not work, but it was soon found that the product proved very useful at delaying the formation of reflection cracks in resurfaced carriageways. Even then polyester was the preferred raw material because of the compatibility of its mechanical properties with the behaviour of asphalt. Since then many products made from different raw materials have been developed.

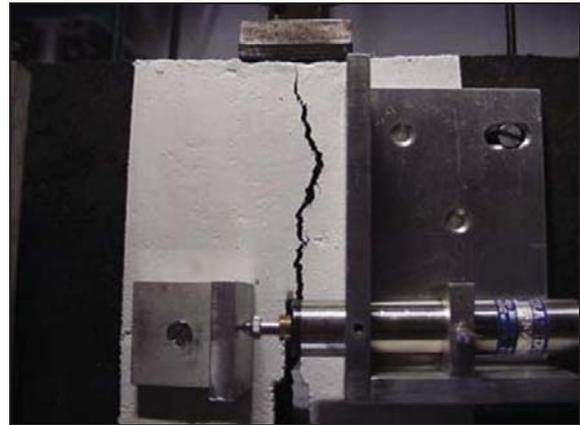
Fig. 3 Unreinforced beam

In beams without a geogrid, the reflective crack came out after a few load cycles. Its growth, in bending and shearing mode, was fast and practically vertical, following the face of aggregates found on the way (Fig. 3). When the reflection crack reached the top of the asphalt beam (7.5 cm) it ruptured and marked the end of the test.

On the unreinforced specimen, with a pre-crack of 3mm, the crack reached the top of the beam after just 79,884 load cycles, whereas the reinforced specimen could resist 477,150 load cycles. With these results a factor of effectiveness was calculated. For the reinforced specimen with a 3mm pre-crack it was calculated to 6.14.

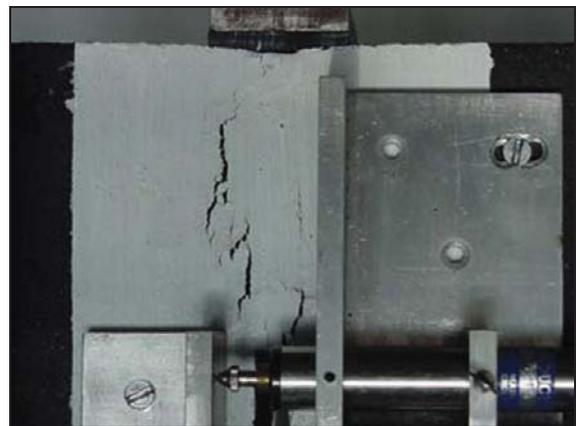
Fig. 4 Reinforced beam

For the beams reinforced with a geogrid, this vertical growth occurred up to 2cm and 3cm, respectively for the less severe case (pre-crack opening 3mm) and more severe case (pre-crack opening 9 mm). Thus, the geogrid reinforcement stops the propagation of the reflective crack. After more load cycles, micro cracks appeared becoming more and more visible, and interconnecting with each other, leading to the formation of new cracks of less severity spread over a greater volume of asphalt concrete (Fig. 4). This fact was observed for the bending load position as well as for the shearing load position. In beams with reinforcement, the test was concluded when only one crack of less severity reached the surface.

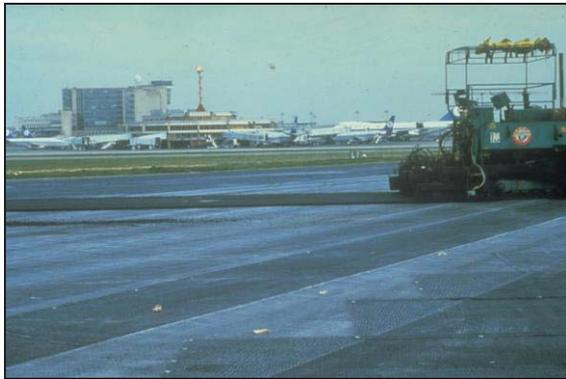
Fig. 5 Installation of the PET asphalt reinforcement 1979

The 45 m wide existing concrete runway at Brussels Airport was showing damage to such a serious extent that a complete refurbishment was considered essential. This was the first time that asphalt reinforcement was used to delay the propagation of cracks at the expansion joints, and in the concrete slabs themselves, through to the surface of an overlay. Firstly 10mm existing asphalt were milled off the runway surface, then any holes broken out of the concrete slabs were in-filled and a bituminous regulating course was applied. A bituminous coated PET Geogrid was then installed as asphalt reinforcement on top of the regulating material.

As the highest loading from landing aircraft occurs in the centre of the runway, just the central 25 m wide strip of the runway was reinforced. The 10 m wide edge zones remained unreinforced. The

whole of the runway surface was then overlaid with a 50mm binder course and a 50mm surface course. The resurfacing works were only required to preserve the use of the runway for two years.

Three years later in 1983, when the first formal assessment took place, it was found that in the unreinforced zones virtually all the expansion joints between the concrete slabs had propagated through to the blacktop surface. In the PET-grid reinforced zone no individual cracks could be seen, even with the highest loads in these sections. The last assessment took place in 1990 (10 years later), the runway was still in excellent condition. Apart from some minor surface treatment, up to then, no further measures had been necessary. As reported by the project engineer Francis Knappenberg (Knappenberg F., 1983) the refurbishment of the runway using a reinforcement grid had been successful!

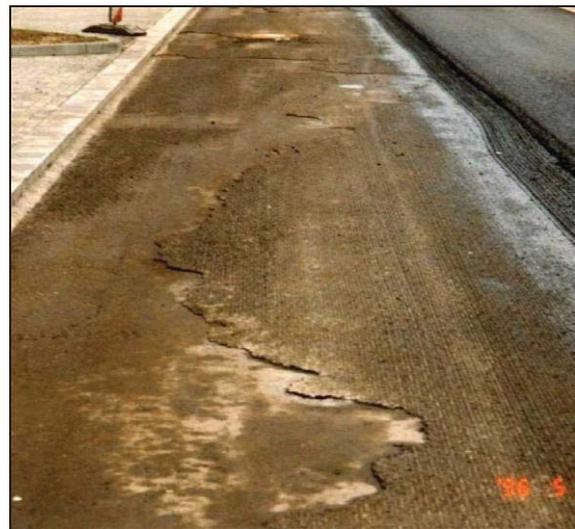
Fig. 6 Surface after milling

After milling off the 50mm surface course a PET grid as asphalt reinforcement was installed, and covered again with a 50mm 0/11 AC asphalt layer. The whole project was finished in summer 1996.

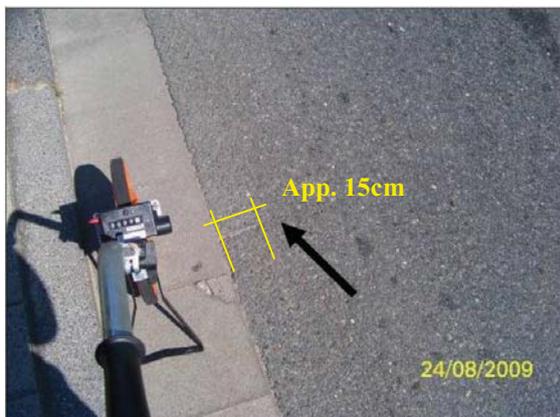
Fig. 7 Lateral crack at the edge

After 13 years of use, the cracking condition value (ZWRIS) for the section of the road repaired with the PET asphalt reinforcement in 1996 was determined as being excellent. According to the LGA, the visual inspection of the road surface revealed almost no damage to the substance. Two repair sites were recorded over the entire section; these, however, were due to work carried out on the drainage system. A few lateral cracks were discovered at one point on the outer edge of the built-up road. Small cracks along the road surface were also found at a few other points on the outer edges (Fig. 7).

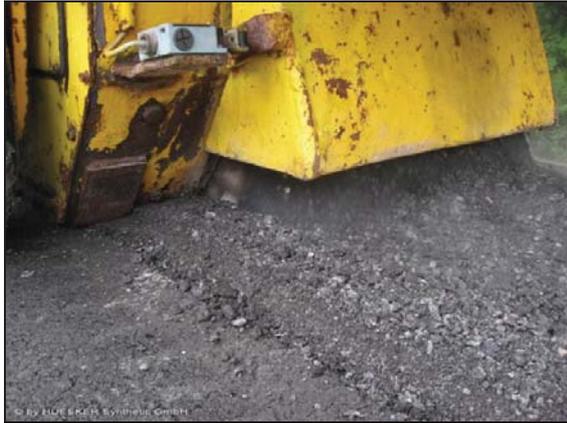
Fig. 11 Milling the asphalt including the reinforcement

A milling depth of about 50mm was selected to ensure that the asphalt surface course and the first 10mm of the asphalt binder course (including reinforcement) were removed by the milling machine in a single milling operation (Fig. 11). This procedure was recommended by the manufacturer for the removal of reinforced roads.

Result: During removal of the material no detrimental effect on the milling operation was observed. Over the full test length, the millings were finely graded. The fibres of asphalt reinforcement produced from the milling process were evenly distributed in the millings. The fibres had an average length of about 100mm.

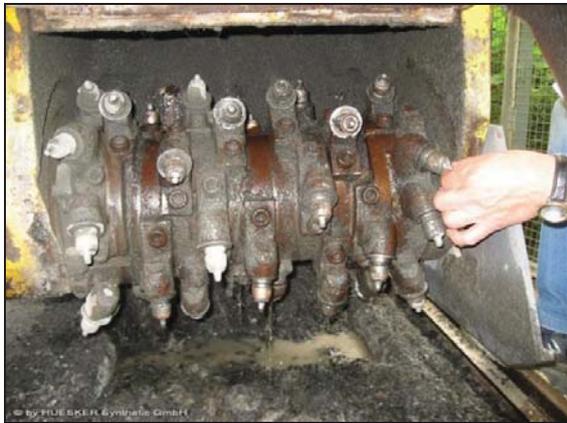
Fig. 12 Virtually no fibres on the milling drum

After completion of the milling operations, the milling drum was checked for adhering fibres. It was clear that over the whole test bed almost no (only 2) fibres had been trapped in the milling drum (Fig. 12). During this test, no detrimental effects on the milling process were observed.
