Geosynthetic interface displacements during the construction of a landfill cap

ABSTRACT: This paper reports the findings of a unique field instrumentation project on a steep, 1(v) in 2.3(h), landfill cap. Displacements and strains were monitored during and post placement of restoration soils above a geosynthetic cap. The relative geosynthetic interface displacements were measured between the Geomembrane (GM) and both an underlying geotextile and an overlying Geocomposite Drainage Layer (GDL). The instrumentation was installed during 2014 and was monitored over a five-month period. The instrumentation comprised two monitoring tables each with six extensometers to measure displacement and relative displacement within the geosynthetic lining system of the landfill cap. The locations of the extensometers were 10, 15 and 20m below the crest of the slope for both the GM and GDL. All of the extensometers cables were installed over the GM and underneath GDL panels. Additionally, six DEMEC strain gauge installations were made, each comprising a set of 4 markers to facilitated four strain measurements at each of the six locations (two measurements across the slope and two measurements along

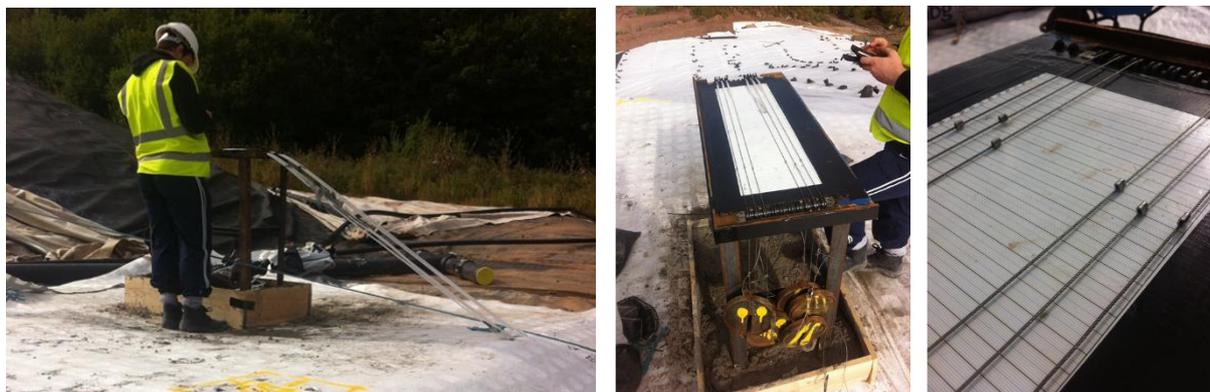
Figure 1. Extensometer Measuring Table and Cables

The investigation comprised two primary geotechnical monitoring systems and was supported by local surveying on site. The first comprised a series of wire extensometers attached to the GDL and the GM. Two monitoring tables (See Figure 1 and 2) each with six extensometers were installed as part of a monitoring condition within the permit for the site. This was to measure total displacement and relative displacement within the geosynthetic lining system of the landfill capping. The monitoring tables were spaced 10m (two panels of GM) horizontally across the slope from each other. The location of connection points of the extensometers to the geosynthetics were 10, 15 and 20m below the crest of the slope for both the GM and GDL. The extensometer system used 1.5mm steel wire within a 6mm OD nylon tubing to protect the cables from pinching outside of the area of interest. The resilience of the tubing was trialed in a 300mm shear box under 100 kPa, nearly double the maximum representative loadings. The monitoring table was a welded steel structure, fixed to a 100 mm concreted base for stability, with lubricated machined nylon runners, and was the same equipment as previously deployed at Milegate Quarry Extension landfill as reported by Zamara et al. (2012). Tensioning of the wires was carried out using weights hung from the free end of the pulley system.

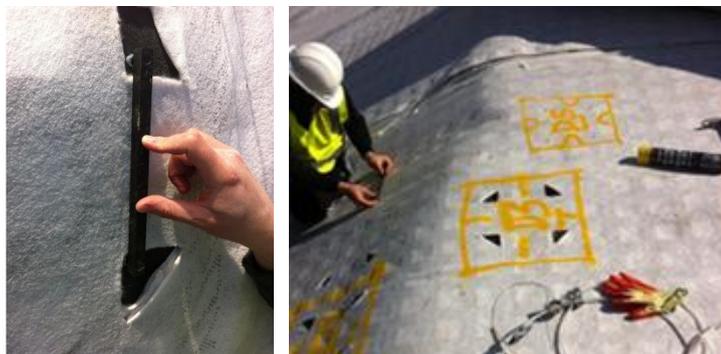
Figure 3. DEMEC installations

Six DEMEC strain gauge installations were made (above and immediately below the slope crest on the GM near to Table 1 and just below the crest near Table 2). Each comprised a set of 4 marker points (See Figure 2 and 3). This facilitated four strain measurements at each of the six locations (two measurements across the slope and two measurements along the slope). Although initial readings were taken on the DEMEC strain gauges, these were erroneously buried during the placement of the first 500mm of soil. Although they were exhumed, no meaningful readings could be taken from these and the remainder of the paper shall concentrate on the extensometer findings.
