# Leak location liner system in environmental containments - China experience

**ABSTRACT:** A proper geomembrane installation and associated construction quality assurance (CQA) are always crucial to the long-term performance of geosynthetic lining system. Traditional geomembrane CQA program focuses only on quality of welded seams through destructive and non-destructive tests. To ensure the sealing integrity of installed geomembranes, leak tests and field monitoring are designed to locate leaks in installed geomembranes during and after construction, and even when the facilities are in operation. A new generation leak location liner system has been developed, successfully tested and verified as a reliable and effective technology that significantly enhances the quality of liner leak detection surveys at post-installation and long term monitoring of installed geomembranes during operation. This paper presents two environmental containments located at southwest China that using leak location liner system. The first project is a hazardous waste landfill designing with double liner system, and the other is a demonstration pad carried out at an industrial waste facility. Field investig

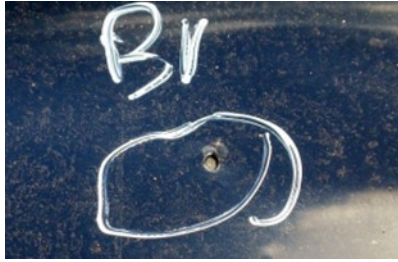
Figure 1 Defect caused by welding process

Survey data on occurrence of liner defects reveals that 24% of total amount comes from preliminary construction phase (geomembrane deployment, seam welding, etc.), 73% is related to final construction phase (backfill on geomembrane), defects occurrence at post-construction, early operational phase only takes 2% (Nosko 1996). Figures 1 and 2 are classic examples of such defects. In addition, traditional CQA program is only able to examine the liner quality during preliminary construction phase. These statistical data clearly indicates that to ensure the liner integrity and long term performance, it is crucial to carry out electrical liner integrity survey (ELIS) on the entire installed geomembrane, and this will be an effective supplement to the traditional CQA program. Electrically spark testing on exposed geomembrane (ASTM D 7240) and dipole survey on covered geomembrane (ASTM D 7007) are proven technologies for such surveys performed at the final construction stage. Leak location liner is the geomembrane product that has been tested and verified to be able to enhance the efficiency and accuracy of Electrical Liner Integrity Surveys (ELIS). The combination of leak location liner and combi-modules is the state-of-the-art technology for permanent leak monitoring of the engineering containments.

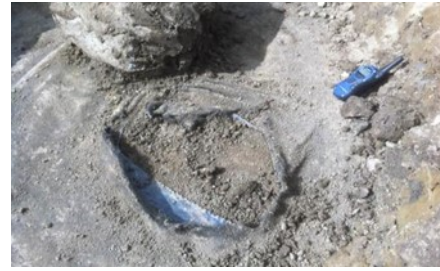
Figure 2 Hole caused by oversized aggregates

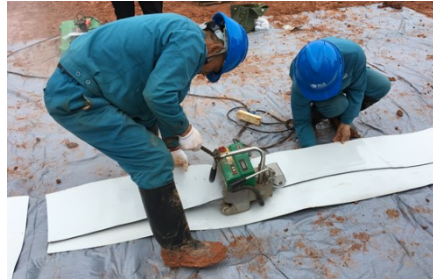
Figure 7 Iso-Wedge trial welding

- Use ISOLation-Wedge (Iso-Wedge) for welding the leak location liner. The Iso-Wedge is an improved fusion wedge that breaks the conductivity of the exposed flap from the rest of the sheet at the welded seams so as to avoid false positive signals when performing ELIS. One just needs to replace the standard wedge with Iso-Wedge prior to seam welding and perform trial welding to verify that the Iso-Wedge functions as required (Figures 5 to 7).

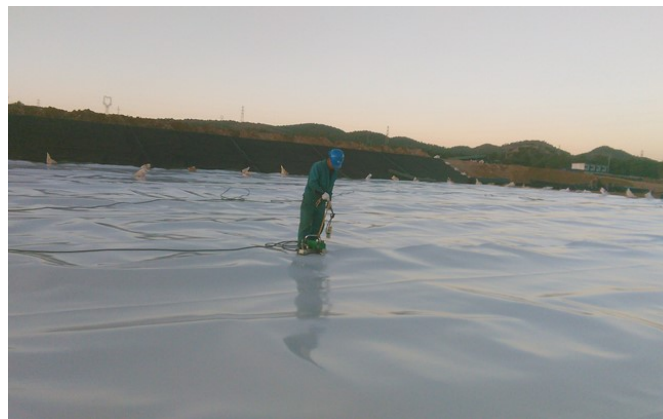
Figure 8 Leak location liner field welding in progress

The deployment and installation of geosynthetic liner system was carried out a local experienced geosynthetic installer. It took almost 40 days to complete the installation of the liner system. Figure 8 shows thermal welding of Leak Location Liner was in progress at site.

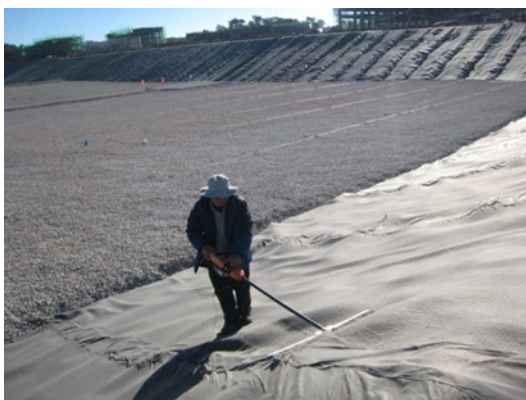
Figure 9 Spark testing at slopes

At Qujing hazardous waste landfill job site, leak testing was carried out by a local third party surveyor at post-installation and after the liner has been covered with gravelly soil. Spark testing was performed at the side slope on the installed leak location liner, and the leak integrity dipole test was performed at the base of containment where leak location liner has been covered with a layer of 30cm thick graded gravel. Water was sprayed on the area to be tested in order to enhance the conductivity of gravelly soils placed above the liner. It took about one week to finish the leak testing and integrity survey (Figure 9 and 10).

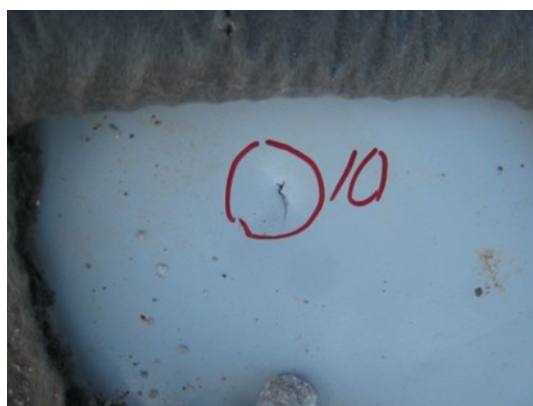
Figure 11 Example of leak detected

Several holes and defects with diameter ranging from 5mm to 50mm were detected and located using the leak location survey (Figure 11). It is believe that these defects and damages were caused during the geomembrane installation and soil backfilling process. All the damages were then repaired with extrusion welds and tested with non-destructive seam vacuum box test before covering back the gravelly soils.

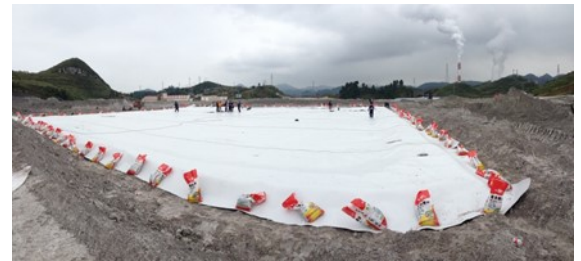
Figure 13 Overview after liner installation

A demonstration test pad of 30m x 30m was constructed on top of an existing gypsum stack. The test pad was prepared with depth of about 30cm and side slope gradient of 4H: 1V. A 60cm deep trench was also constructed to anchor the geomembrane around the peripheral of test pad. The subgrade was properly compacted and levelling before receiving the white surface leak location liner. Figure 12 shows the cross section of the demonstration pad and Figure 13 is an overview of the prepared test pad.

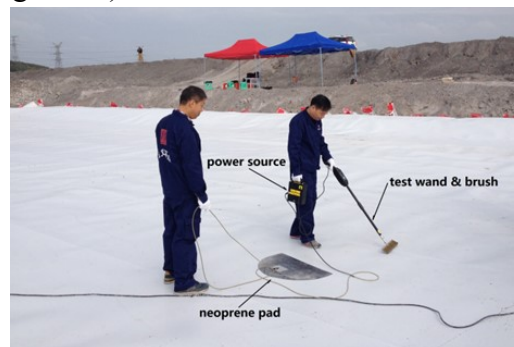
Figure 14 Spark testing in progress

2.0mm white leak location liner used for this demonstration project was deployed and welded according to conductive geomembrane installation guidelines as described in section 3.2 of the paper. Leak location surveys, in the order of spark testing, permanent liner integrity monitoring and dipole test, were implemented on the demonstration pad to verify the effectiveness of every technique means. Spark testing on the entire geomembrane surface completed within few hours. Several installation defects were found and repaired with extrusion welds (Figure 14).

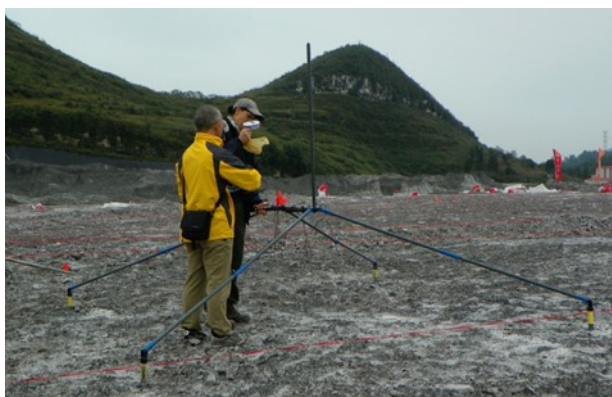
Figure 15 Dipole (quadrapole) test in progress

A dipole test (quadrapole) was conducted by a third party surveyor after two “blind” holes were placed by local EPA personnel and test pad was filled up with 30cm thick gypsum (Figure 15). The survey took about one and a half hour to complete and identified leaks that were intentionally placed as the outcome of a 15 minute data review. One of the holes, nearer to the center of the site than the other was very accurately located to a distance of just a few centimeters. The other leak was closer to the edge of the liner and because of some edge distortion effects the accuracy was not quite as good, but still within a 20 to 30 centimeter radius. Figure 16 is the dipole test electric potential diagram with two leaks being detected.

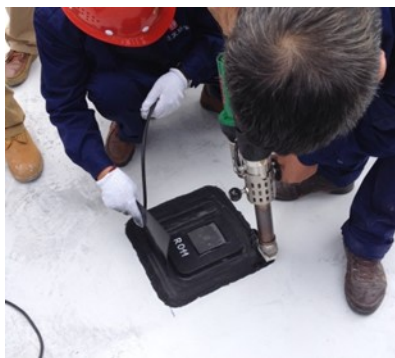
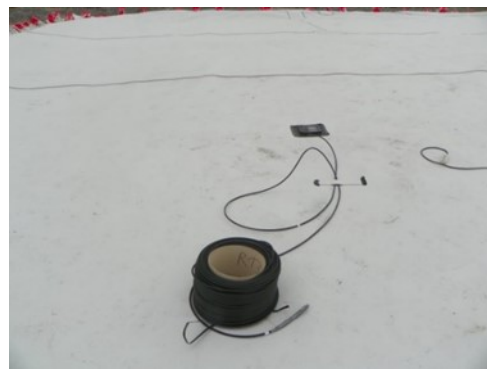
Figure 17 Combi-Module embedded in leak location liner      Figure 18 Combi-module and cable wire after installed

By integrating combi-modules into the leak location liner as shown in Figure 17, field tests have demonstrated that it is a state-of-the-art technology capable of continuous monitoring and permanent quality control of geomembrane liners during the operation of the facility. Combi-Module is an electronic device that functions both as energy source and sensor. It is rare metal plated and encapsulated into a HDPE casing, thus can last as long as the geosynthetic liner even in the harshest environment. The combi-module is embedded in the liner, for doing so, a hole which is slightly smaller than the combi-module is cut off in the membrane sheet and the sensor's flange is inserted and fixed by extrusion welding along the edge. As shown in Figure 18, an integrated cable wire is assembled on top of the liner and connected with the central monitoring unit placed at the border of the facility (usually indoor environment). The plugged-in central computer unit is responsible for collecting and analyzing data from the combi-modules located at different positions, meanwhile supplies power and activates them (Figure 19).

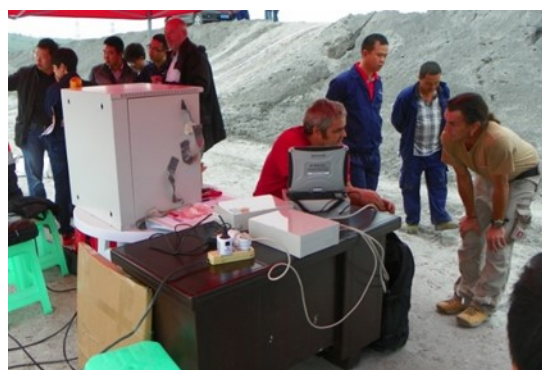
Figure 19 Central monitoring unit

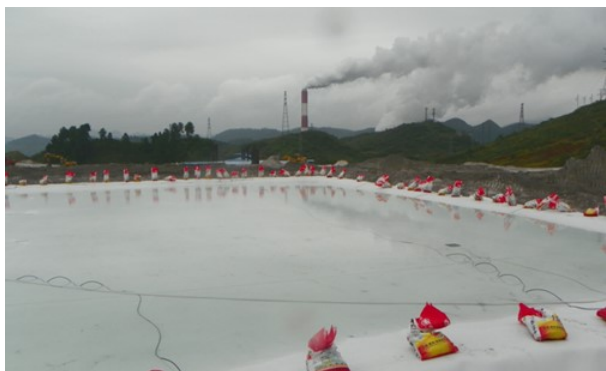
Figure 20 Test pad flooded with acid water

In the demonstration pad, three combi-modules were designed and integrated into the installed leak location liner. Leak as tiny as 1mm<sup>2</sup>, that falls within the triangle area formed by the three combi-modules can be pinpointed. After the installation of leak location liner and combi-modules, and the set-up, calibrations of the central computer unit, a background state was established first. As shown in Figure 20, the site was then flooded with acid water to a depth of between 10-25 centimeters, and officers from local EPA punched a hole, approximately 1.5 centimeters in diameter, through the liner with the absence of all surveyors. The fact is the central computer unit responds quickly within less than 30 seconds after the hole is drilled, receiving data from the three combi-modules to assist in locating the “blind” hole. From the measured data and the subsequent data analysis, the system detected the location of the blind hole with an estimated accuracy within a 1 meter diameter. This calculated location was compared with the actual measured location and was found varied by about 68 centimeters (Figure 21).

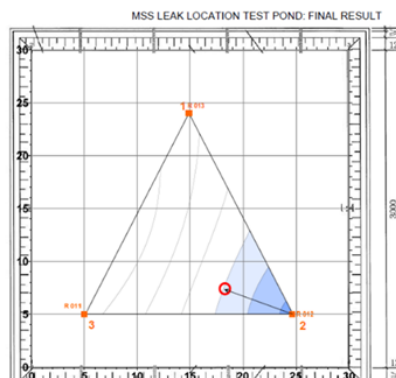
Figure 21 Leak location result
