Evaluation of the effectiveness of permeable paver in sight of water presence

Bruna Gabrielly Oliveira Ribeiro, Ivonne Alejandra Maria Gutierrez Góngora, Haroldo da Silva Paranhos & Cássio Brenner Teixeira de Souza
Catholic University of Brasilia, Brazil

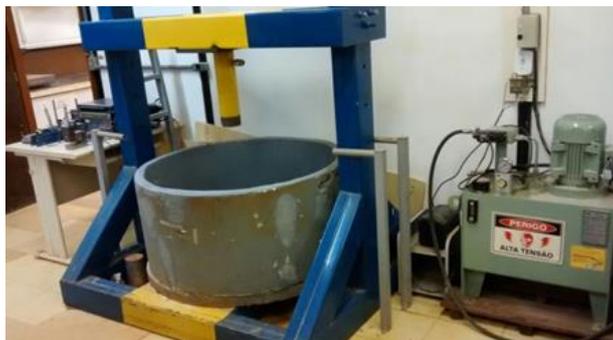
Figure 1. Equipment used in tests.

The equipment used for the tests was developed by Góngora (2015) and is found at the University of Brasília (UnB). Figure 1 illustrates the equipment.

The equipment consisted of a concrete cylindrical tank, with 1000 mm in internal diameter and 520 mm high, where the structure of the permeable paver was installed.

To simulate loads proceeding from the traffic, a hydraulic system composed for: joint engine-bomb; relief valve; valve directional solenoid; hydraulic high-pressure hoses; manometer, hydraulic cylinder and a timer were used. (GONGORA, 2015)

The equipment also counts on a reaction frame, that made possible the application of a vertical cyclic load with the intensity of 18.2 kN and a frequency of 1 Hz on a 200 mm diameter steel plate, that was placed on the surface of the structure.

Moreover, two displacement transducers were used to measure the platen vertical displacement and the vertical displacement at points on the surface of the structure, and a load cell measured the intensity of the vertical cyclic load applied.

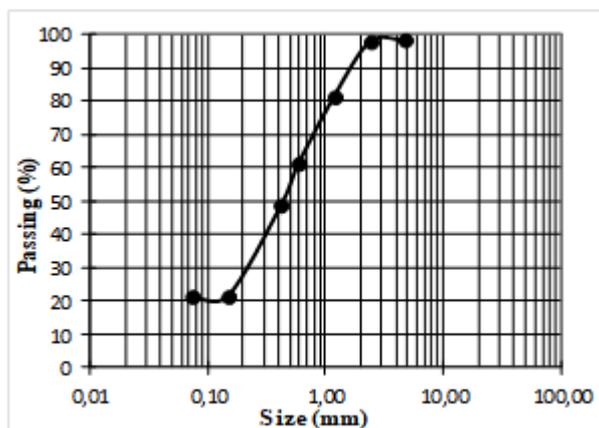
Figure 3. Particle size distribution of the laying course sand.

In the laying course, it was used a fine artificial sand with a density of 2,7. The particle size distribution curve is presented in Figure 3.

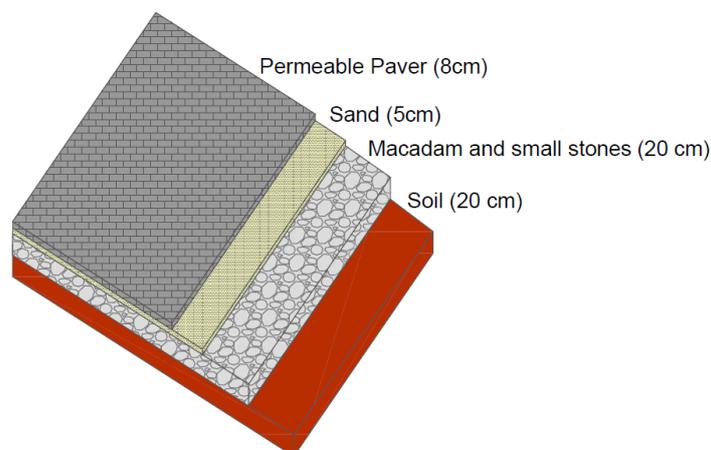
Figure 4. Schematics of the layers of the structure in the first and second test.

In the first test, as mentioned above, the load was applied on the structure with the dry base. Figure 4 presents the disposal and thickness of the layers of the structure.

The structure of the permeable paver was installed in the concrete cylindrical tank. The subgrade material was compacted in two layers (100 mm each) with a static compaction, and 117,20 Kg of soil was used per layer.

In the base layer macadam was used, and after it reaching 200 mm of height the small stones were placed. A rubber hammer was used to generate a light vibration and make sure that all the voids were filled by the small stones. The laying course (50 mm high) consisted of fine artificial sand.

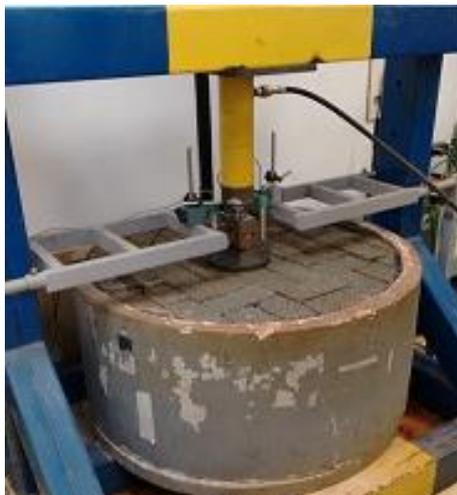
Figure 5. Second test execution.

To saturate the structure 50 L of water were used. The criterion applied to define the amount of water used to saturate the structure was the observation of the layers; once water was detected in the base layer, the test began. Figure 5 portrays the execution of the test.

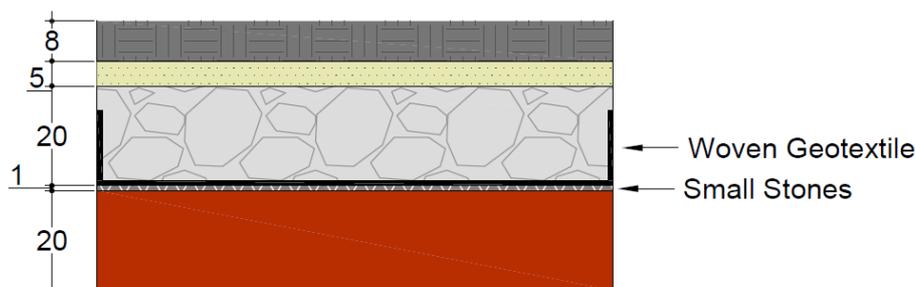
Figure 6. Schematics of the layers of the structure in the third test (dimensions in centimeters).

In the third test, the loads were applied on the surface of a saturated structure reinforced with a woven geotextile. Figure 6 presents the disposal and the thickness of the layers of the structure.

The geotextile was placed in the interface base-subgrade, since they are the most requested layers in the structure and, therefore, where there was a greater necessity of reinforcement.

A 1 cm layer of small stones was added over the subgrade layer, before placing the geotextile, in order to provide a better adherence of the geotextile to the structure.

The geotextile extremities were folded in the base layer to guarantee its anchorage and avoid problems during the application of the loads. After placing the geotextile, the procedures used in the other layers were similar to those mentioned above in the previous tests.

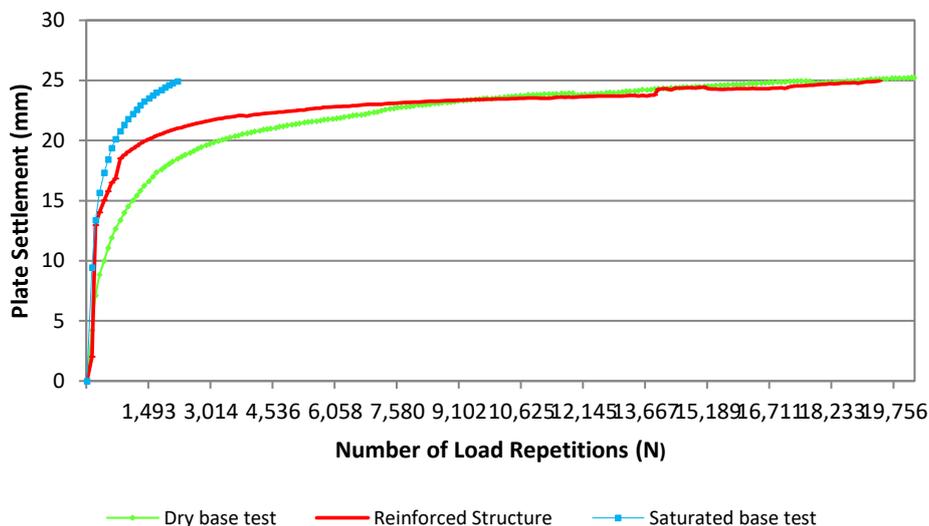
Figure 10. Plate Settlement of the structures of the three tests versus number of load repetitions.

Figure 10 presents the comparison of the vertical displacements versus the number of load repetitions gotten in the tests.

As it was presented in Figure 10, the saturated and the reinforced structure had shown a similar behavior in the beginning of the test. However, after reaching 15 mm of vertical displacement, it was possible to notice a loss of stability on the saturated structure, that ended up reaching the maximum vertical displacement (25 mm) quickly.

The reinforced structure, on the other hand, had its performance improved by the action of the woven geotextile. The geotextile acted distributing the load applied and making the structure work together, in order to support it without harming its stability. Due to this reinforcement, the structure was capable of bearing up to eight times more numbers of load repetitions than the saturated structure.

In the first test, the maximum vertical displacement (25 mm) was reached after a number of 20.230 load repetitions. Due to the error in the installation of the permeable paver, the data of this result will not be taken as relevant in the conclusion of the research, but only as means of comparison to the performance of the other structures.

In the second test, the maximum vertical displacement was reached by the saturated structure after a number of 2.230 load repetitions. And in the third test, the reinforced structure reached the vertical displacement of 25 mm after a number of 19.457 load repetitions.

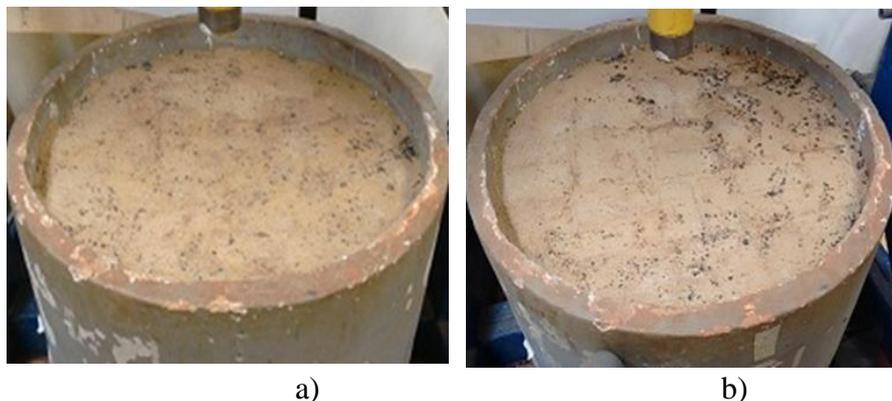
Figure 11. a) Laying course of the saturated structure, b) Laying course of the reinforced structure.

The layers of the saturated structure presented a deformation only where the loads had been applied, which means that the load were bore by one spot in the whole structure. It explains why the maximum vertical displacement was reached after a fewer number of load repetitions when compared with the other structures.

The reinforced structure had a completely different behavior, and while observing its layers it could be noticed the action of the geotextile in the improvement of the structure's performance. Differently from the saturated structure, the layers did not present an accented deformation in the spot where the stresses had been transferred, once the geotextile acted in the distribution of the loads.

The different deformations obtained by the structures after the tests are represented in Figure 11a and 11b, that presents the laying course of the saturated structure and the laying course of the reinforced structure, respectively.
