Design considerations for high reinforced soil structures in a mountainous and seismically active region in Luzon, Philippines

Jose Carlo Eric L. Santos, MSCE, John Michael B. Gargullo & Karen Joy R. Leobrera
AMH Philippines, Incorporated, Philippines

This paper presents the design considerations for high reinforced soil structures (RSS) constructed on a seismically active mountainous region.

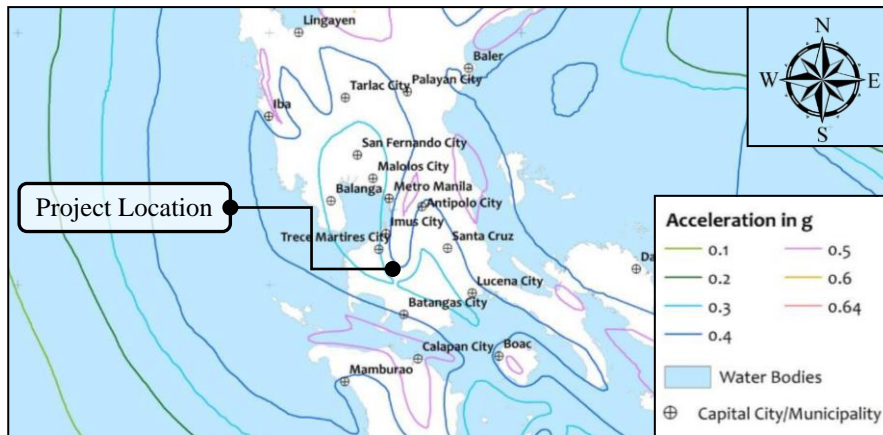
Figure 6. Extract from Peak Ground Acceleration Map of the Philippines for 500-yr Return Period on Stiff Soil (PHIVOLCS)

The nearest seismic sources, West Valley Fault (WVF) and Lubang Fault (LF), were considered in the analysis. Considering the assigned magnitude and proximity to the project site of these seismic sources, PGA values of 0.30g and 0.28g were computed for WVF and LF, respectively. Moreover, peak ground acceleration (PGA) values, were also verified from the PGA Acceleration Map of the Philippines published by PHIVOLCS. Based on this, the project site may experience PGA between 0.3g and 0.4g.

For prudence, PGA value of 0.4g was used in the analysis. Thus, for the design of the reinforced soil structures, a maximum horizontal (kh) and vertical (kv) seismic acceleration of 0.2g and 0.1g, respectively, were considered in the analyses. These seismic coefficients were based on the recommendations of Hynes-Griffin and Franklin to consider coefficients equal to 0.5 of the PGA.

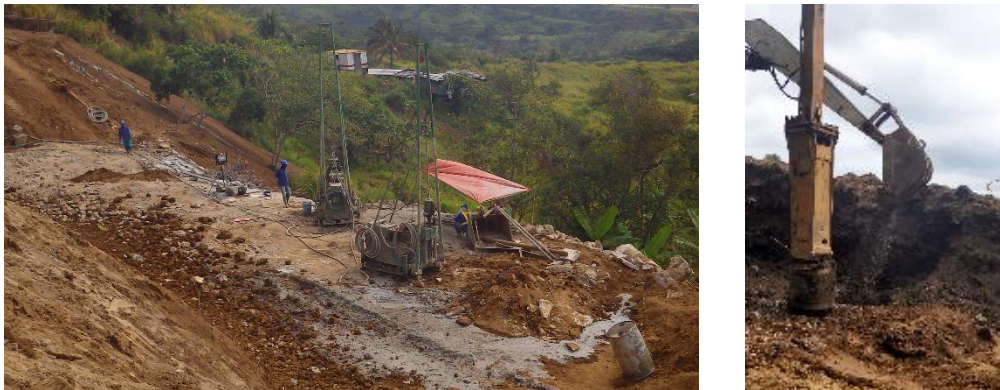
Figure 9. Jet grouted piles and stone columns construction photos

Considering the height of the structure, it was anticipated that it will induce significant load on the slope. Based on the soil investigation results, the upper layers of the subsoil where the RSSs will rest, predominantly consist of loose to medium dense sand. As such, ground improvement techniques such as jet grouting and stone columns, were utilized to support the structures. Moreover, these were also employed to intercept deep seated failure surfaces.
