Engineering performance assessment of a reinforced soil retaining wall founded on unstable ground

ABSTRACT: Excessive settlement caused by deep ground instability problem raised the alarm for a retaining wall founded on such problematic ground conditions. The reinforced soil retaining wall is over 10 m high and functions as a separation between two levels of high value residential properties. There were genuine concerns over potential sudden rupture of reinforcement induced by excessive settlement which could result in heavy concrete facing panels falling down and large scale slope movement. Performance assessment of the retaining wall was therefore undertaken by reviewing the original retaining wall design and construction, site inspection and investigation followed by numerical modelling which enabled the engineer to not only assess the wall condition at the time but also predict the future performance as a result of further settlement. The review of the original design shows that the local and global stability assessment gives adequate factors of safety based on the assumption that the wall was constructed to the design requirements. The site inspection and investigation reveal

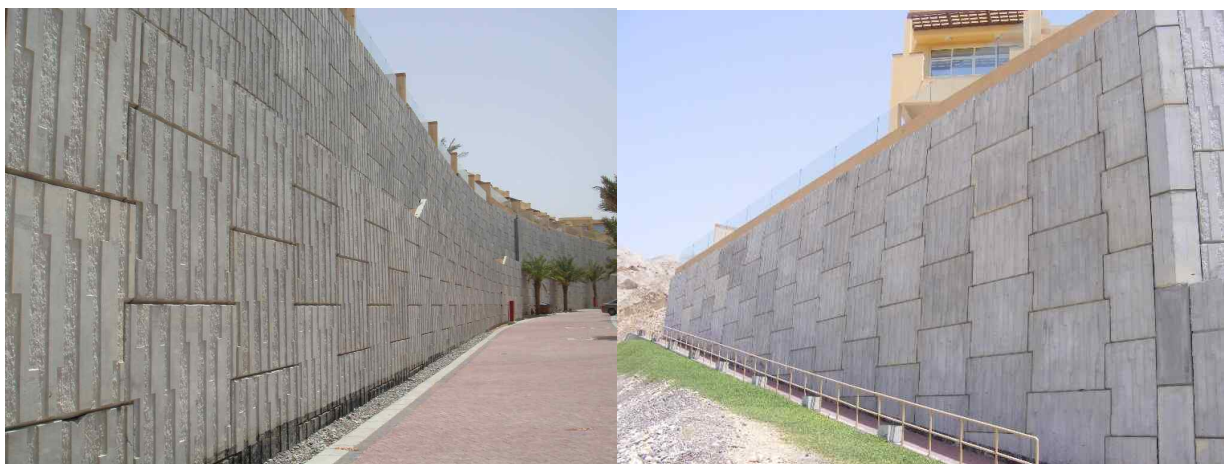
Figure 1. Views of Retaining Wall

The retaining wall comprised two tiers (lower and upper) of 6 m and 5.5 m height respectively, as shown on Figure 1. It is founded on a concrete levelling bed set on the engineered rockfill. Reinforcement behind the wall was polyester single strap reinforcement placed in 600 mm layers, ranging in strength from 70 kN for the bottom four layers, 50 kN for the middle four and 30 kN for the top four layers in each section of the wall. Granular backfill was used in the wall construction, compacted in 200 to 300 mm layers. Precast reinforced concrete facing panels are used to support the anchorage for the reinforced earth mass. The reinforced soil mass is approximately 9 m in depth and approximately 200 m in length. Drainage is provided at the back of the wall via a free draining material wrapped in a geotextile material to prevent ingress of fines.

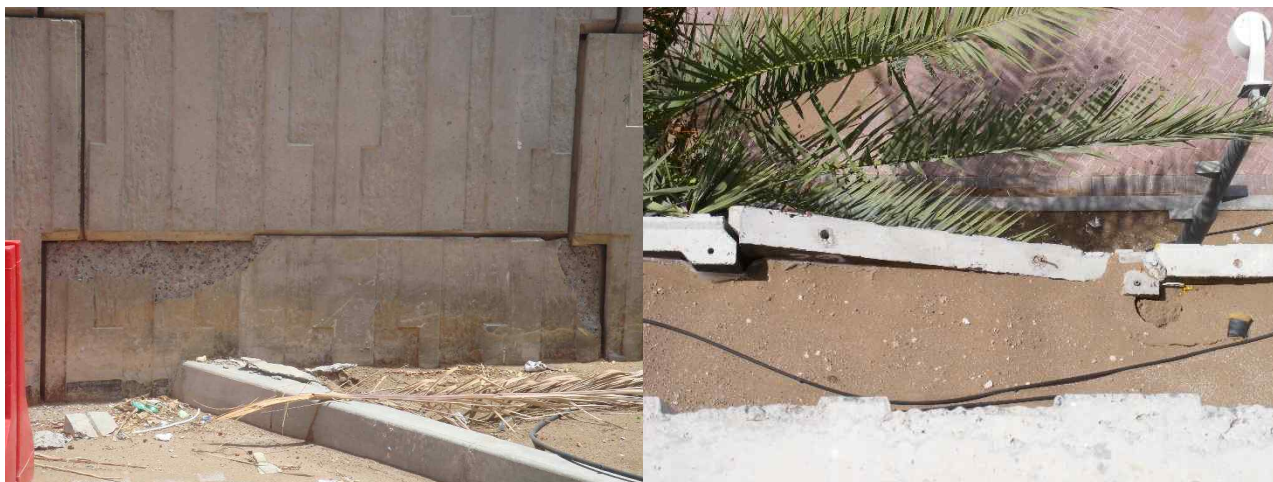
Figure 2. a) Damage near the bottom of the wall; b) Panel movement observed from top

The initial inspection of the retaining wall identified obvious signs of distress caused by the ground settlement. Localised settlement has occurred over an approximate length of 30 m of the retaining wall directly in front of Villas No.3 to No.7 on the upper level. In addition, there were crushed corners of the

concrete panels at the base of the wall indicating excessive settlement had taken place, as shown on Figure 2a. When viewing the wall from the upper level numerous bulges can be observed and some panels are displaced laterally by up to 50 mm, as shown on Figure 2b. There were also leaks of drainage gravels through the enlarged gaps between the concrete panels.

Lateral movement of the retaining wall varies over the length of the wall between Villas No.4 and No.8 at the upper level, and can be clearly demonstrated with reference to the gaps between the tie columns (supported on the capping beams to the wall) and wall panel (supported on footings bearing on the fill). Evidence of ground movements can be seen within the landscape area at the upper level behind the retaining wall.

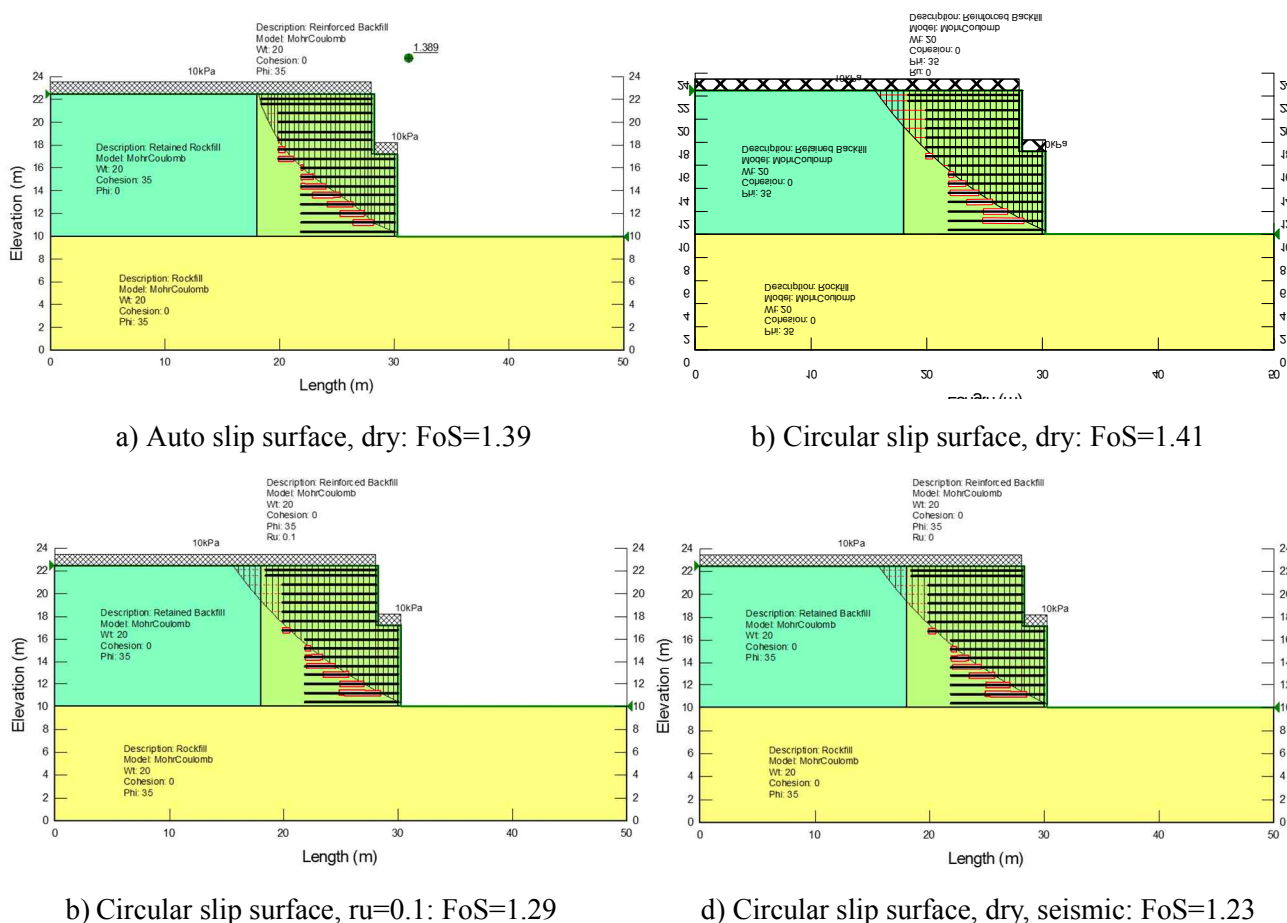
Figure 4. Global slope stability analyses

Global stability of the reinforced soil retaining wall was analysed using the generalised limit equilibrium method. The dimensions of the retaining wall and the configuration of the reinforcement are directly taken from the existing information as detailed above, as shown on Figure 4.

The factor of safety calculated for the dry condition (Figure 4a) using the auto located slip surface function is 1.39. When using the circular slip surface (Figure 4b), the factor of safety slightly increases to 1.41. When applying a pore water pressure which is equivalent to a r_u value of 0.1 (Figure 4c), the factor of safety reduces to 1.29. These values are satisfactory considering a minimum required value of 1.30. The effect of a seismic coefficient of 0.1 indicated in the original design was also analysed. The factor of safety is calculated as 1.23 and considered satisfactory, as shown on Figure 4d. The review therefore concluded that the compound stability of the original retaining wall design was acceptable.

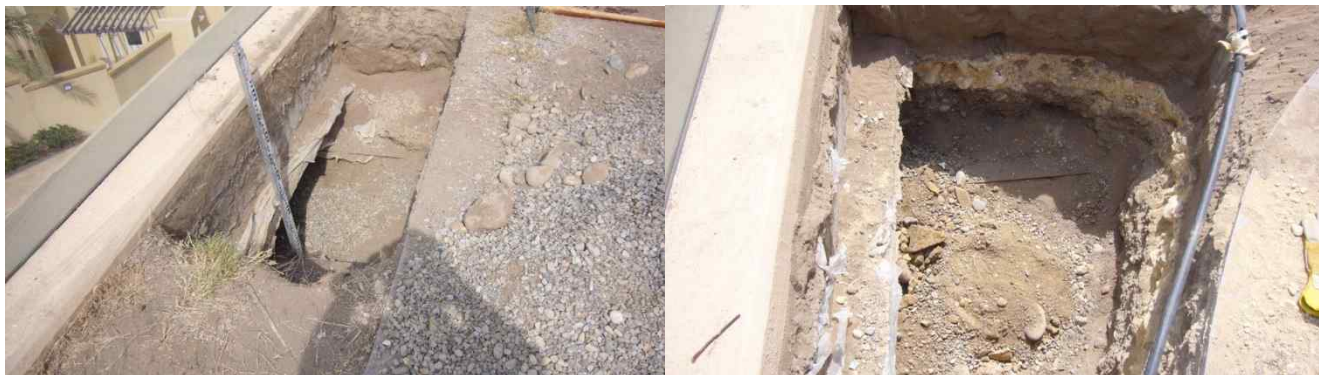
Figure 5: Trial pit excavation

Trial pitting was carried out to examine the connections between the reinforcement and the concrete panel. Four trial pits were excavated behind the face panels of the reinforced soil wall, as shown on Figure 5. The purpose of the trial pitting was threefold:

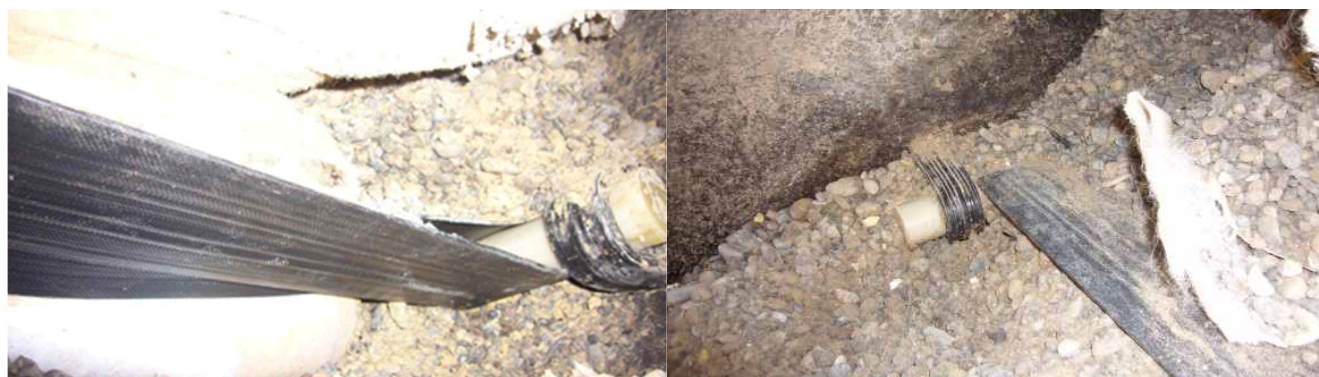
Figure 6. Condition of connections between reinforcement and facing panel

The top connections to the panels were exposed in all four trial pits and found to be in a satisfactory condition with no evidence of overstressing or damage, as shown in Figure 6.
