Experience with geosynthetics in canal irrigation projects supported by the world bank

Herve Plusquellec

Consultant, Former World Bank Irrigation Adviser, France

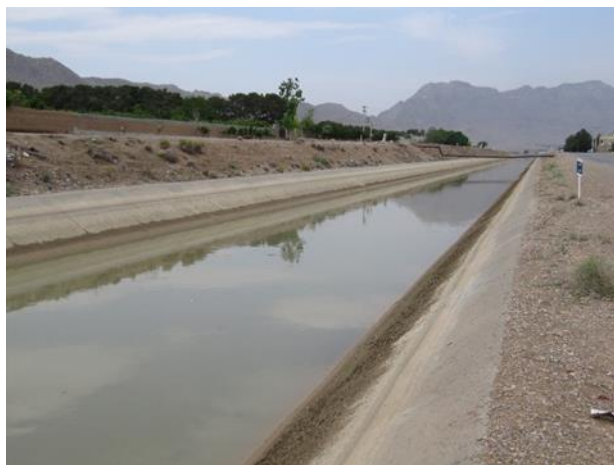
The author of this paper did not have the opportunity to visit the project located around the city of Raqqa. However he visited the main canal serving the Esfahan area in April 2016, about 45 years after the installation of the geomembranes. No damages was reported by the management office of the canal with only a case of buckling of the concrete panels due to exposure to very high temperatures during a closure of the canal.

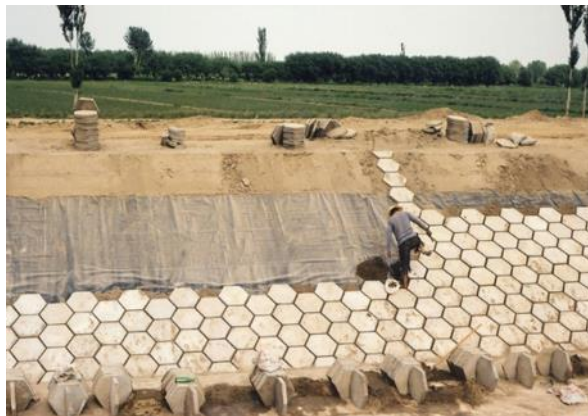
results clearly indicate the low performance of concrete lining alone in adverse climatic conditions and the higher performance of welded geomembranes. The remaining loss of 4 to 6 mm per day reflects the quality of workmanship of the geomembranes and its protection during installation. The author has no information on the performance of canal lining under these two project during the last 15 years, and especially the stability of the thin prefabricated panels placed over the geomembranes.
